# Arboricultural Report

Proposed alterations  
Former HSBC Bank  
High Street  
Ruabon  
Wrexham  
LL14 6NH

*For the purpose of dealing with all tree issues in accordance with  
BS5837:2012 Trees in Relation to design, demolition and  
construction: Recommendations for a development at the site*

Survey date:  
3<sup>rd</sup> July 2018

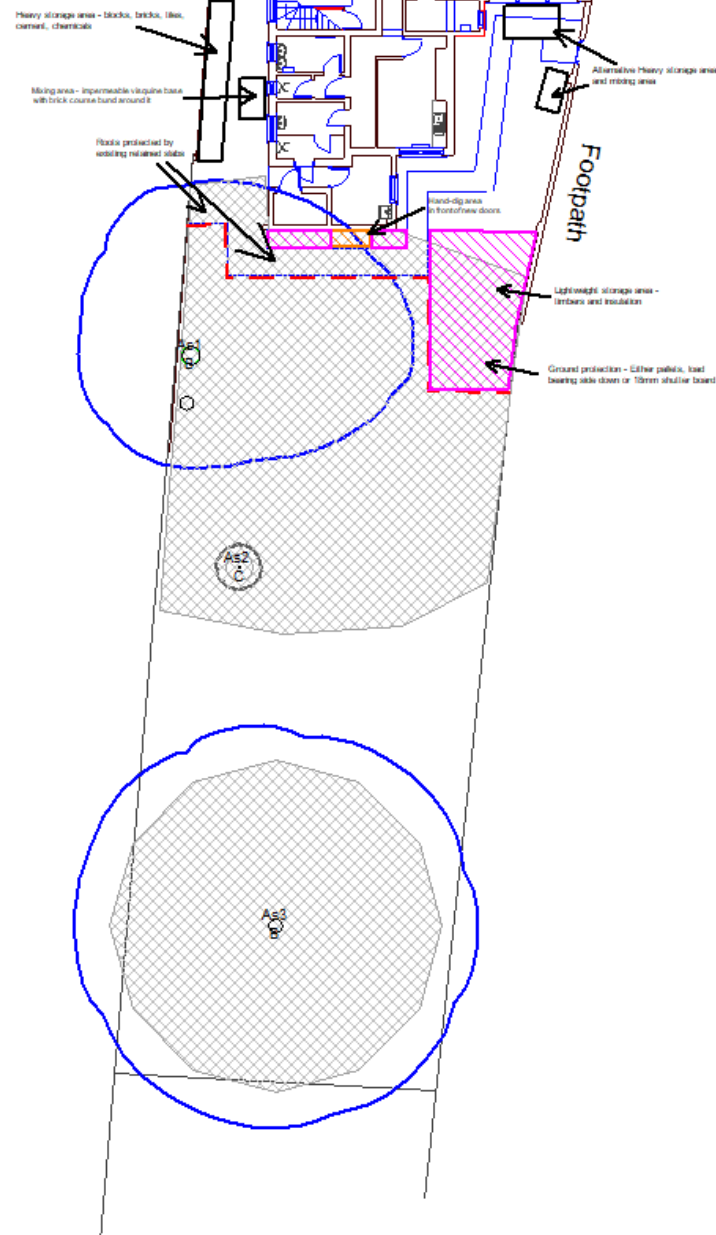
| <b>Summary TPP</b><br>Former HSBC Bank, High Street, Ruabon,<br>Wrexham, LL14 6NH | |

| <b>Tree Protection Plan</b><br>Showing all retained trees, crown dimensions, tree categories,<br>RPAs, fencings, careful hand dig areas and storage areas | |

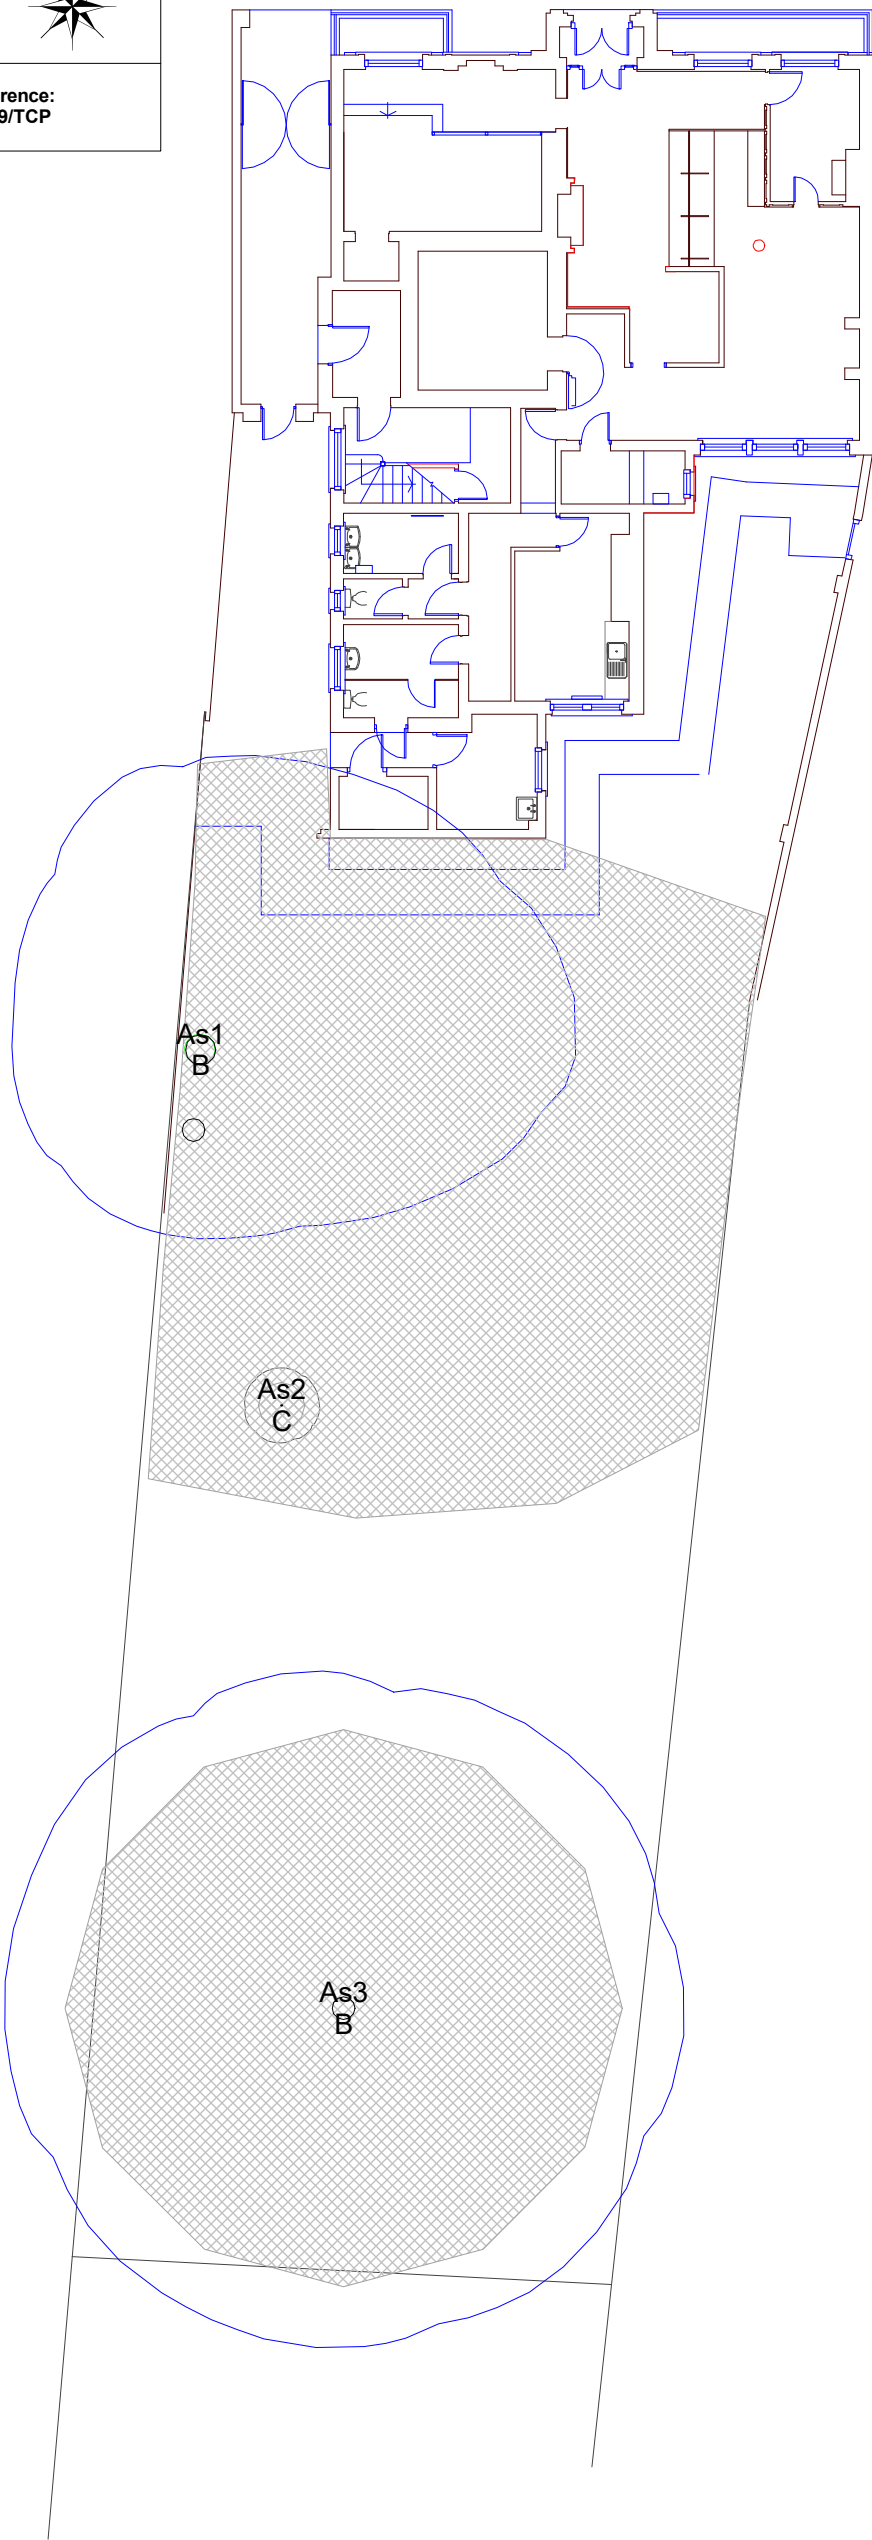
# Appendix B

Tree Protection Plan  
Showing all retained trees, crown dimensions, tree categories, RPAs, fencing, careful hand dig areas and storage area

Heavy storage area - blocks, bricks, tiles, cement, chemicals

Mixing area - impermeable visquine base with brick course bund around it

Hand-dig area in front of new doors

Lightweight storage area - timbers and insulation

- 7.10 A small area, at the rear of the building, where a new entrance is to be created will require some excavation to lay a patio at the same level as the existing slabs. Excavations will need to be made to approximately 100mm depth. It is not expected that significant roots above 50mm in diameter will be found here but it could happen. Should smaller roots be found they should be neatly cut using secateurs. Should larger roots be found, the opinion of an arboriculturist should be sought to ensure roots are not damaged, and a system of boxing them in is devised. The remaining area not excavated should be protected from compaction by laying 18mm thick shuttering board on it.

- 7.11 Space in the rear garden for storage of large construction items is limited. Appendix B shows where a part of the RPA of As1 is used as a storage area for lightweight products such as insulation and timbers. Heavy items such as packs of bricks will need to be dropped off at the front of the property and brought around by hand or wheelbarrow into the areas specified in Appendix B.

- 7.12 An area is also shown for mixing of cement and chemicals. To prevent contamination of the soil which can be of harm to nearby trees an impermeable base such as visquine should be used with a brick height bund around it to prevent loss of any liquids.

- 7.13 The entire base of the lightweight storage area over the RPA is to be constructed of either upturned pallets (pallets with flat face on the ground) or 18mm diameter shutter board. It is to remain in place throughout the build, whether used or not.
