# Arboricultural Report

Land behind Sion Chapel,  
Pontfadog,  
Wrexham

*For the purpose of dealing with all tree issues in accordance with  
BS5837:2012 Trees in Relation to design, demolition and  
construction: Recommendations for a development at the site*

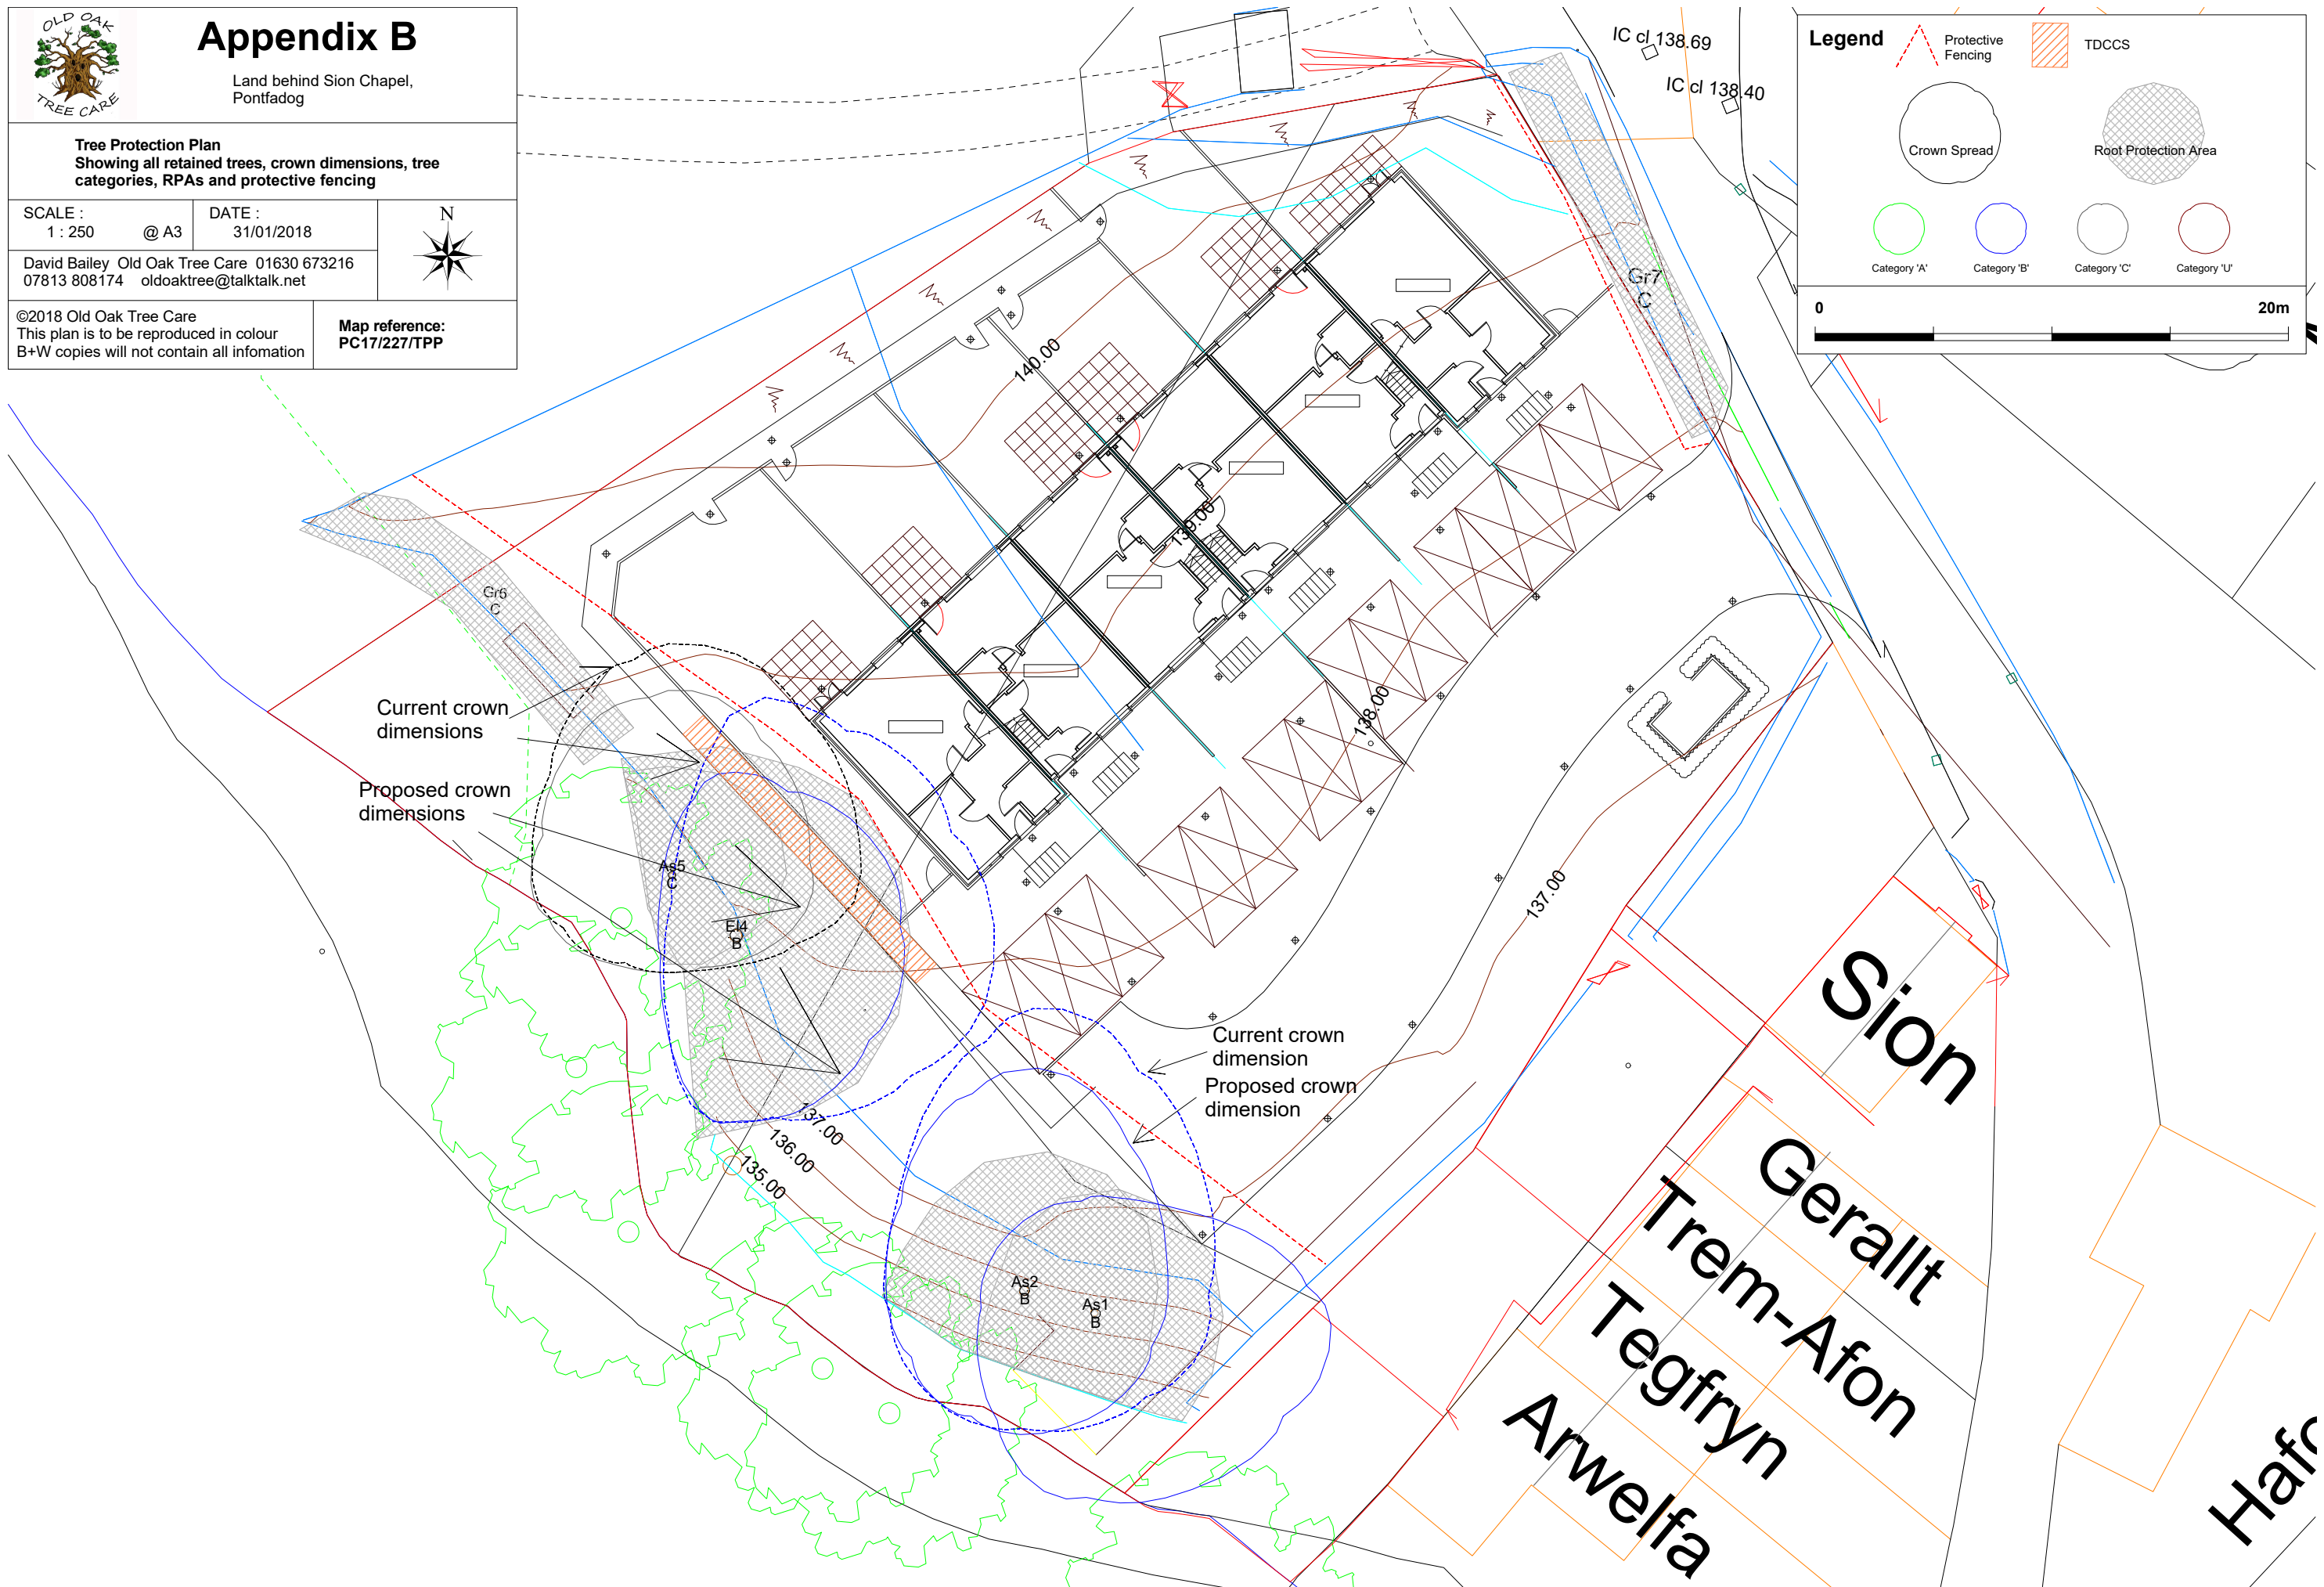
**Tree Protection Plan**  
Showing all retained trees, crown dimensions, tree  
categories, RPAs and protective fencing

- 6.3 In addition to this, the crowns of As5 and As2 should be cut back, away from the site by 2 metres to further reduce overshadowing and increase the amenity of the trees. Appendix B shows the extent of crown reshaping.
