## **TREE REPORT (BS 5837:2012)**

PROPOSED NEW CEMETERY

BANGOR ON DEE  
WREXHAM  
NORTH WALES

Author: P Murray  
Date: 19<sup>th</sup> April 2017  
Ref: PM/BS/19/04/17

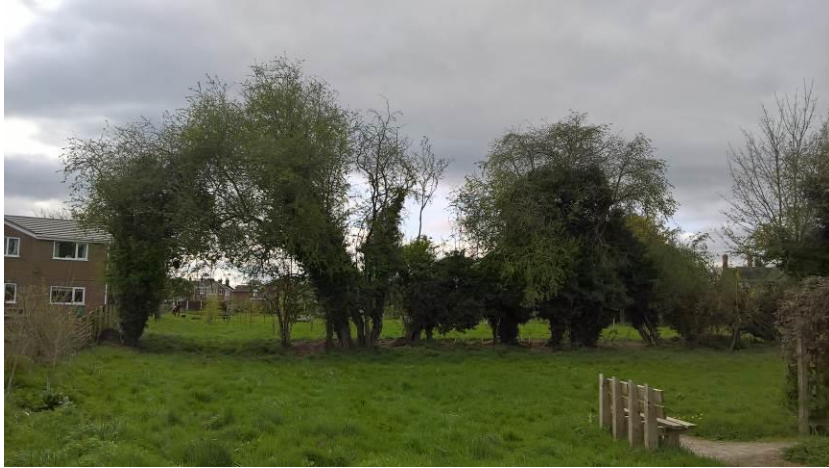
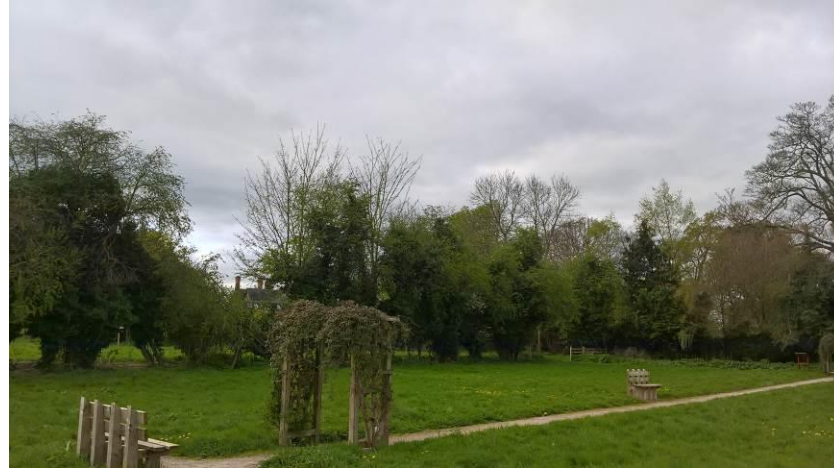
| Arboricultural Data Sheet: New Cemetery, Bangor on Dee Community Garden, off Friars Court | | | | | | | | | | Date of Survey: 11/04/17 | | Surveyor: PM | | | |
|---|---|---|---|---|---|---|---|---|---|---|---|---|---|---|---|
| H1 | Hedge - Thorn, Elder & Sycamore | 300 | <10 | Y-M | 7 | 3 | 5 | 3 | 0 | B/C | An old overgrown Thorn hedge with several stems in decline and several breakouts present. Most of the group is swamped in Ivy. Several Elderberry present and 3 early-mature Sycamores with Squirrel damage. Some young plants have been planted in gaps but severely shaded out. - <b>Consider coppicing all Thorn &amp; Elderberry within the winter months and re-planting the gaps.</b> | 10+ | C2 | 40.72 | 3.60 |

H1 – Pre-dominantly Thorn

- H1 – Coppice all Thorn & Elderberry within the winter months and re-plant the gaps with Hawthorn whips. Retain the three Sycamore trees.
- T1 – Check ownership and reduce crown by approx. 30% to form a pollard.
- H2 – Check ownership and coppice all stems and plant up gaps with Hawthorn whips.
- H3 - Coppice all stems and plant up gaps with Hawthorn whips.

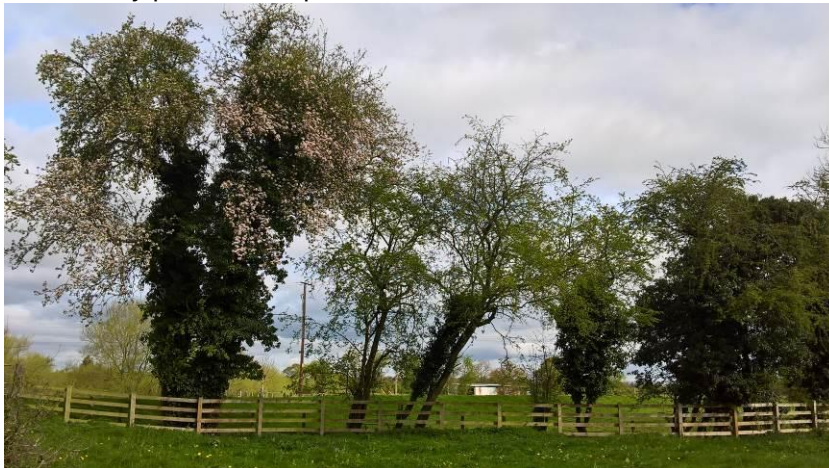
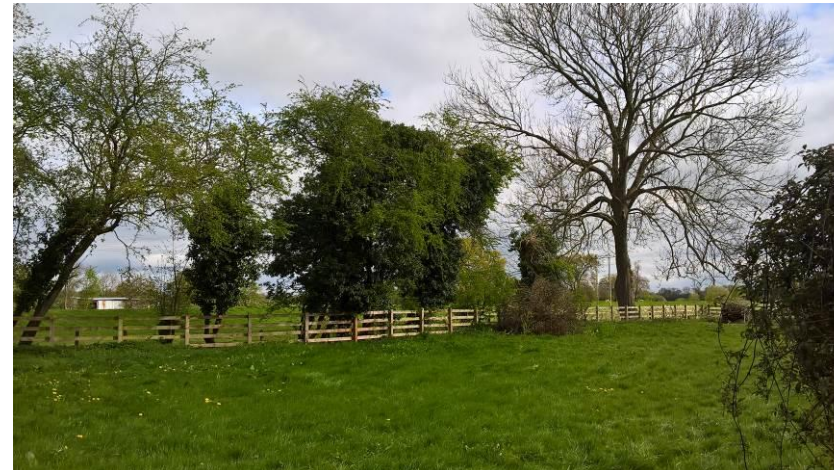
| Arboricultural Data Sheet: New Cemetery, Bangor on Dee Community Garden, off Friars Court | | | | | | | | | | Date of Survey: 11/04/17 | | Surveyor: PM | | | |
|---|---|---|---|---|---|---|---|---|---|---|---|---|---|---|---|
| H2 | Hedge - Thorn | 400 | <10 | FM | 4 | 3 | 5 | 3 | 0 | C | An old overgrown hedge within old ditch, ownership unclear. One stem recently snapped. Most of these stems are swamped in Ivy and have significant basal damage. - <b>Consider coppicing all stems within the winter months and re-planting the gaps.</b> | 5-10 | U | 72.38 | 4.80 |

H2 – Mostly poor Thorn specimens

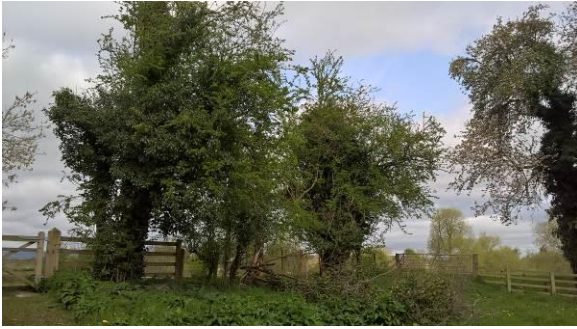
| Arboricultural Data Sheet: New Cemetery, Bangor on Dee Community Garden, off Friars Court | | | | | | | | | | Date of Survey: 11/04/17 | | Surveyor: PM | | | |
|---|---|---|---|---|---|---|---|---|---|---|---|---|---|---|---|
| H3 | Hedge - Thorn | 300 | <6 | M | 3 | 4 | 3 | 3 | 0 | C | An old overgrown hedge exhibiting poor form with one failed stem present. All stems swamped in Ivy. - <b>Consider coppicing all stems within the winter months and re-planting the gaps.</b> | 5-10 | U | 40.72 | 3.60 |

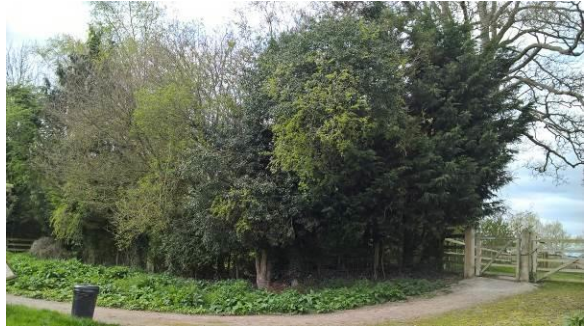
| Arboricultural Data Sheet: New Cemetery, Bangor on Dee Community Garden, off Friars Court | | | | | | | | | | Date of Survey: 11/04/17 | | Surveyor: PM | | | |
|---|---|---|---|---|---|---|---|---|---|---|---|---|---|---|---|
| G1 | Group - Cypress, Birch, Field Maple, Thorn & Elderberry | 180 | <10 | SM-EM | 4 | 4 | 4 | 4 | 0 | B | A group of closely planted specimens within the adjacent garden. | 20+ | B2 | 14.66 | 2.16 |

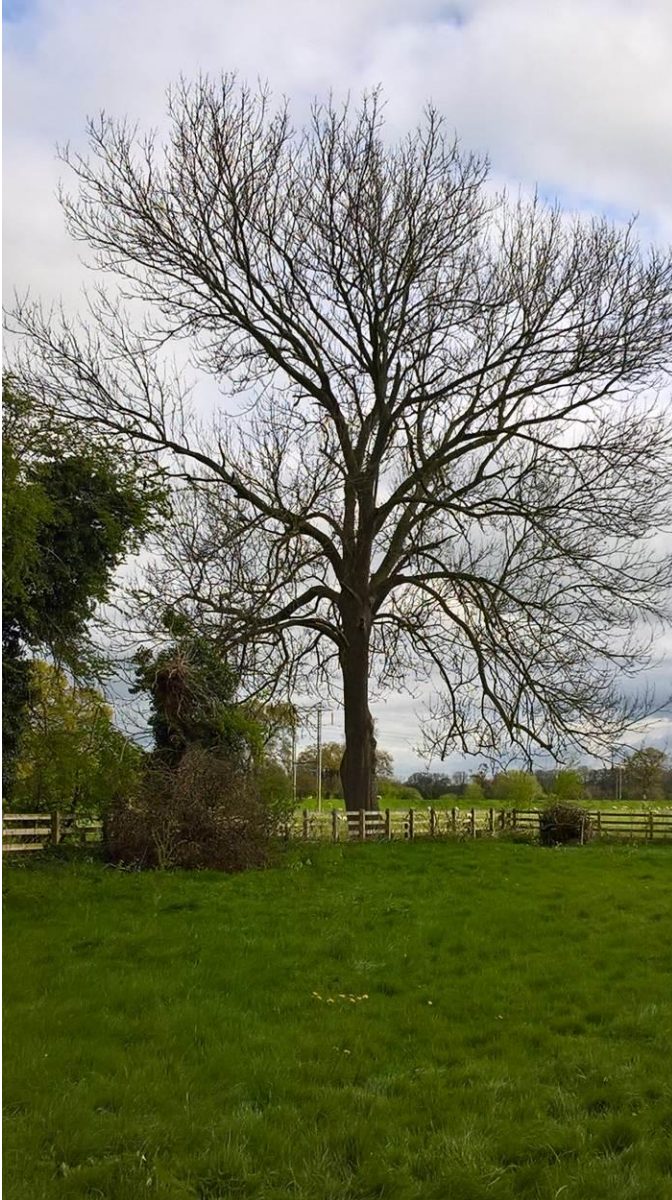
| Arboricultural Data Sheet: New Cemetery, Bangor on Dee Community Garden, off Friars Court | | | | | | | | | | Date of Survey: 11/04/17 | | Surveyor: PM | | | |
|---|---|---|---|---|---|---|---|---|---|---|---|---|---|---|---|
| T1 | Ash | 1010 | 18 | FM | 11 | 12 | 9 | 12 | 3 | B/C | A large individual specimen located within the adjacent field within an old ditch. The tree exhibits reasonable form but shows evidence of several limb failures and broken branch stubs throughout its crown. It is forked at 2.5m and has a cavity at approx. 3m with some decay present. This tree is obviously reaching the end of its safe useful life expectancy and if the area is to be used on a more regular basis then it would d be a hazard in its current state. - <b>Reduce crown by approx. 30% to form pollard and remove deadwood.</b> | 10+ | C2 | 461.48 | 12.12 |

T1 – Ash
