## Ash Road South

### Tree climbing survey for bats

### Badger assessment

*Report date:* 15 August 2016

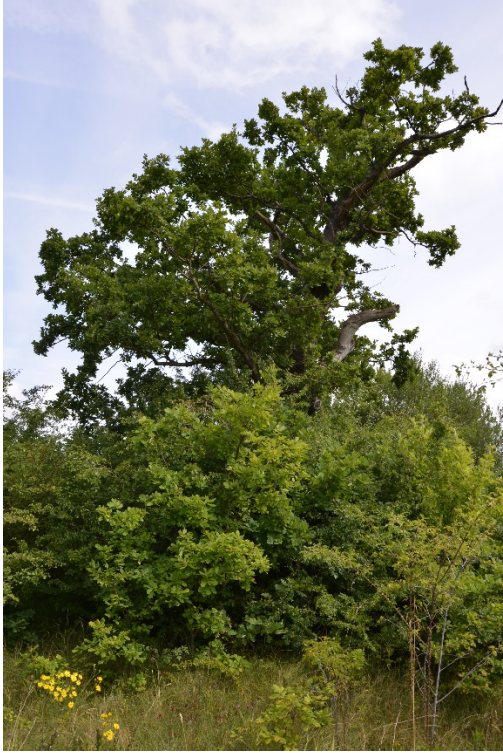
| <p>T1 Northernmost oak <i>Quercus robur</i></p> | <p>10m height</p> <p><i>Potential bat roost features:</i></p> <ul style="list-style-type: none"> <li>1 deadwood/splits, East facing, 5m height</li> <li>2 pruning wound, East facing, 6m height</li> <li>3 Cavity underneath branch, East facing 7m height</li> <li>4 Split bark, West facing 6m height</li> <li>5 Rot hole, South facing 6m height</li> </ul> |

All features were inspected at close quarters and did not contain evidence of use by bats, and/or did not contain cavities of sufficient size to provide habitat for bats.

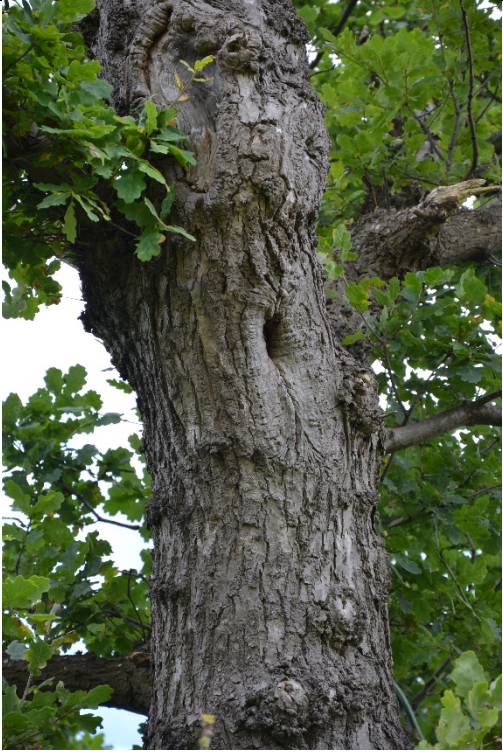
| | <p>Example of stem cavity</p> |

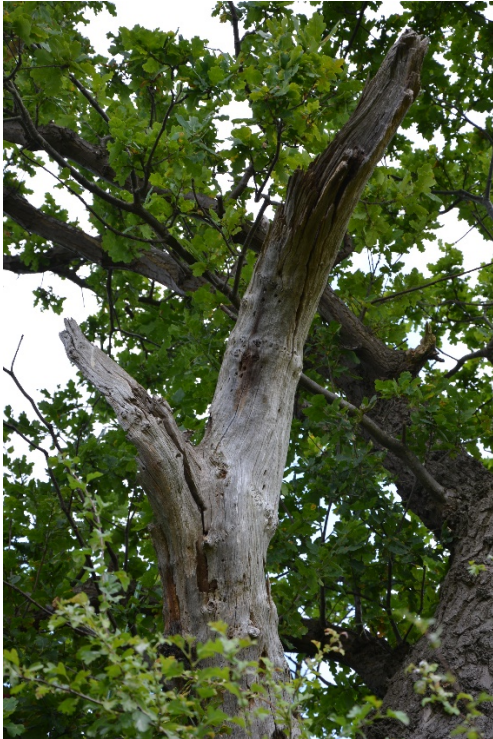
Example of deadwood split cavities

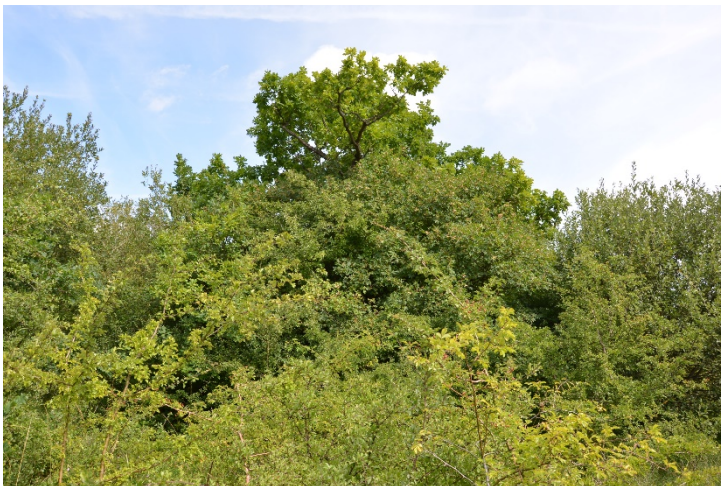
T2 central oak

8m height  
Stem failure open to elements from top.  
Stem rot and ivy covered.  
No suitable cavities present

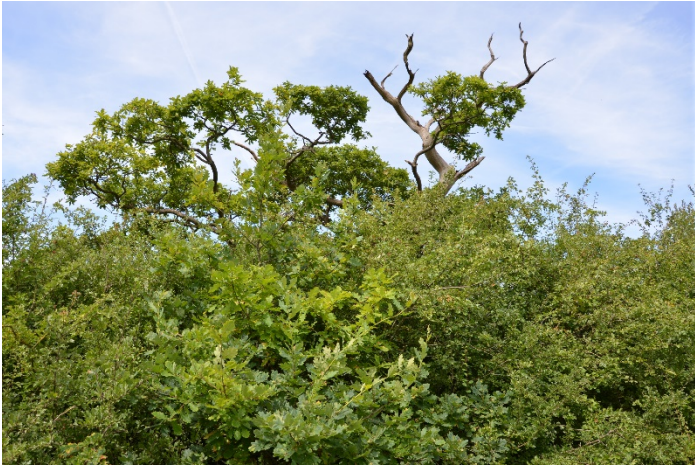
| <p>T3 southernmost oak</p> | <p>8 height<br/>Stag-headed oak in declining health<br/><i>Potential bat roost features:</i><br/>1 Lifted bark – open to rain ingress<br/>2 Various small rot holes<br/>3 Deadwood cavity, North facing, 6m height<br/>4 Deadwood cavity, South facing, 7m height</p> |

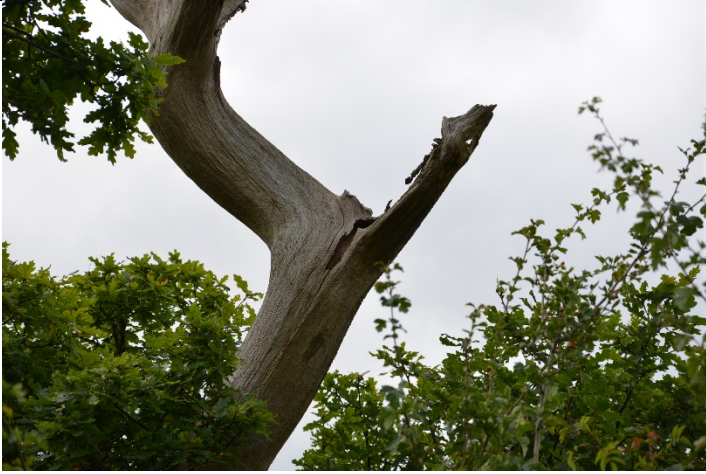
| | <p>Example of deadwood split cavities</p> |

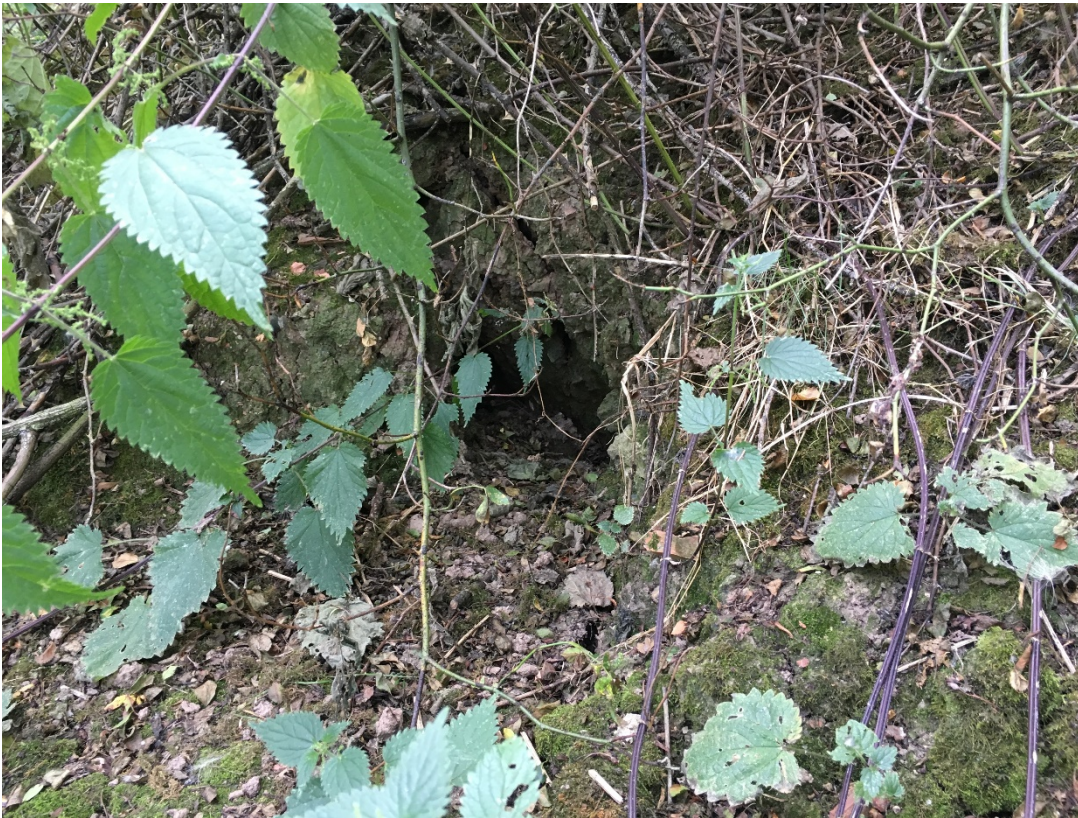
Fox/rabbit hole on site's northern boundary

The site did not contain evidence of badger runs and only two holes were present along the northern boundary. The holes were not in recent use and appeared to have been dug by rabbits or a fox.
