# Preliminary Arboricultural Impact Assessment

BS5837:2012 Trees in Relation to Design, demolition and construction –  
Recommendations

| SITE REFERENCE: | Wrexham Technology Park |
| REFERENCE: | DEV016.WAL.04GM |

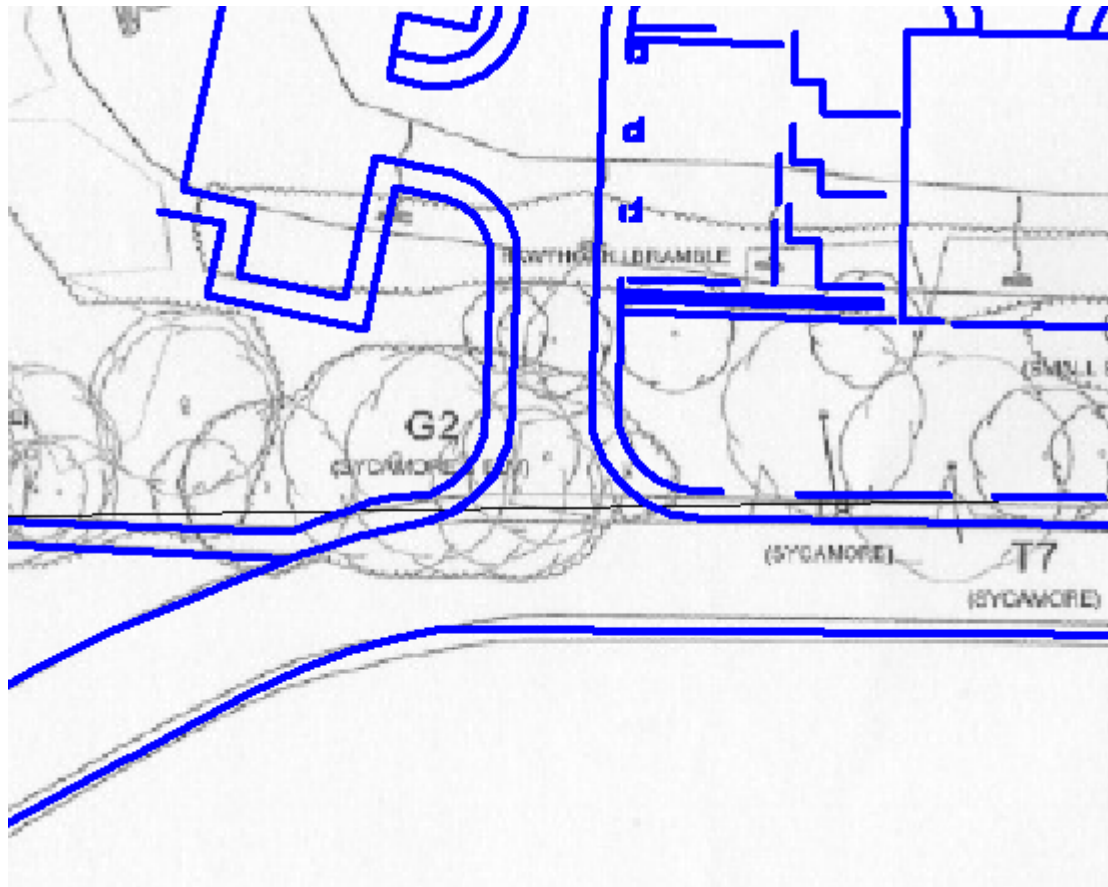
The proposed location of the new entrance on to Plas Bennion Road runs through the edge of group G2 which is composed of early mature Sycamore with a small Elm component.

This will require the removal of several trees of limited arboricultural significance.

6.6 In order to facilitate the development a number of trees will need to be removed from the group G2 in order to create the new entrance onto Plas Bennion Road. We believe that the loss of amenity is limited and that this will be more than adequately compensated for through the proposed woodland landscape improvements.

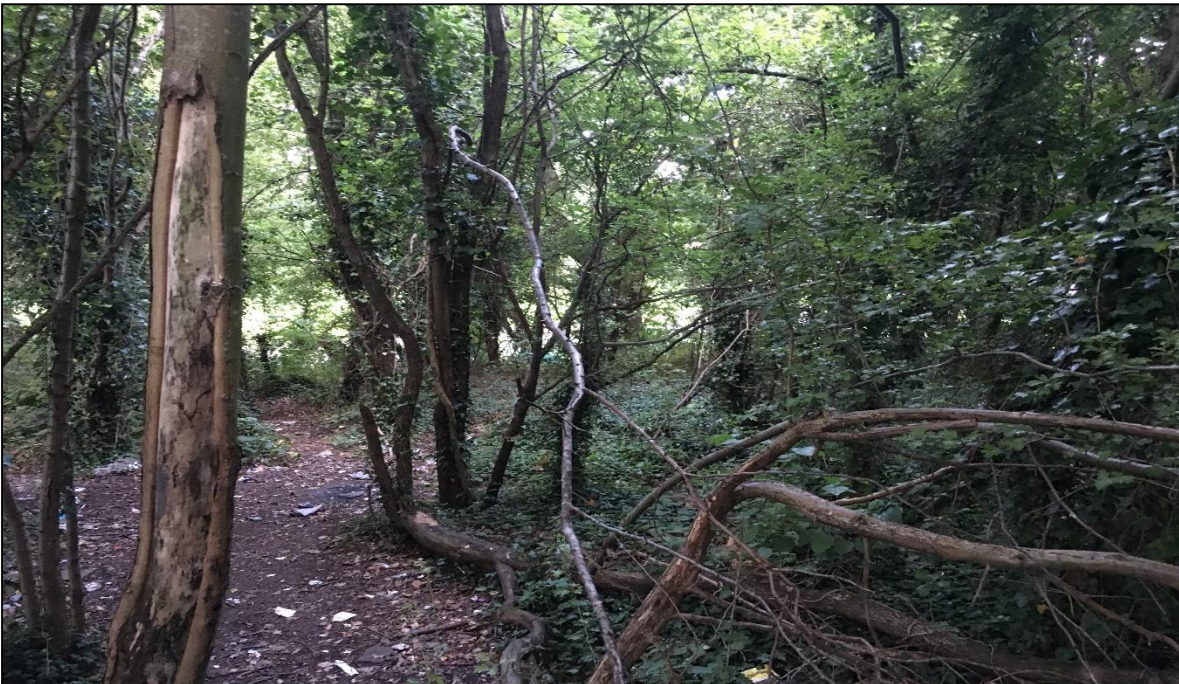
- 5.3 The centre of the site is populated by groups of self-set Willow / Hawthorn / Birch and are of no arboricultural significance.
- 5.4 The woodland is generally very poor. Internally there is very little light and there is no understorey or shrub layer other than a blanket of Ivy this appears to in spite of the additional planting referenced in the Management Plan and is possibly due to the density of the canopy.

Internal to woodland showing poor quality

- 8.4 As part of the overall landscape improvements it is proposed to selectively thin the boundary group to increase light, improve the potential for woodland stratification and address issues associated with the existing wooded area of antisocial behaviour and fly tipping.

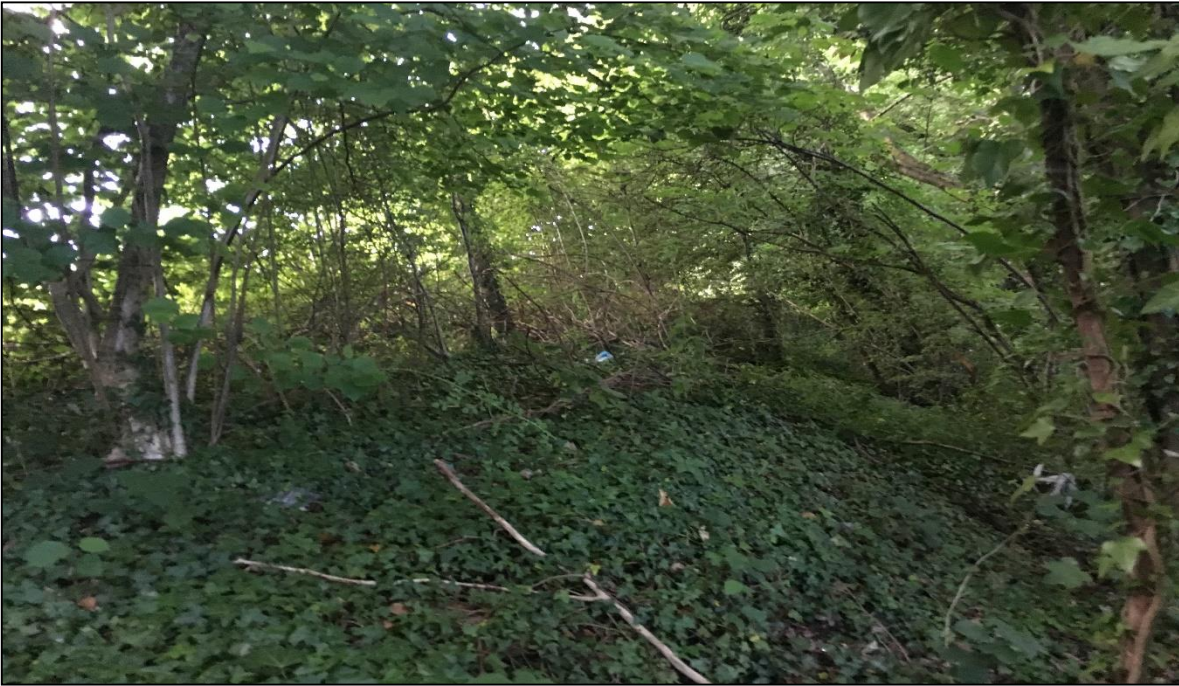
The bund (note dense ivy coverage)
