| Project title | WAST Western Gateway | Job number |
| Subject | Preliminary Summary of Ground Investigation findings (following completion of the factual report for the ground investigation). | |

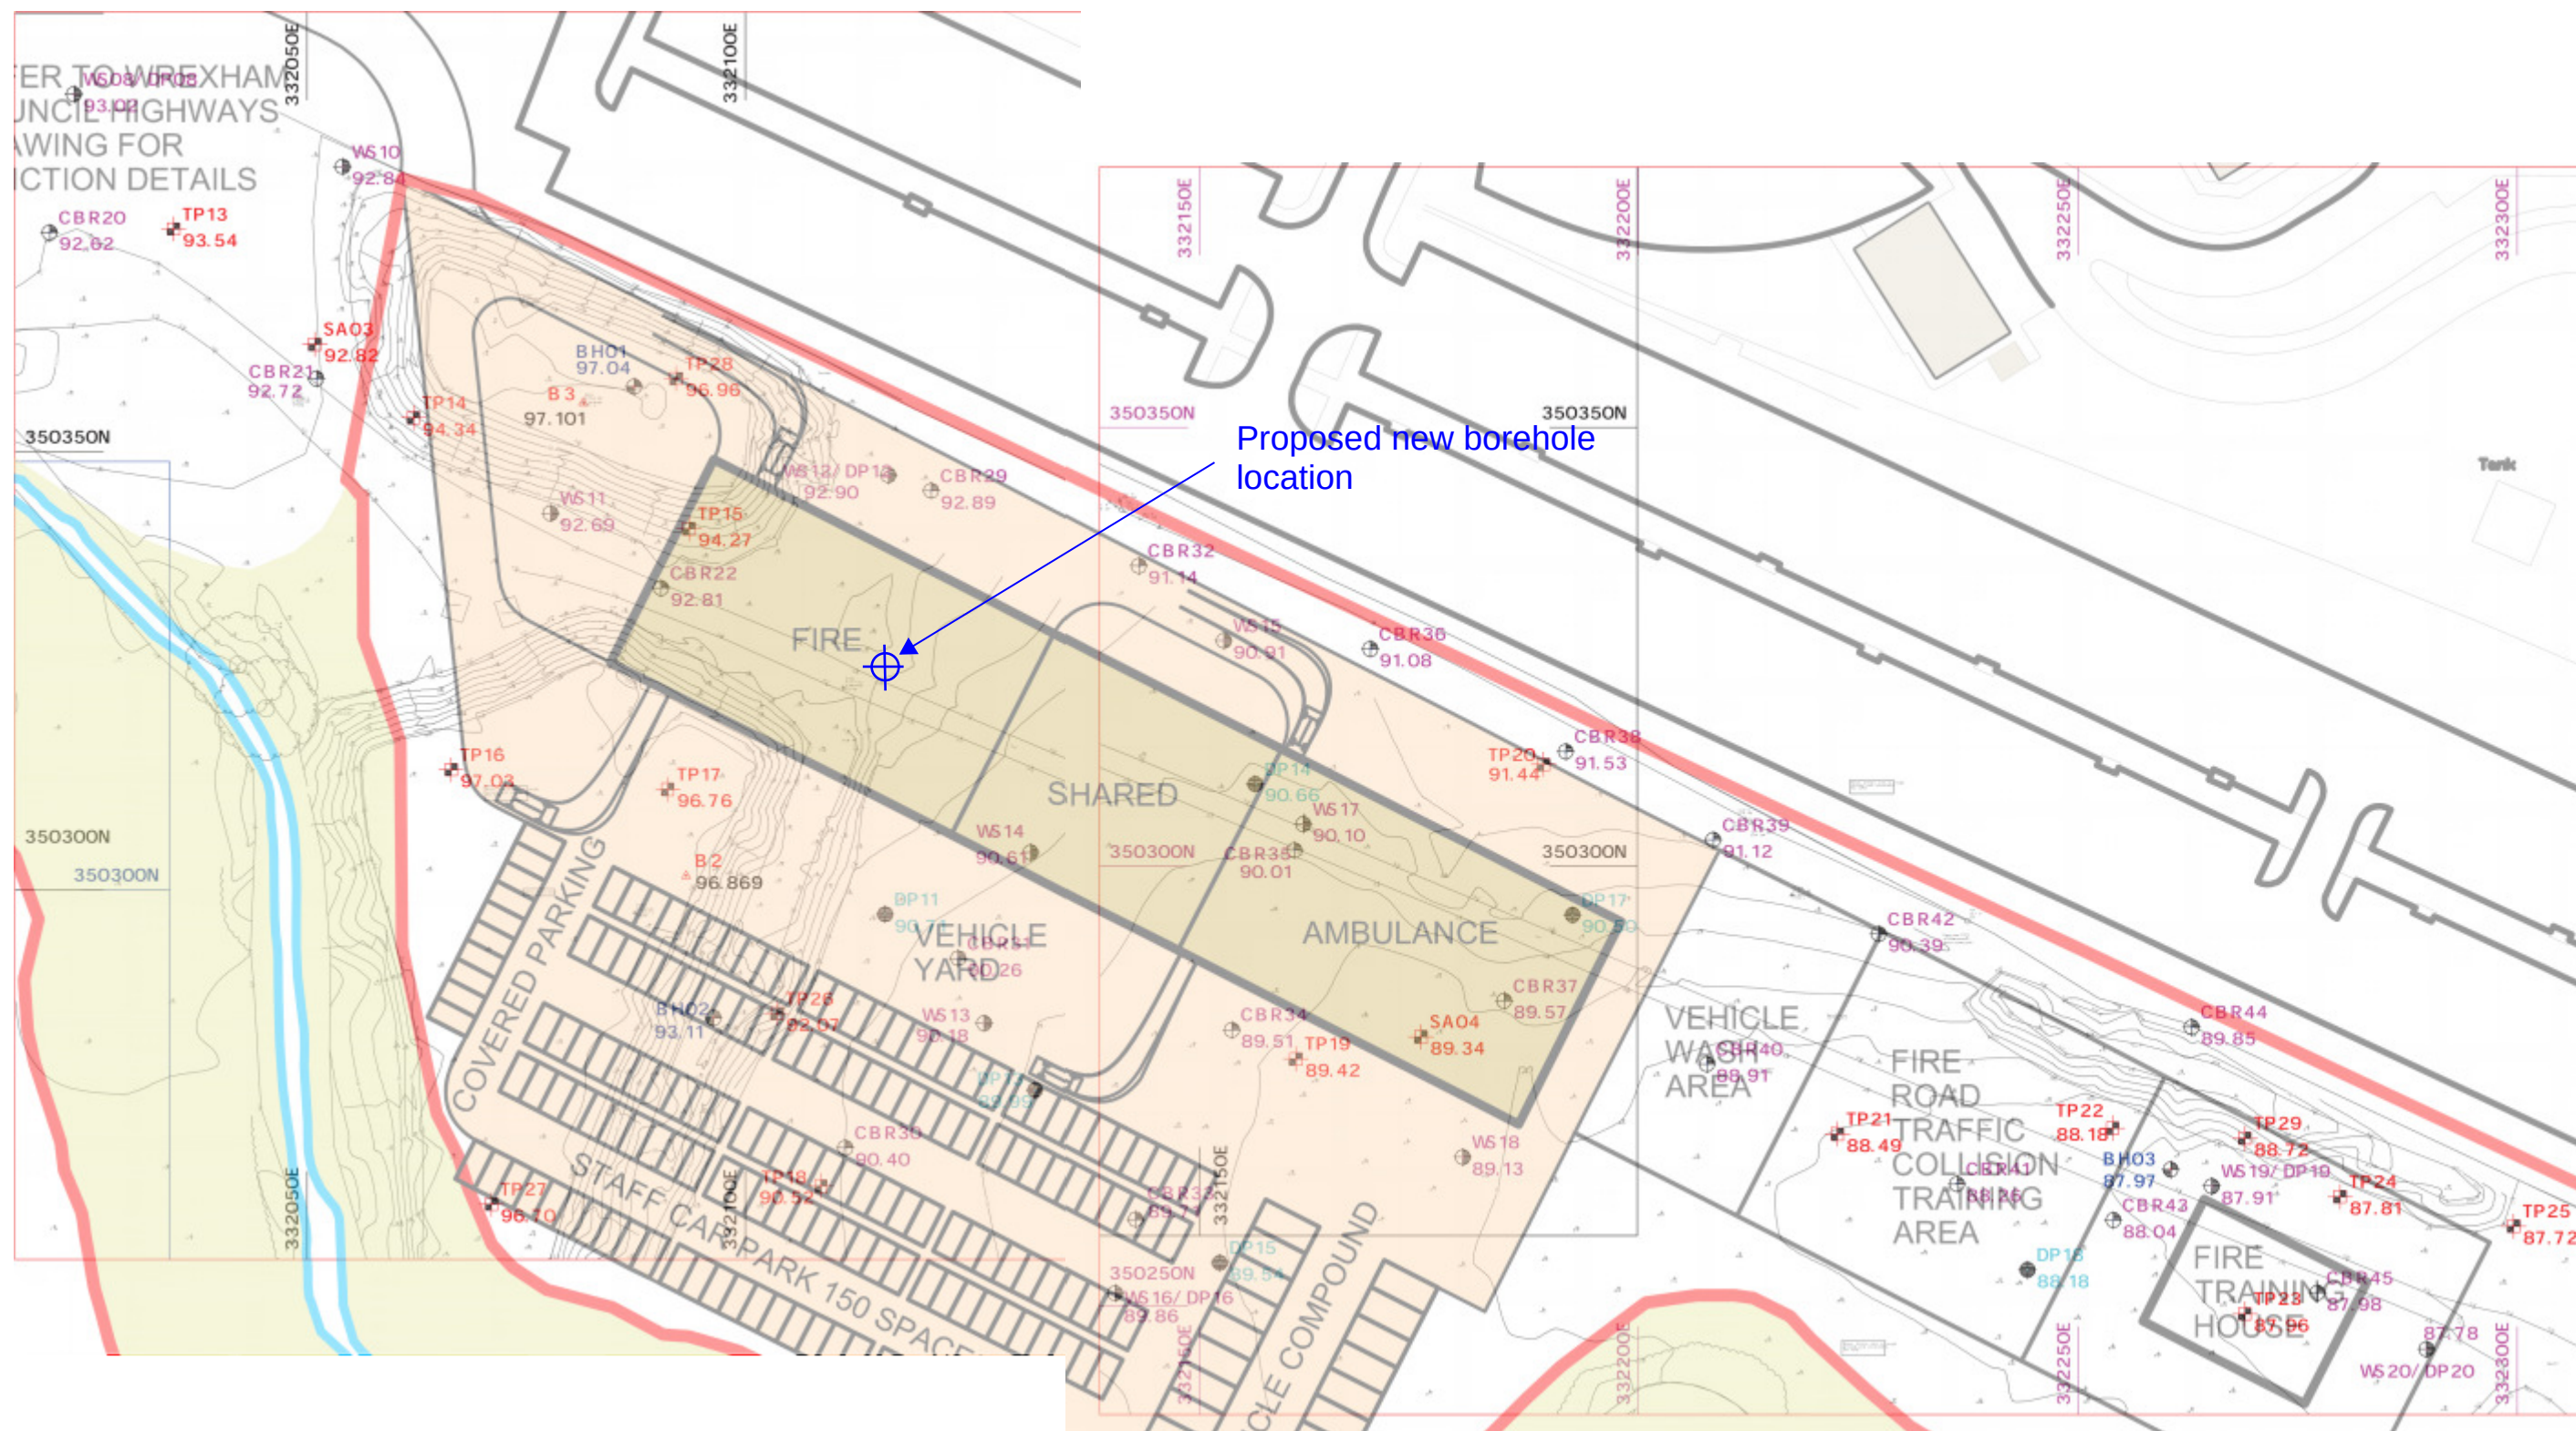
Figure 2  
WAST Western Gateway  
Exploratory hole location plan

Boreholes, window samples, dynamic probes, trial pits and hand TRL probes for CBR tests were undertaken at the site. Standpipe water/gas piezometers were installed at a number of locations. The factual information from the investigation is contained in the factual report by Ian Farmer Associates, June 2011. Figure 2 shows the location of the exploratory holes and the approximate locations of the proposed buildings.
