## **TOP HOUSE, BRONINGTON**

### **BUILDING DEMOLITION**

#### **Protected Species Survey**

| <b>Date of Survey:</b> | <b>11<sup>th</sup> February 2011</b> |

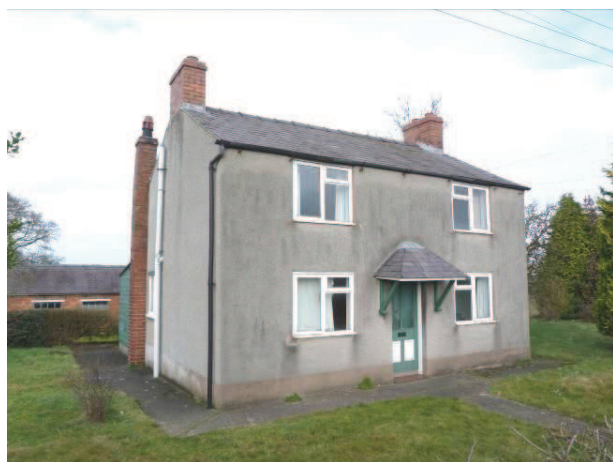
Photo 1: Top House, as viewed from the south west.

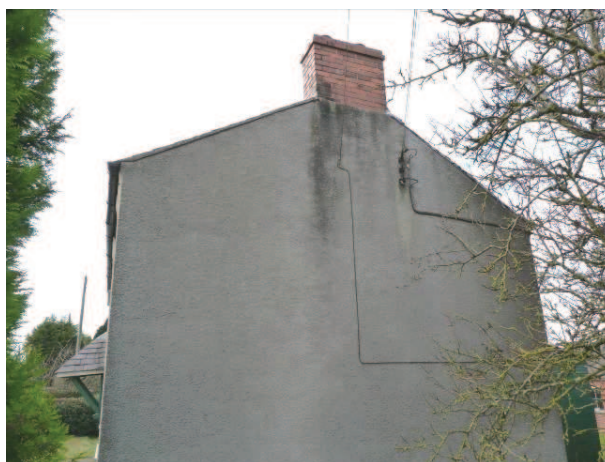
Photo 2: Top House, as viewed from the east.

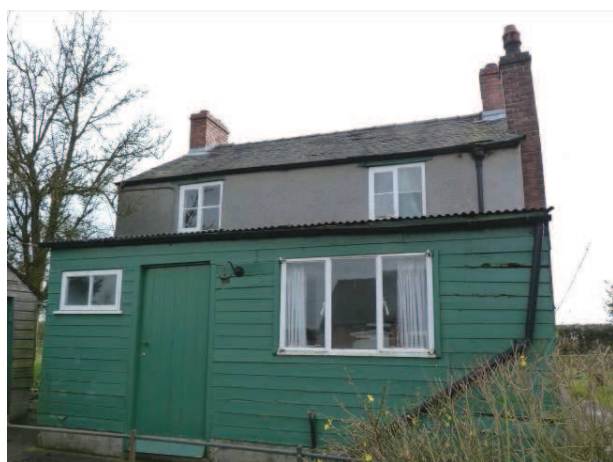
Photo 3: Top House, as viewed from the north.

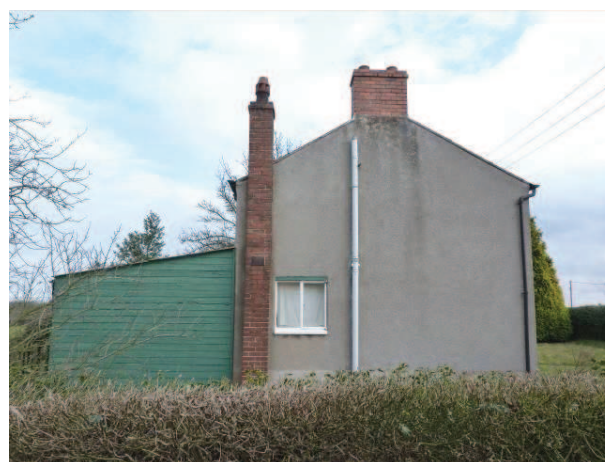
Photo 4: Top House, as viewed from the west.

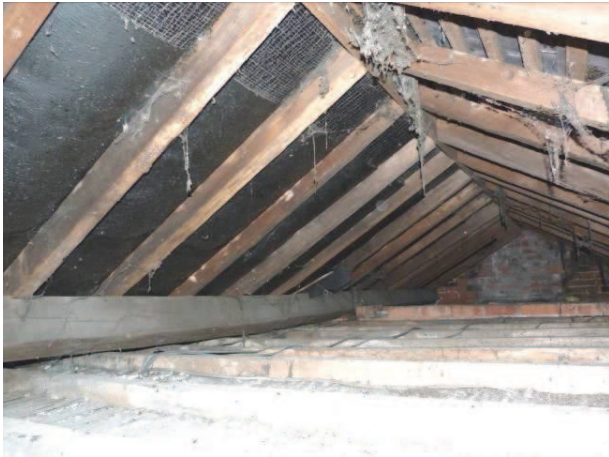
Photo 5: Internal view of the roof void.

Approximately 20-30 scattered bat droppings originating from an undetermined species of bat was recorded within the roof void.

A low number of scattered bat droppings were recorded within the roof void. Further survey, to include an emergence survey between May and September is therefore essential to assess true levels of bat usage and the species of bat utilising the roof structure. The building should be considered to constitute a bat roost and as such no works may be undertaken on the building until the correct permissions and if necessary, a Welsh Assembly Government European Protected Species Development Licence has been obtained. This should be applied for by a suitably qualified ecologist. Suggested mitigation should be utilised to decrease the potential impact of the development and will be recommended upon completion of the recommended future emergence survey.

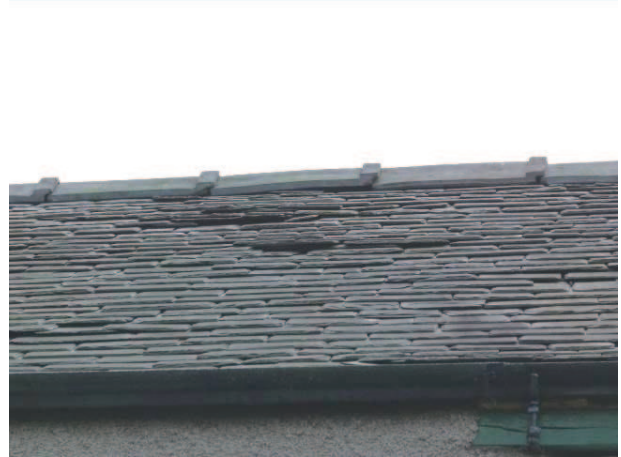
Photo 6: Showing slipped/raised/missing roof slates creating potential bat access points.

The construction methods and good state of repair of the walls of the house resulted in very low potential for bats to roost within the walls. Raised lead flashing was noted around chimneys. Numerous slipped, raised and missing slates and raised ridge tiles created potential bat access points and roosting locations. The roof void contained a low number of scattered droppings and combined with the numerous potential access points, this resulted in high potential for the roof to support roosting bats. Further survey, to include an emergence survey between May and September is therefore essential to assess true levels of bat usage and the species of bat utilising the roof structure.
