### ARBORICULTURAL REPORT (BS 5837:2012)

**9 GROVE ROAD  
WREXHAM  
NORTH WALES  
LL11 1DY**

**C/PM/23/03/20**

**Date: March 2020**

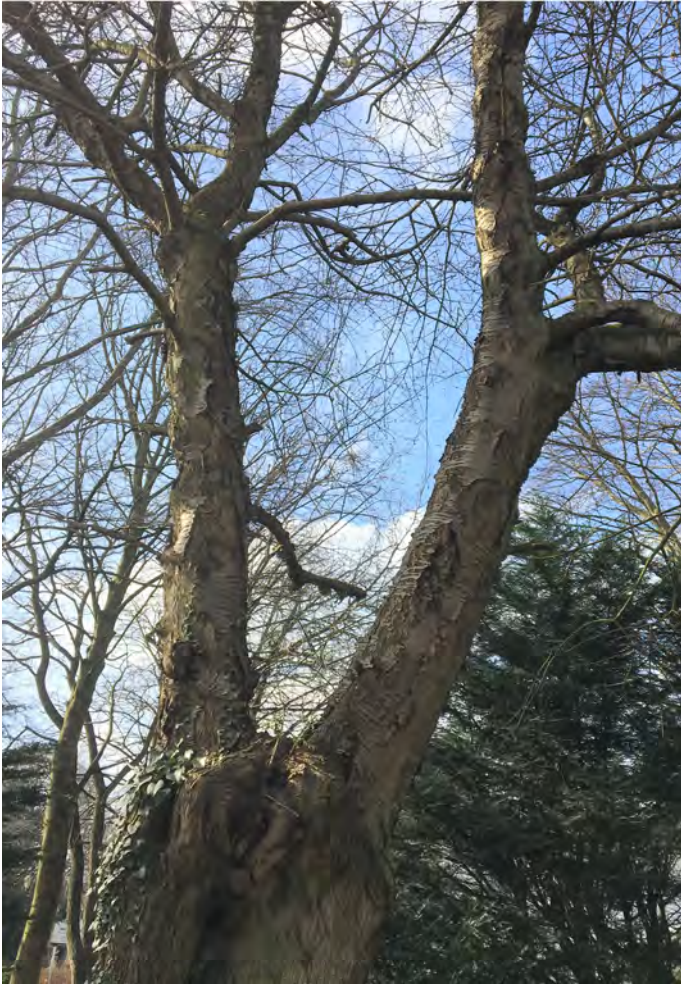
T3 Cherry

- 5.1.1 The loss of any tree is always regrettable but in this instance T3 (Cherry) is reaching the end of its safe useful life expectancy and is unlikely to withstand the impact of development. Its removal would also free up more room for access and storage of materials relieving pressure on the other trees.
- 5.1.2 G2 is largely to be retained with the removal of the Hawthorn nearest the development and the two Robina and Ash that spoil the more significant Yew trees. These 4 Yew can be retrained successfully provided they are fenced off at the edge of their crown spreads.
- 5.1.3 G3 is a scattered group of fruit trees with several self-sown saplings and suckers from the Plum present. This group is of minor significance and has not been maintained for a number of years.
- 5.1.4 There is plenty of scope within the site for replacement tree planting following development.

| Arboricultural Data Sheet: 9 Grove Road, Wrexham, LL11 1DY | | | | | | | | | | | Date of Survey: 05/03/2020 | | Surveyor: PM | | | |
|---|---|---|---|---|---|---|---|---|---|---|---|---|---|---|---|---|
| T3 | Cherry | 820 | 11 | FM | 7 | 6 | 5 | 8 | 2 | B | A mature specimen near entrance. Forked at 2.5m. Several stem wounds and associated decay. Canker present. Reasonable overall form and vigour but reaching the end of its safe useful life expectancy. | n/a | 10+ | C2 | 304.19 | 9.84 |

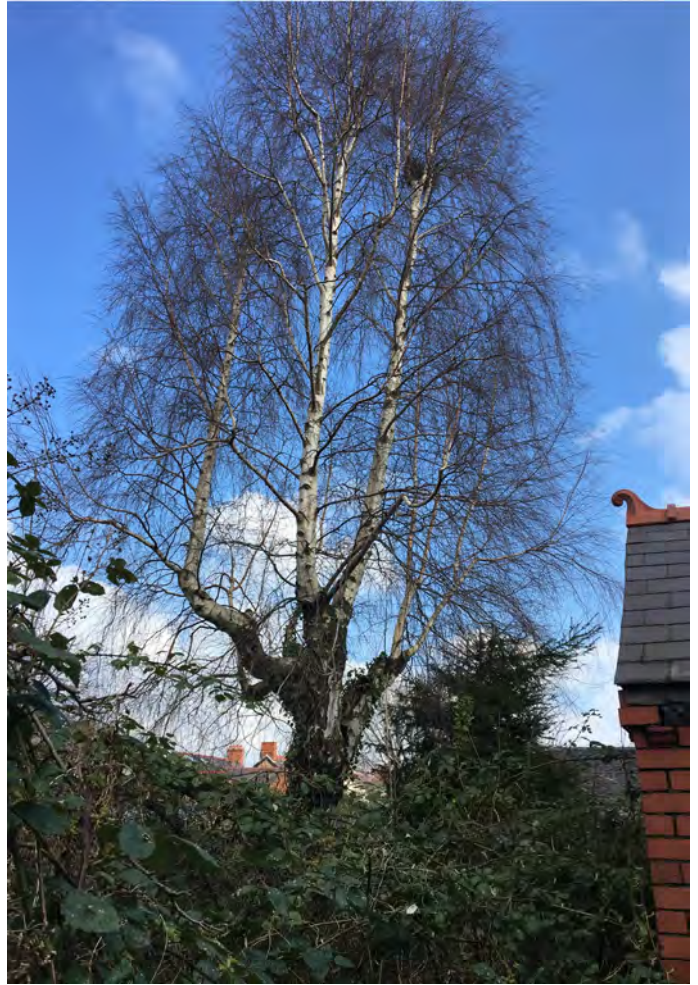
| Arboricultural Data Sheet: 9 Grove Road, Wrexham, LL11 1DY | | | | | | | | | | Date of Survey: 05/03/2020 | | Surveyor: PM | | | | |
|---|---|---|---|---|---|---|---|---|---|---|---|---|---|---|---|---|
| T5 | Silver Birch | 500 | 12 | FM | 5 | 4 | 5 | 4 | 4 | C | Located within the adjacent property to the rear of wall. Forked at 3m. Previously topped at 3-4m with severe decay in scaffold limbs. Ivy on the lower stem. No access to base. Three main leaders. Potential for collapse if not maintained. | n/a | 5-10 | U | 113.10 | 6.00 |

T5 Birch with decay

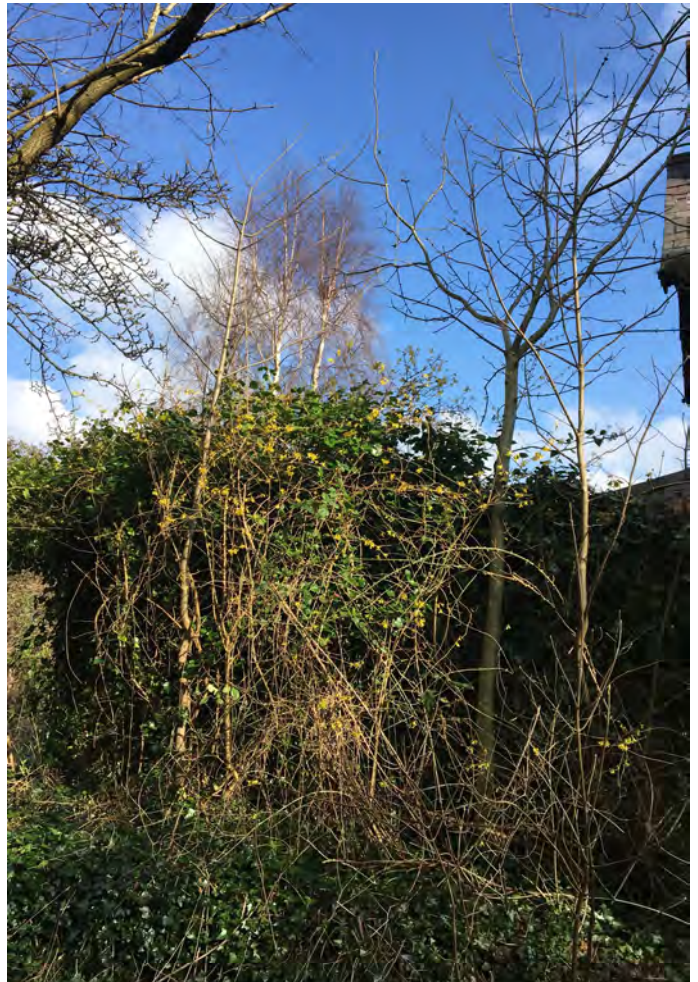
| Tree No. | Species | Root Protection Area (m <sup>2</sup> ) | Circle Radius (m) | Distance to any proposed construction or surfacing (m) | Can the Tree be Successfully Retained |
|---|---|---|---|---|---|
| G2 | Mixed | <162.86 | <7.20 | Remove Hawthorn, Robinia and Ash for development but retain the 4 Yew | |

Ash in G2

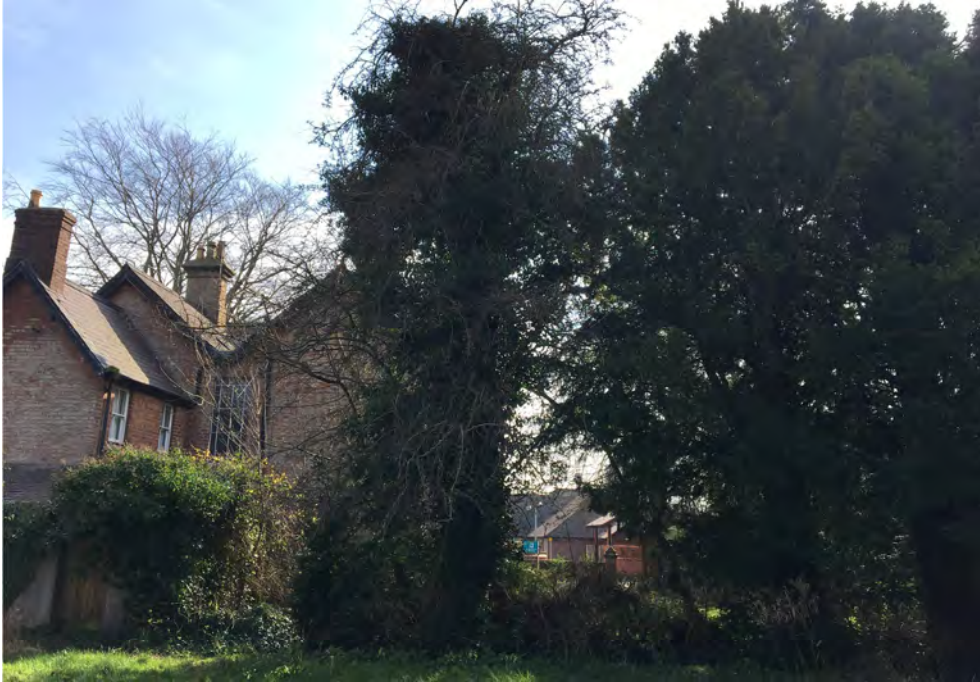
Hawthorn in G2

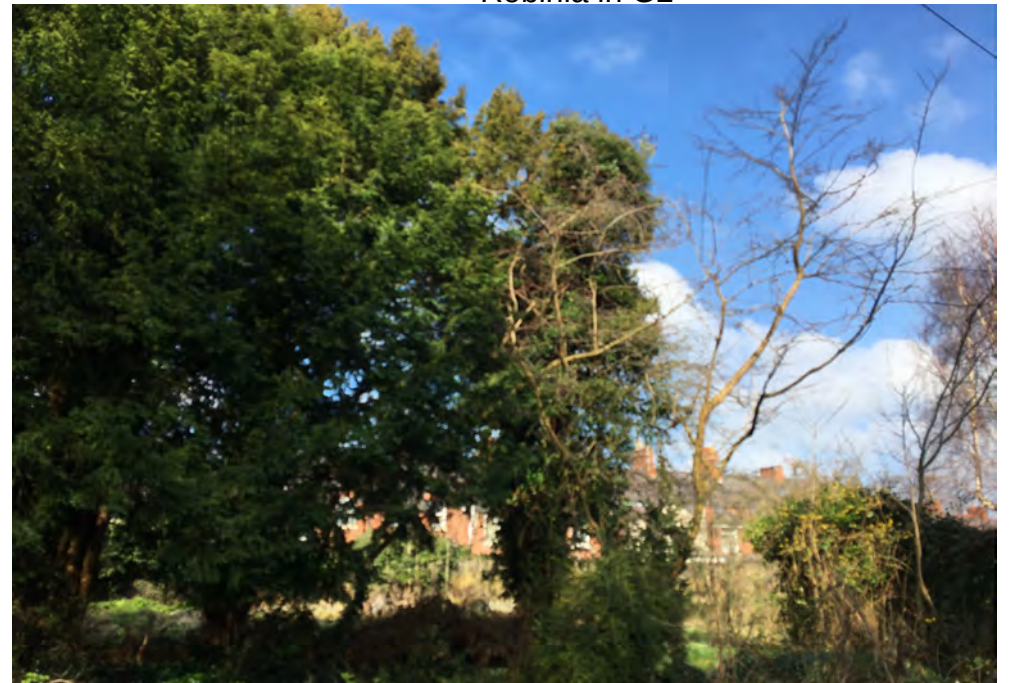
Robinia in G2
