### ARBORICULTURAL REPORT (BS 5837:2012)

#### FOR DEVELOPMENT

**31 MARFORD HILL  
MARFORD  
WREXHAM  
LL12 8SW**

Date: March 2021

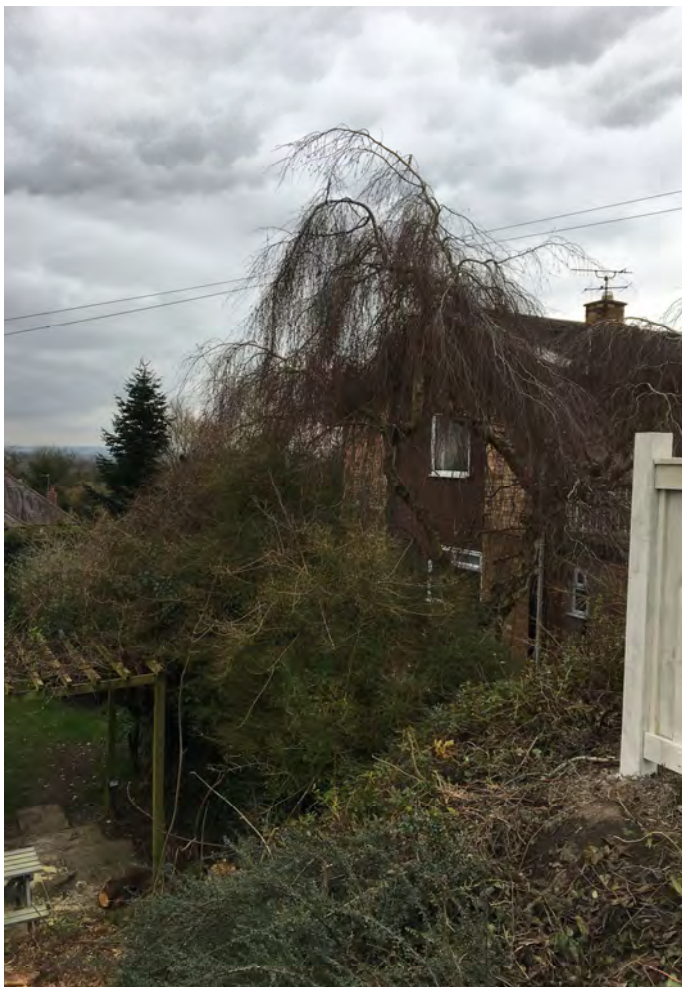
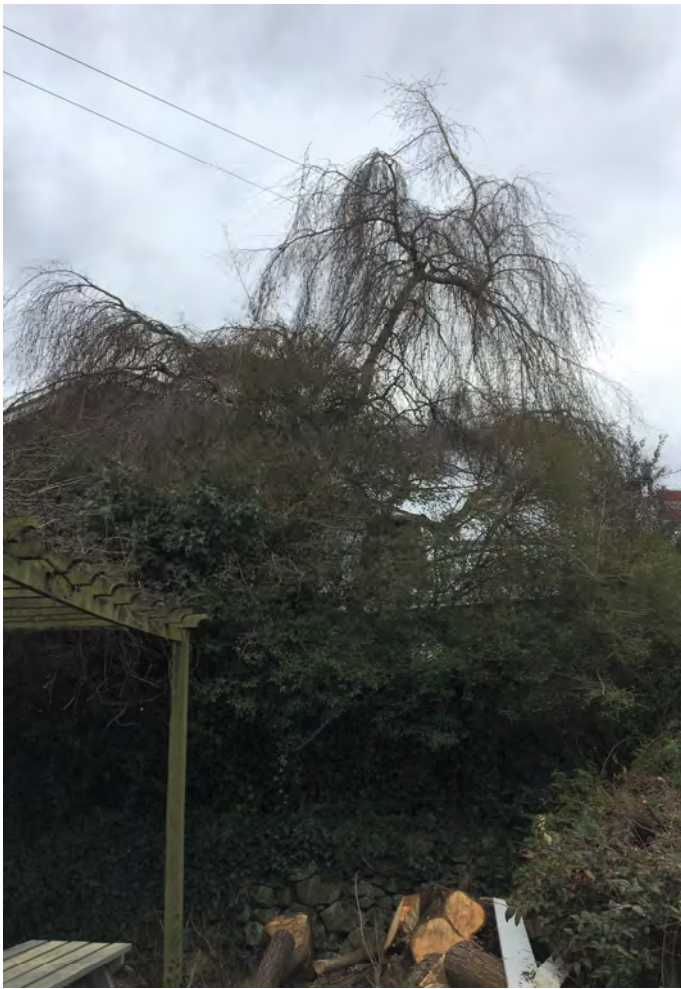
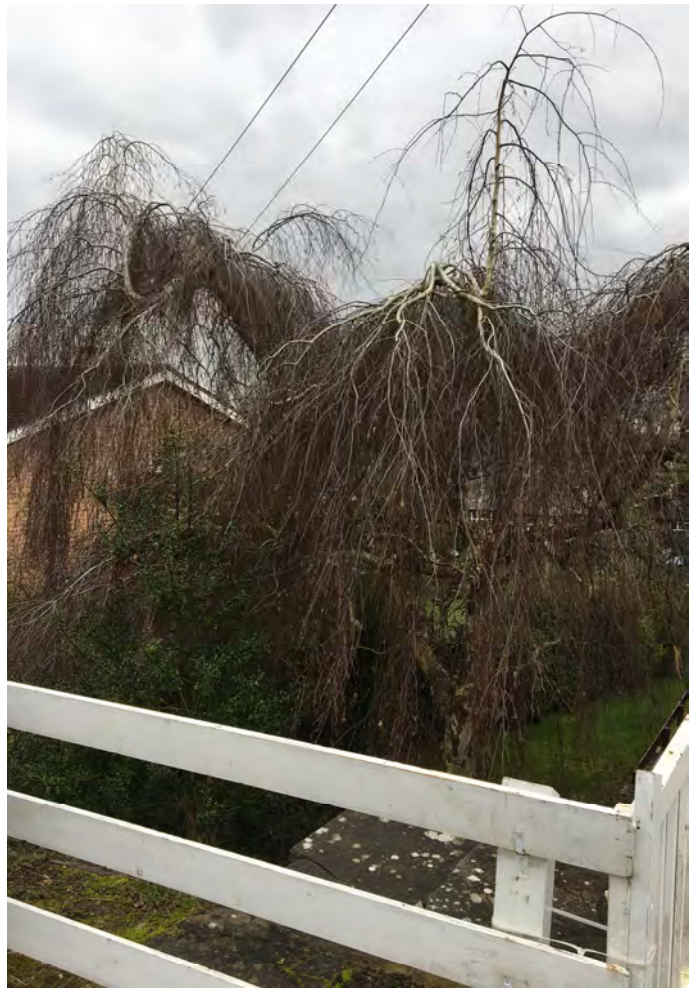
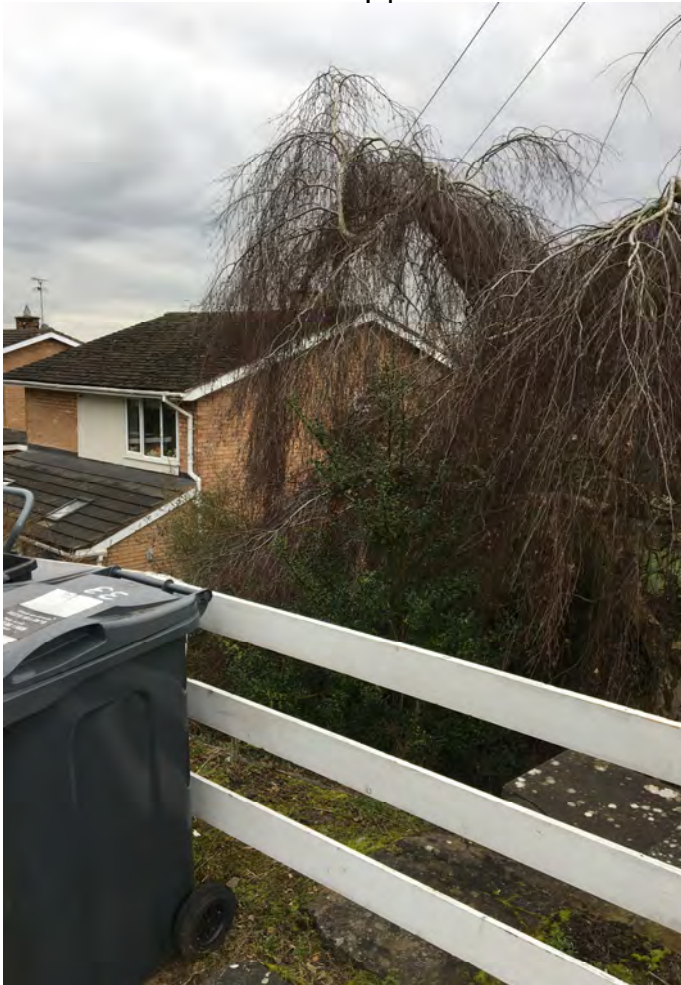
5.1.2 The nearest tree to the development is T4, which is an ornamental Weeping Silver Birch situated within the adjacent property. This tree is located on a higher level than the site (approx. 1.5m) and is at least 5m away from the new extension. The canopy of this tree barely overhangs the site as you can see from the attached photographs.

| Arboricultural Data Sheet: 31 Marford Hill, Marford, Wrexham, LL12 8SW | | | | | | | | | | Weather: Dry | | Date of Survey: 04/03/2021 | | Surveyor: PM | | |
|---|---|---|---|---|---|---|---|---|---|---|---|---|---|---|---|---|
| T4 | Weeping Silver Birch | 380 | 6 | M | 4.5 | 4 | 4 | 5 | n/a | B | Located within the adjacent property, approximately 1.5m higher than the site. This is an ornamental specimen with reasonable form and good vigour, close to the adjacent property. No crown overhanging within site. | n/a | 20+ | B1 | 65.33 | 4.56 |

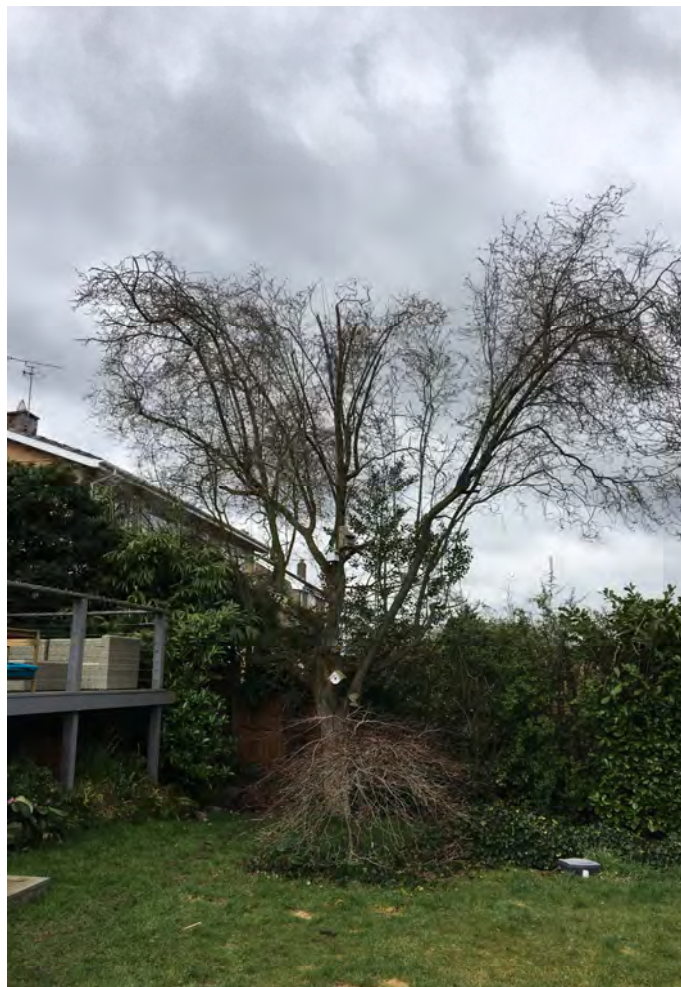
| Arboricultural Data Sheet: 31 Marford Hill, Marford, Wrexham, LL12 8SW | | | | | | | | | | Weather: Dry | | Date of Survey: 04/03/2021 | | Surveyor: PM | | |
|---|---|---|---|---|---|---|---|---|---|---|---|---|---|---|---|---|
| T1 | Cherry Plum | 380 | 6 | M | 4 | 5 | 3 | 4.5 | 3 | C | A mature specimen located on the boundary. Southern crown previously pruned. Several decay fungus bracket present (Ganoderma spp.). Poor fork at 1.2m with included union starting to open up. Declining crown. | Consider removal. | 0-5 | U | 65.33 | 4.56 |

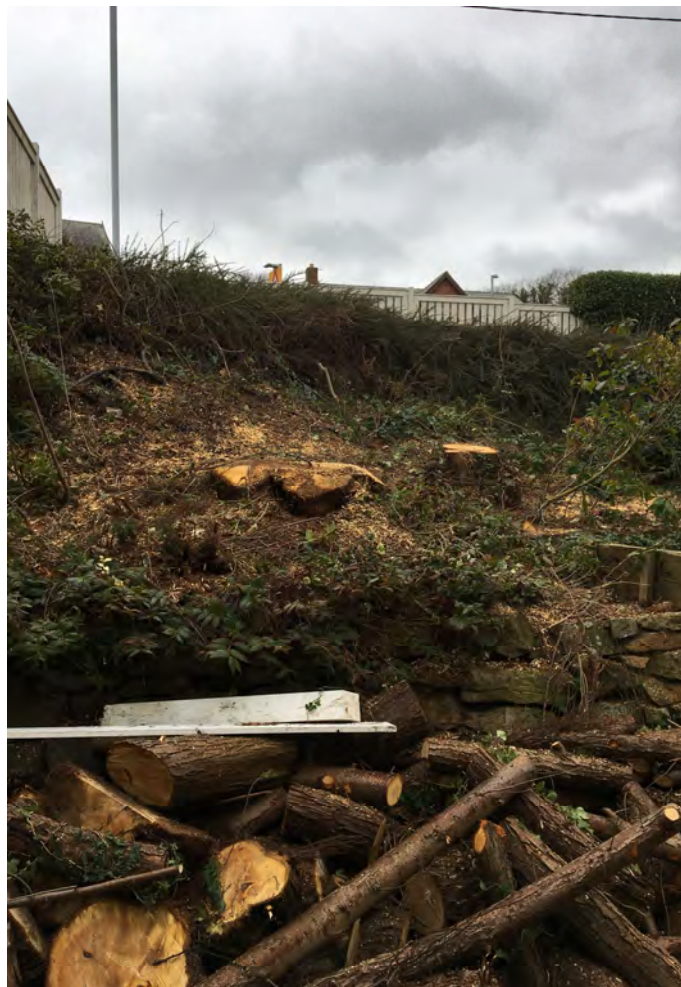
Conifers removed at front of house
