REF: 2032/SCP/RepLet/mjs

31<sup>st</sup> January 2018

## **RE: SALEM CHAPEL, PONCIAU: SHALLOW MINING ASSESSMENT**

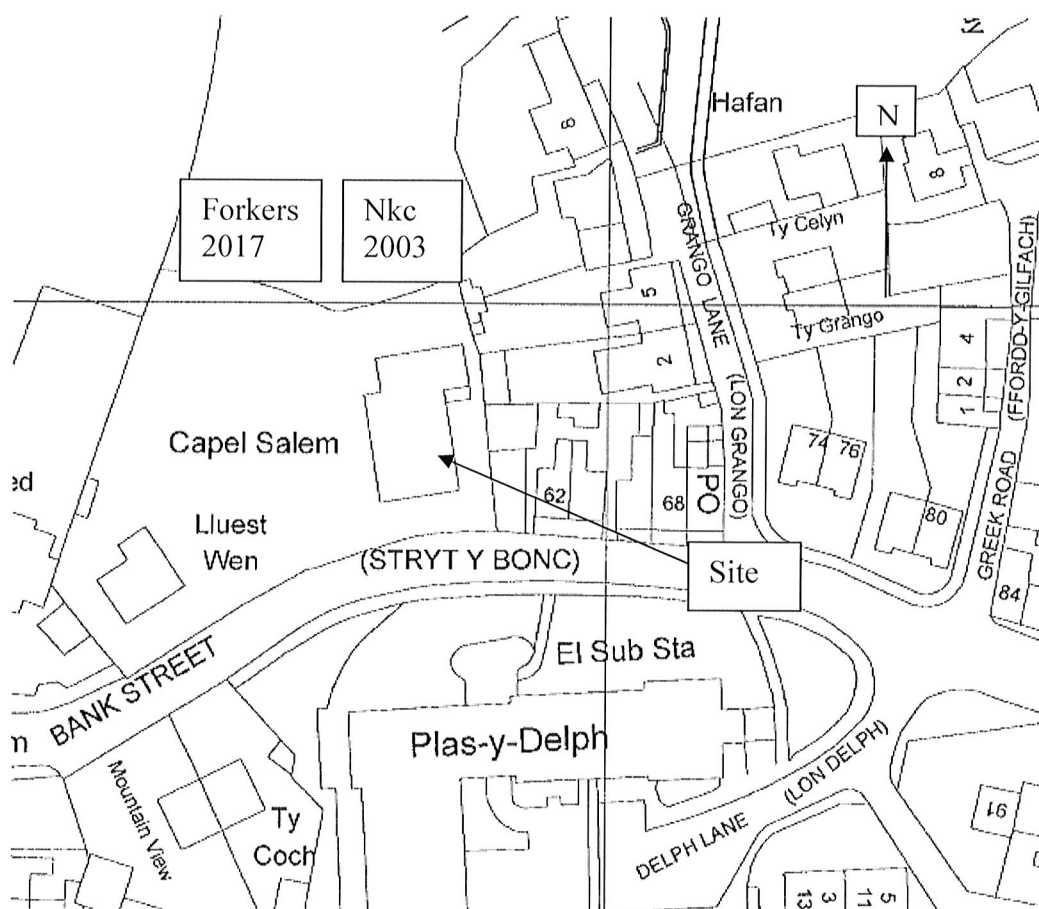
Nkc Geotechnical investigated the location of a property called Thorlie, in 2003, which is immediately adjacent to the northern site boundary, see above. The findings of the investigation are presented in Appendix B.

In December 2017 the site immediately west of Thorlie was drilled and grouted by Forkers under the supervision of GSL.

The locations of both investigations are presented below.

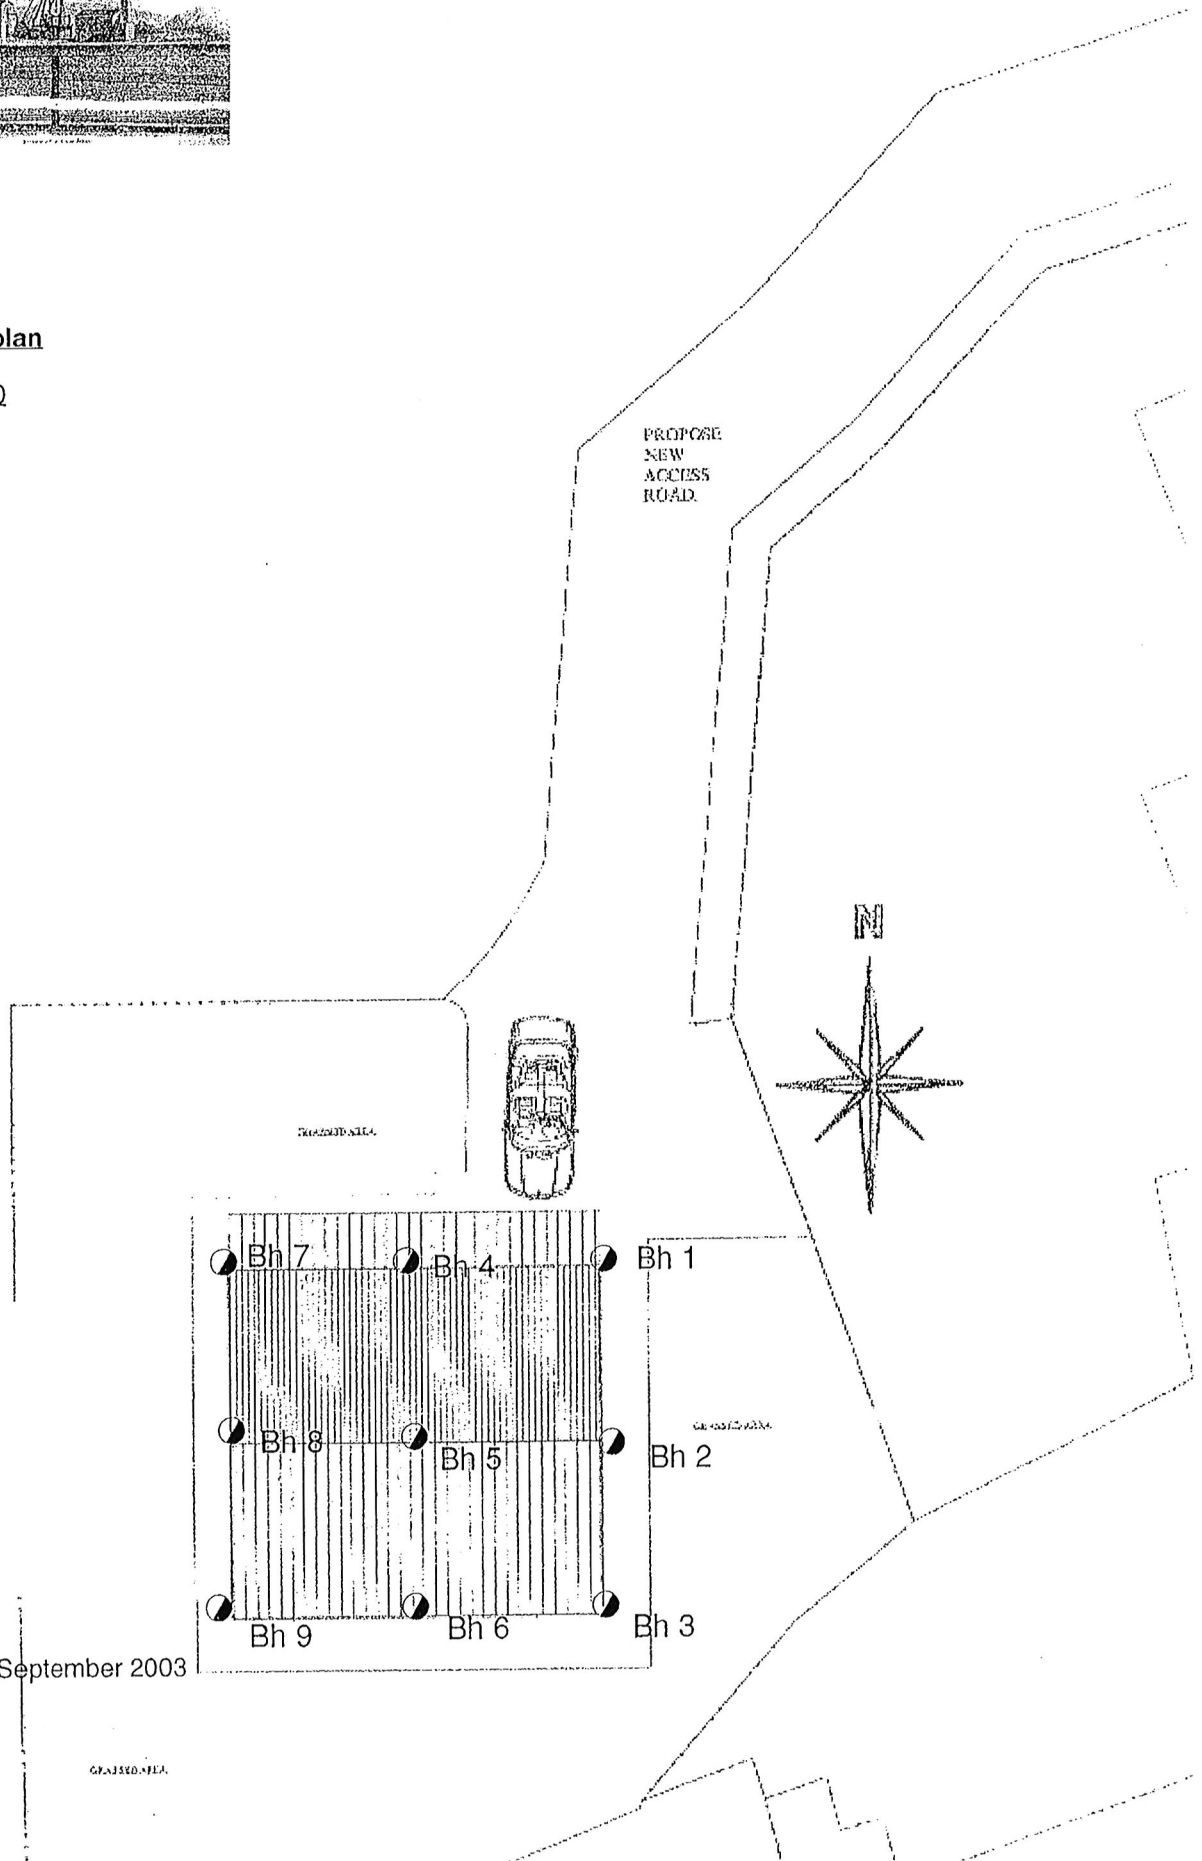
# Borehole plan

There are old and unrecorded mineworkings present in the Brassey Coal. Subsidence of these workings could cause crown holes to be formed on the site, with dimensions of upto 2.0m deep and 2.0m diameter. There may also be old and unrecorded mineshafts upto 2.0m in diameter present under the fill.

Use a structural foundation designed to span 3.0m in case there are old infilled crown holes and unrecorded shafts present.
