DATE: April 2021

## **BS5837: 2012 TREE REPORT**

**Yew Tree Cottage, Sun Lane, Bowling Bark, Wrexham**  
**For Chris Bryan**

AUTHOR: MARK CHESTER

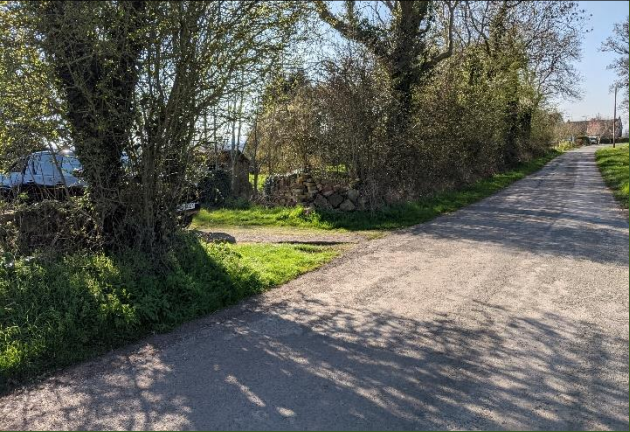
| <b>Image 1:</b> The road frontage looking west. | <b>Image 2:</b> Looking in to the site, with T1 centrally and T2 to the left. | <b>Image 3:</b> Looking to the wider property, to the west. |

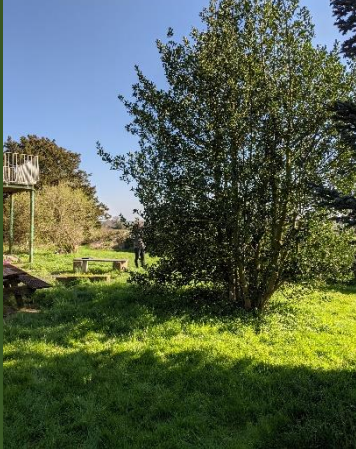
4.3.1 It will be necessary to remove trees T2, 3 and 5, plus the hedgerow H1 to facilitate the works. T1 can be retained initially.

| <b>Image 4:</b> The Holly, T2 | <b>Image 5:</b> The Yew T4, viewed from the rear of the existing dwelling. | <b>Image 6:</b> Standing by the Yew, looking towards the Goat Willow, T5. |

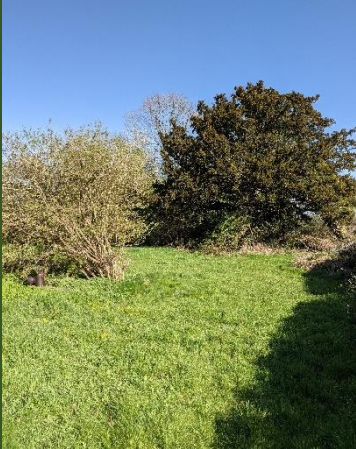
Only the trees close to the development area (five) have been surveyed. One tree, a Yew, has been identified for retention. Measures to protect it during the construction process are presented. Mitigation for the loss of trees is proposed.

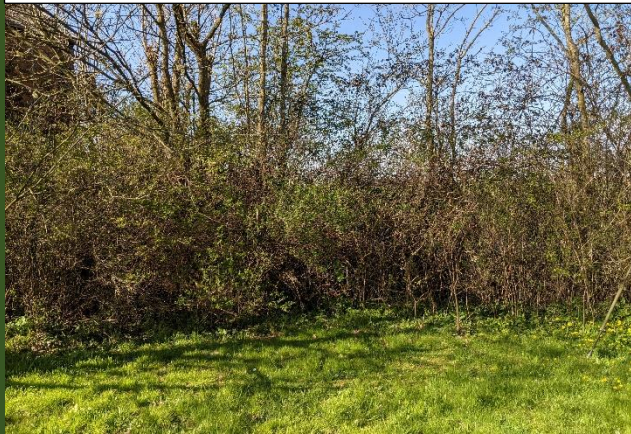
| H1 | Hedge | M | 12 | 0 | 2 | 2 | 2 | 2 | M | 10-20 | C2 | | M | This is an overgrown hedge in need to new planting. | Yes | Fell and replace within planting scheme | | |

**Image 7:** The hedgerow viewed from within the site.
