# Welsh-Wood

## Arboricultural Report

BS5837:2012 Trees in Relation to Design,  
Demolition and Construction

Redwither Business Centre  
Fourth Rd, Wrexham  
LL13 9XR

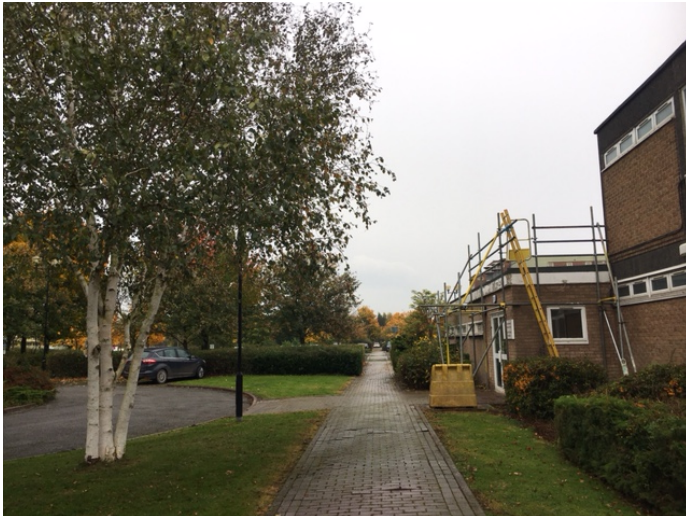
- 3.3.1 T1 and T2 are both situated next to the footpath servicing the structure to the northeast. T1 Bird cherry has no significant defects and will not be impacted upon by the proposed demolition however the crown for T2 Himalayan birch overhangs the

demolition area, as indicated by the black hatched line on the Tree Protection Plan, and as such has been recommended for remedial works to lift and partially reduce the crown.

3.9.1 The crown of T2 hangs low over a portion of the demolition area and as such recommendations have been made to lift and partially reduce the crown in advance of any other on-site works.

P1 – T2 crown low over demolition area contained within footpath (pruning specified)

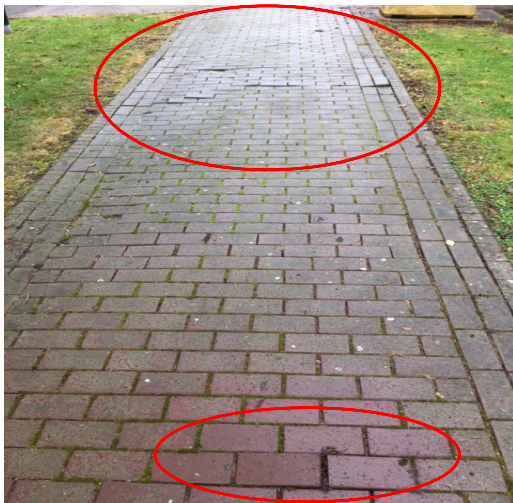
- 3.3.2 In addition the roots from T2 have begun to lift the adjacent footpath which is a patterned brick construction. This footpath falls within the demolition area. As such recommendations have been made to place ground protection mats over the RPA for this tree along the footpath to prevent root damage and address the current trip hazard posed by the lifted bricks.

3.8.1 Given the location of the trees the only below ground constraints to demolition is T2 where a portion of the root protection area is beneath the footpath. Recommendations to install ground protection mats has been made within the method statement in this report.

P2 – T2 Birch roots lifting pattern brick footpath (ground protection mats required)

- 4.2.1 As noted the roots of T2 have begun to lift the adjacent brick pattern footpath that falls within the demolition working area. The lifted footpath also presents a trip hazard. It is necessary to install ground protection mats over the root protection area for T2, as indicated on the Tree Constraints Plan.
- 4.2.2 Ground protection mats vary in dimension and load bearing capacity and can easily be hired to address this requirement. The mats must be capable of supporting the weight loading of any planned activity and machinery usage in this portion of the site.

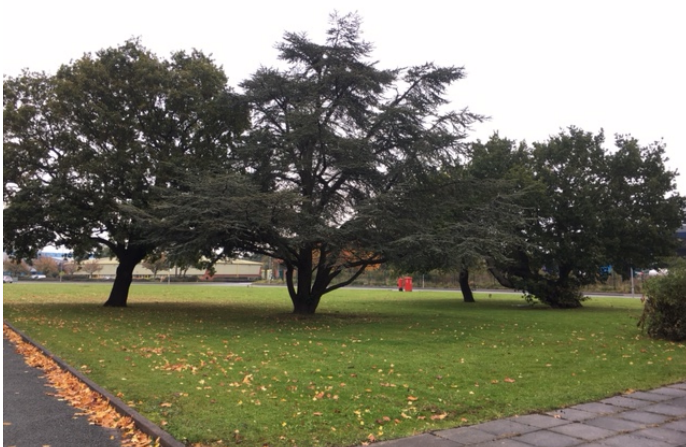
- 3.3.3 T3 – T6 (Atlas Cedar and Oak) are all situated on the open space to the north of the site and the trees and their root protection areas fall outside of the demolition area. They have been noted given their size and proximity and will require Tree Protection Fencing. There are some factors relating to the condition of T3 – T5 that while irrelevant to the demolition are of note, as such a copy of the tree schedule and plan have been passed onto the Arboricultural Officer at WCBC for consideration.

- 3.5.1 Physiological condition relates to the health of the trees surveyed.
- 3.5.2 T3 – T5 all have factors that it is thought prudent to pass onto the landowner.
- T3 has some burrowing at the stem base which requires monitoring during routine inspections.
  - T4 has two brackets of the decay fungi *Ganoderma lucidum* at the base which should be noted and may require further investigation.
  - T5 is a veteran that has suffered significant stem and branch failure. While no remedial action is thought necessary at this time it is felt relevant to record its presence, condition and significance.

P3 – T3 to T6 on open space to north of site

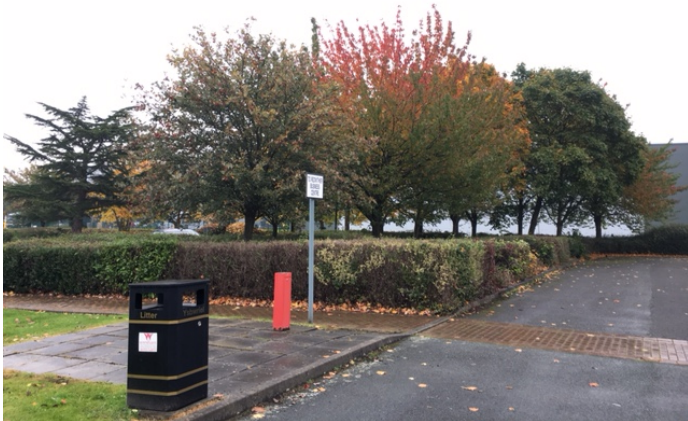
- 3.3.4 G1 consists of mixed broadleaf trees established as a screening group and underplanted with shrubs. It does not impede demolition however will require Tree Protection Fencing for the duration of on-site works.

P4 – G1 requires Tree Protection Fencing

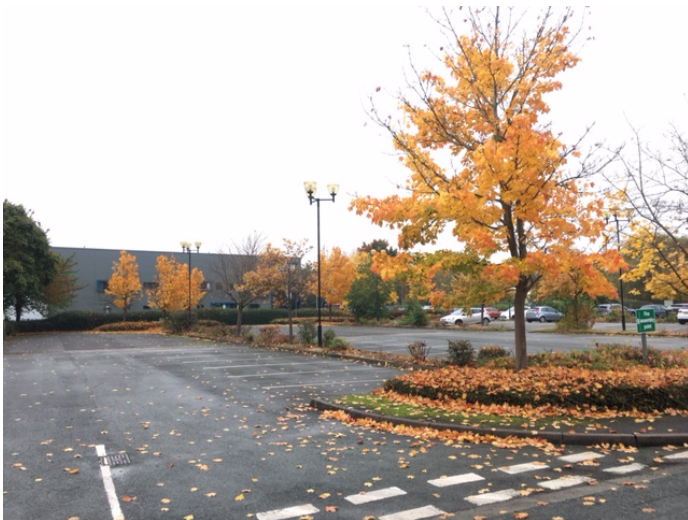
- 3.3.5 G2 consists of formal planting, predominantly Cherry species, along vegetative divisions within the adjacent car park area. The trees have been grouped given their location away from the demolition area however they still require Tree Protection Fencing.

P5 – G2 requires Tree Protection Fencing. Also shows access point and area for site compound.

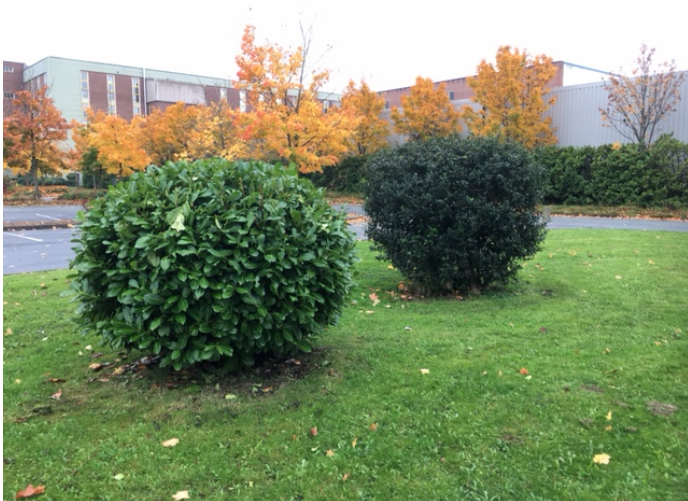
- 3.3.6 G3 consists of two trees situated on a formal grassed verge. These two specimens, laurel and holly, have been grouped given their distance from the development. Despite their potential to make a lasting contribution their removal has been proposed to facilitate machinery access to the site for the purpose of demolition.

- 3.4.2 No significant structural defects were noted however, both trees in G3 are coppice specimens and as such would require cyclical pruning to prevent their stems from exceeding their optimum size and as such becoming susceptible to failure.

P6 – G3 requires Tree Protection Fencing (2 trees maintained as shrubs)

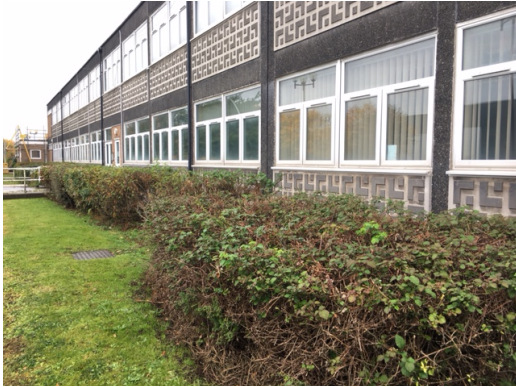
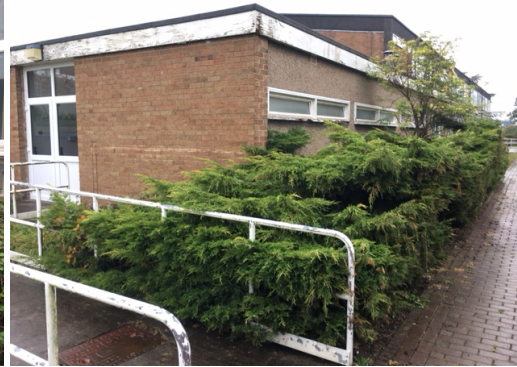
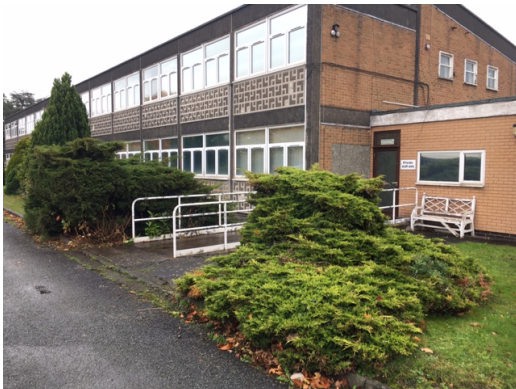
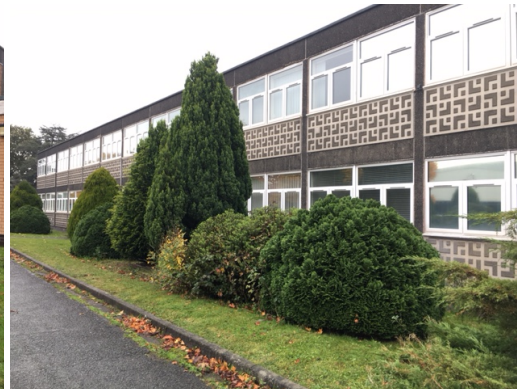
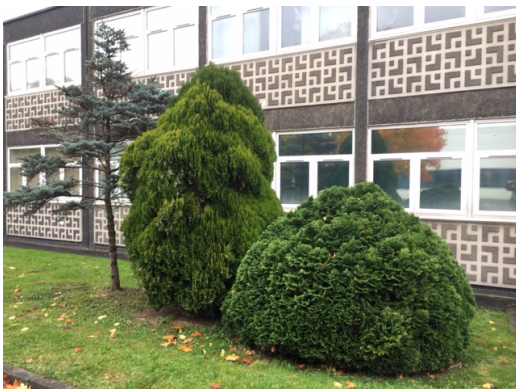
- 2.2.4 There are several coniferous and mixed species shrub beds situated at the building footprint which will require removal prior to demolition. They consist of a variety of evergreen shrubs and ornamental conifers. In addition to their presence impeding demolition they have a high ecological value as nesting habitat and therefore they should be removed prior to the end of December 2020 to ensure no birds begin to establish nests. Despite this being outside of the nesting season birds often make the most of favourable conditions and extend their breeding season outside of the recognised timeframe.

P7 – P11 Coniferous and mixed species shrub beds at structure footprint for removal

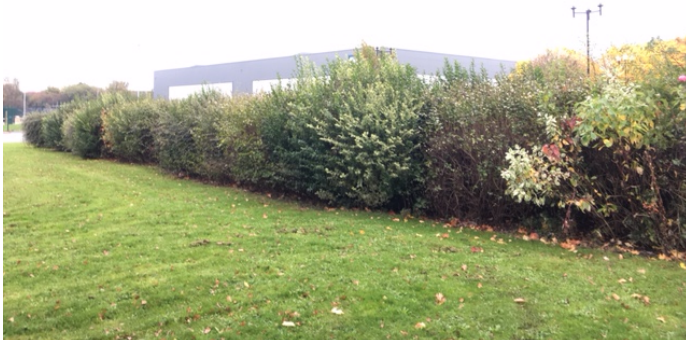
P12 – Broadleaf shrub bed

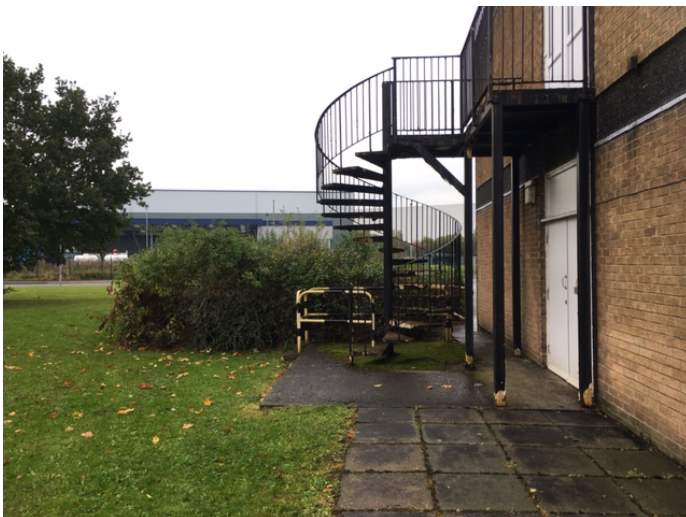
P13 – Corner of broadleaf shrub bed requires pruning to facilitate demolition and fence installation

- 2.2.5 It is also necessary to remove a maximum 2m strip from the south west extents of the broadleaf shrub bed shown on the Tree Protection Plan to facilitate demolition and fence installation. This should also be completed at the earliest opportunity and prior to the end of December 2020 for the same reasons as noted in 2.2.4.
