ST. MARY'S CATHEDRAL, PRESBYTERY, REGENT STREET, WREXHAM,  
LL11 1RB

## **HERITAGE IMPACT STATEMENT**

Rev A – November 2020

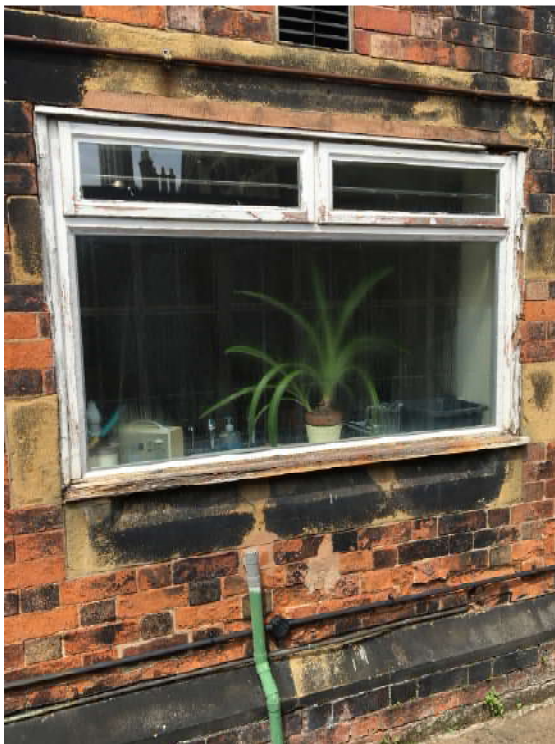
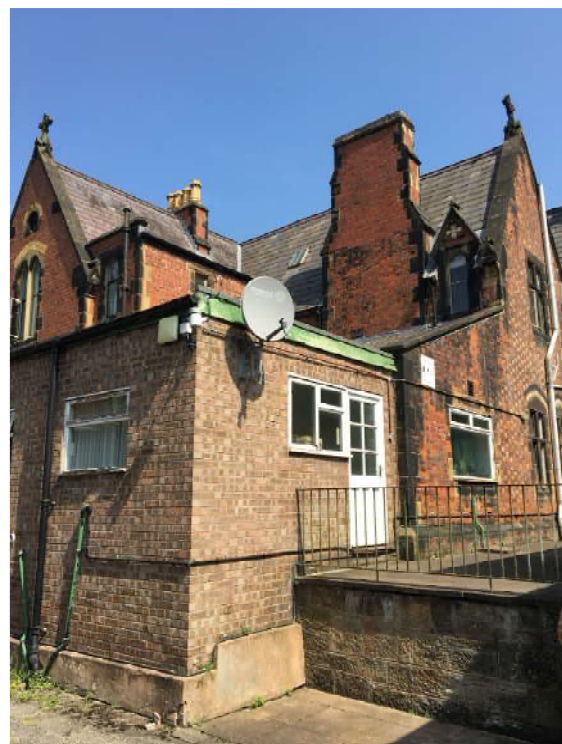
Figures 1 and 2 – the existing timber frame window to be reinstated

In the kitchen, the large window has been previously replaced with a modern timber frame installed within the original stone casing (see fig. 1). The timber frame is rotted in places, including the cill, and the paint has chipped. It is evident from the marks on the stone casing that the original window featured two stone mullions, separating the window into three panels. It is proposed it be re-instated as the original, with two stone mullions and squared head to match the adjacent existing windows, albeit without a transom (fig.3) The stone detailing appears structurally solid, with no obvious deterioration except where the surface exhibits smoke staining and is heavily encrusted with sooty matter and dust. It is proposed to be retained.

In addition, the most impactful proposal is to reinstate the rear window to the kitchen (accommodated within the original outrigger extension to the Victorian presbytery) where the stone tracery is proposed to be reinstalled to match the surviving windows (fig.1)

Three new narrow-framed metal windows will be installed between the stone mullions and reinstated stone jambs to mimic the relationship between frames and stonework elsewhere on the original presbytery.

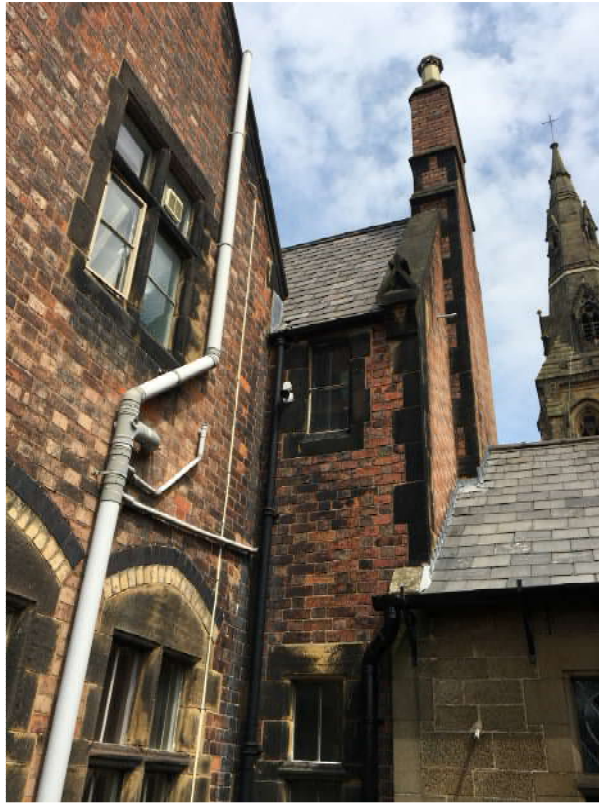
Figure 3 – the existing adjacent windows, showing the stone mullions

The newer uPVC rainwater goods have been left as a bare grey finish or painted green (see figs. 3 and 6), which appears unfinished and contrasting to the original cast iron pipework. It is intended to match existing colours to the original presbytery as closely as possible, and so proposed replacement pipework and gutters to the extension will be a black uPVC to match. It is proposed to paint the pipework to the rear of the presbytery in black to match the cast iron pipes adjacent (see fig. 3).

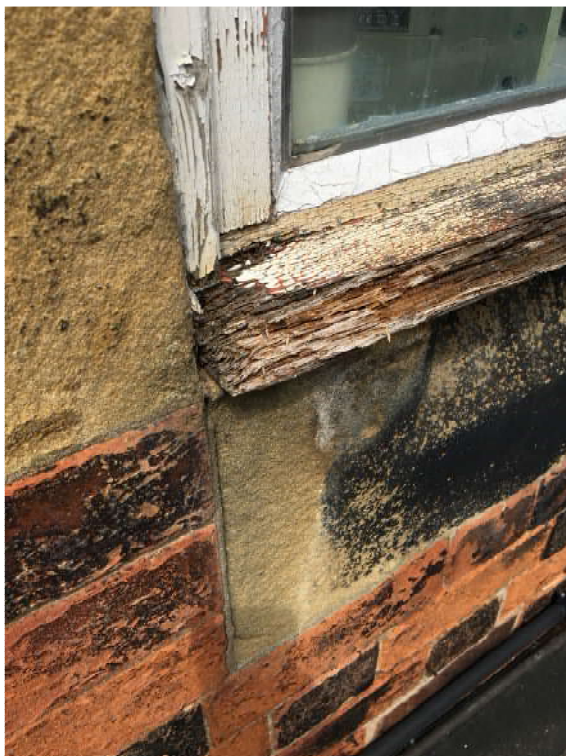
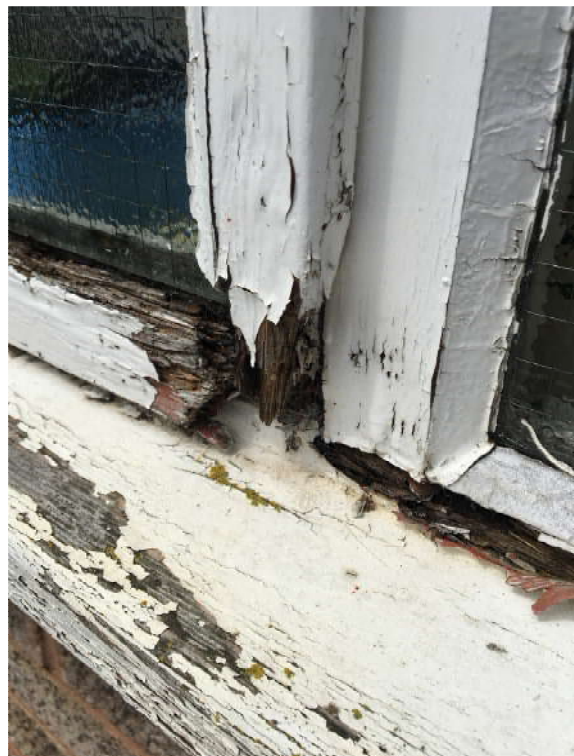
Figures 4 and 5 – rotting timber on the window frames to the extension and to the kitchen

To the scullery, at the rear of the presbytery kitchen (accommodated within the 1960s flat-roofed facing brick extension), it is proposed that the two timber frame windows and door in the modern extension are replaced with new replacement uPVC elements as they are in a state of disrepair with localised rotting and paint chipped away. Lack of maintenance is an ongoing issue; the choice of low-maintenance uPVC instead of a straight like-for-like timber replacement reflects this.

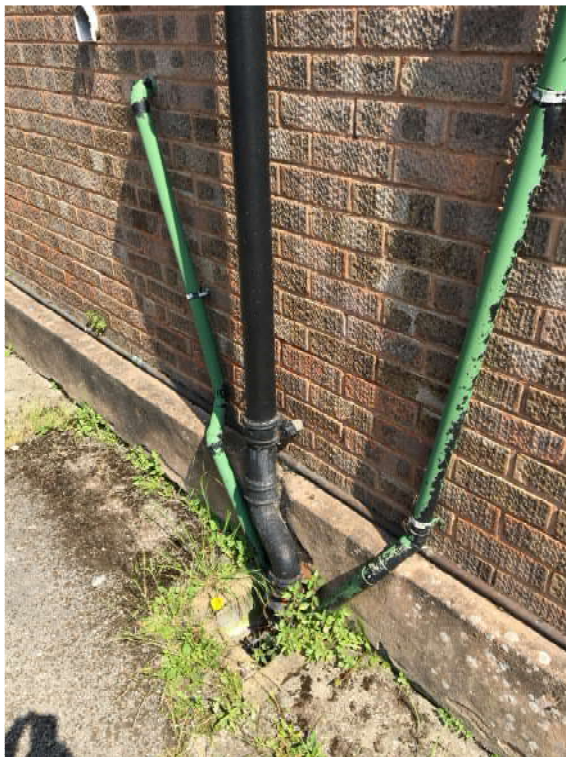
Figures 6 and 7 – green pipework and green soffits with evidence of rotting and warping.

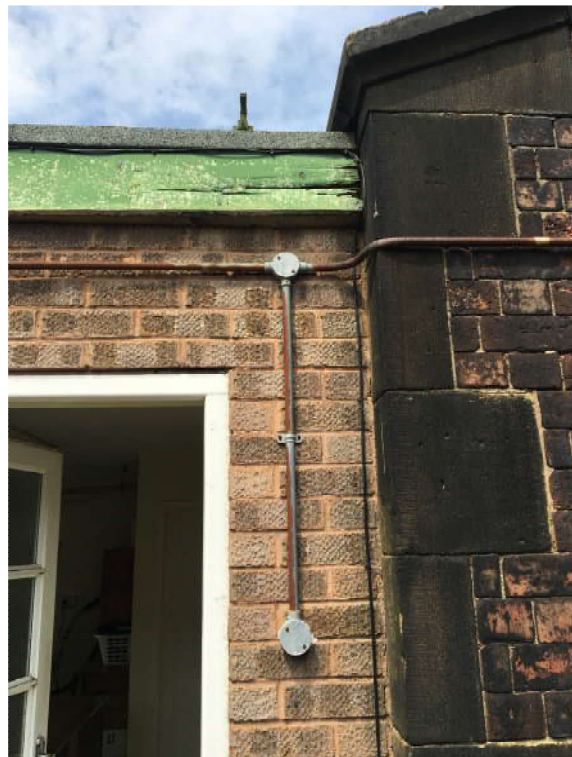
The fascia to the extension is very badly rotted in places - again reflecting a lack of ongoing and regular maintenance – and warped and are painted green (see fig. 7).

It is proposed to replace the fascia with low-maintenance white uPVC.
