## GREDDINGTON ARMS

# UPDATE PRELIMINARY ROOST ASSESSMENT AND EMERGENCE SURVEYS

Report Ref EE.711.RH

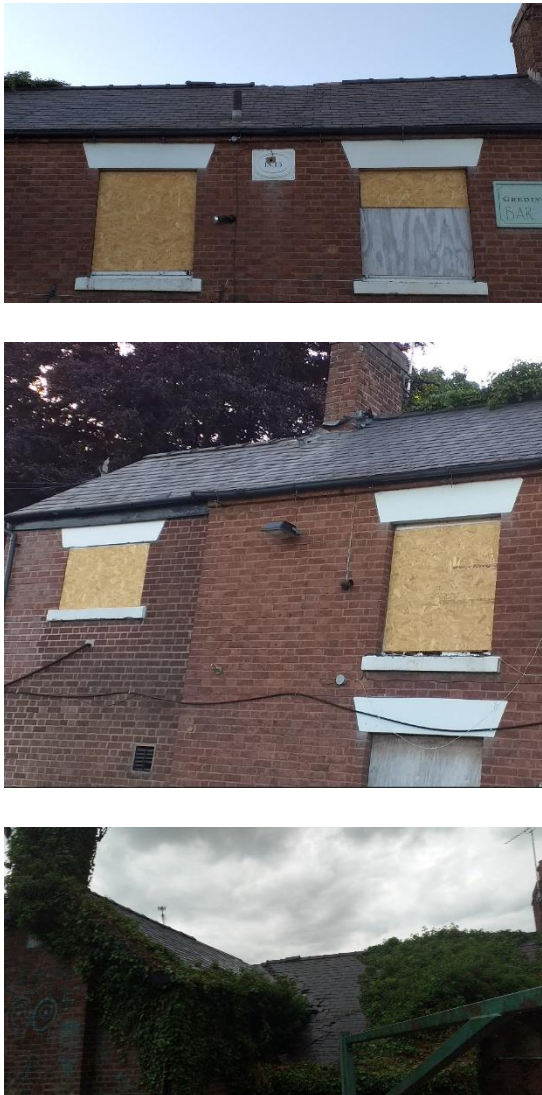
| Building Section | Description | Photo |
|---|---|---|
| Main pitched roof section of the pub | Many slates and ridge tiles missing, especially from the northern aspect. Gaps present behind soffits/ barge boards. | The 'Photo' column contains three separate photographs. The top photo shows a brick wall with two windows boarded up with plywood; a small sign is visible between the windows. The middle photo shows a similar view from a slightly different angle, highlighting the boarded-up windows and the roofline. The bottom photo shows a side view of the building with a gable end, showing missing roof tiles and a boarded-up door area. |

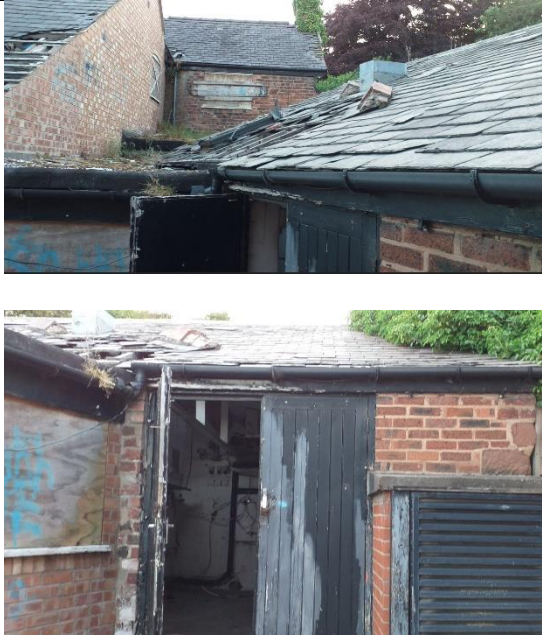
| Building Section | Description | Photo |
|---|---|---|
| Extensions to the east of the building | Large areas of roof with missing slates and lead flashing. Door open allowing access into separate store area. | |

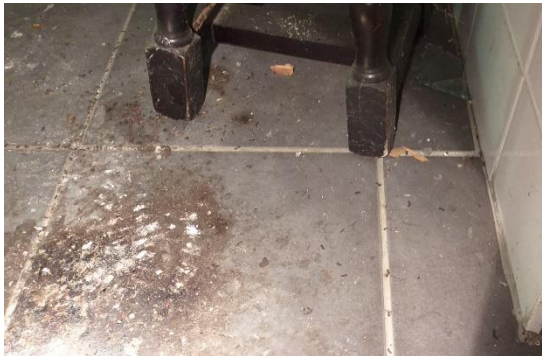
| Building Section | Description | Photo |
|---|---|---|
| Internally – main building | Large area of scattered lesser horseshoe droppings, one lesser horseshoe observed hanging up in the toilets. | |

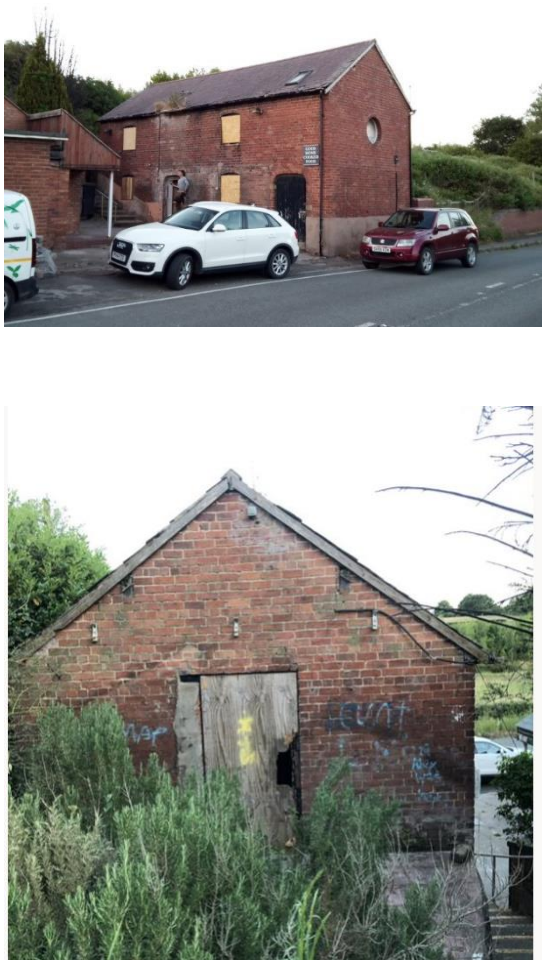
- 4.2 The barn appeared to be in a similar condition, externally and internally (where could be surveyed), to that of the previous survey, however, a skylight was broken and there was also a hole in the boarded-up door (Johnstone, 2015).
- 4.3 Please see the building inspection results in Table 4.1 below.

| Building Section | Description | Photo |
|---|---|---|
| Barn | Barn in better condition than the main building, however a broken sky light provided access into the upper storey and a hole in the boarded up door. Access behind barge boards and holes in brickwork. | |

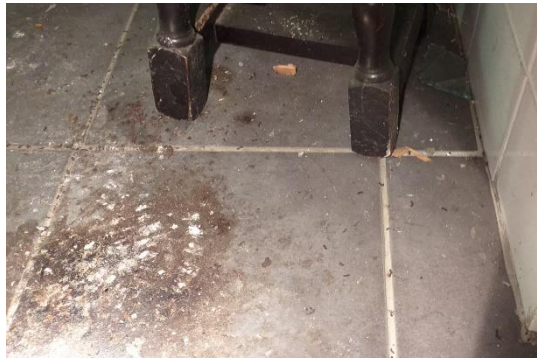
- 
- 4.4 Lesser horseshoe droppings were present in the downstairs of the main building, there were two accumulations, one in the ladies toilet, and one in the gentlemen's toilets. A lesser horseshoe was observed hanging up in the gentlemen's toilet (Photos 4.1 & 4.2). A small number of lesser horseshoe droppings were also found in the loft space (the loft hatch was off).

**PHOTO 4.1 – LESSER HORSESHOE DROPPINGS IN THE LADIES TOILET**

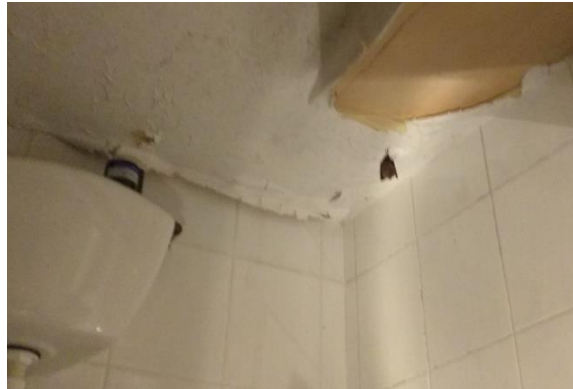
**PHOTOS 4.2 – LESSER HORSESHOE HANGING IN THE GENTLEMEN'S TOILET**

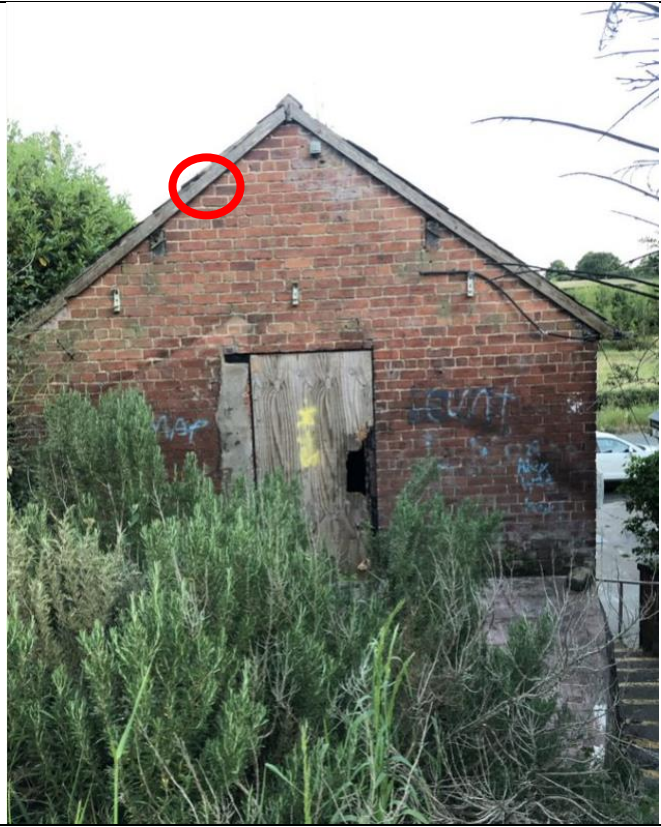
| Time | Species | Emergence (Y/N) | Comments | |
|---|---|---|---|---|
| 21:47 | Unknown | Y | Observed emerging from under the barge boards on the northern gable. Thought to be crevice dwelling | |

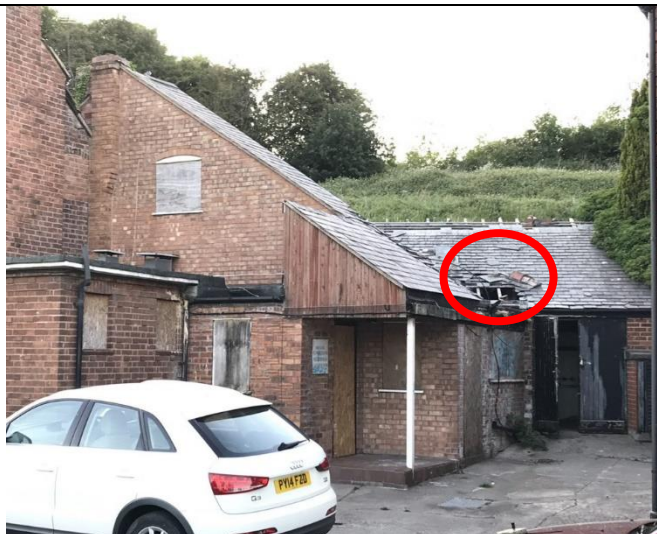
| Time | Species | Emergence (Y/N) | Comments | |
|---|---|---|---|---|
| 22:01 | Lesser horseshoe | Y and re-entry | Emerged and re-entered | |

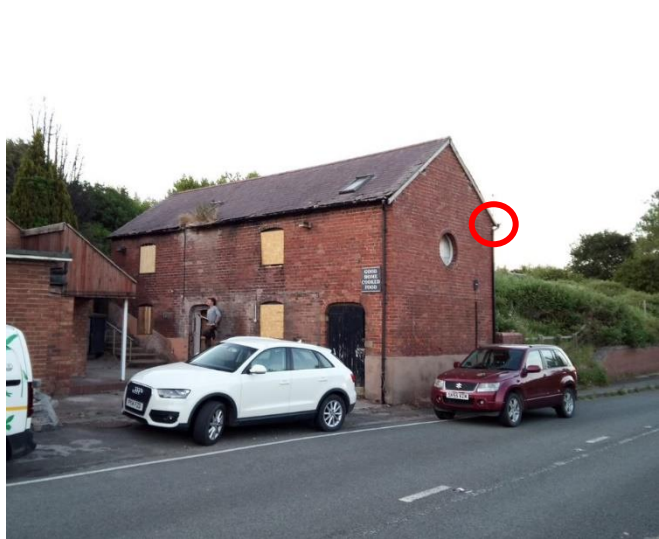
| Time | Species | Emergence (Y/N) | Comments | Picture |
|---|---|---|---|---|
| 21:40 | Pipistrelle sp | Y | Emerged from gable, flew to the north | |

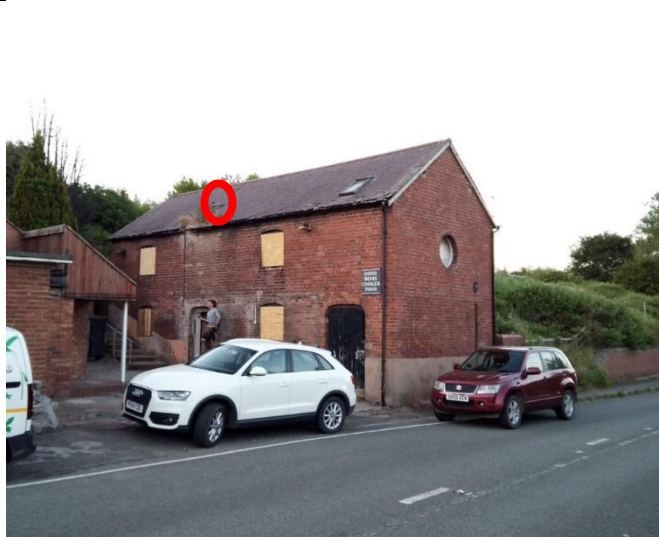
| Time | Species | Emergence (Y/N) | Comments | Picture |
|---|---|---|---|---|
| 22:14 | Not picked up on any detector – possible lesser horseshoe | Y | Emerged and re-entered | |
