**Land off A539,  
Hanmer**

## **BS5837:2012 Tree Survey and Arboricultural Impact Assessment**

**October 2020**

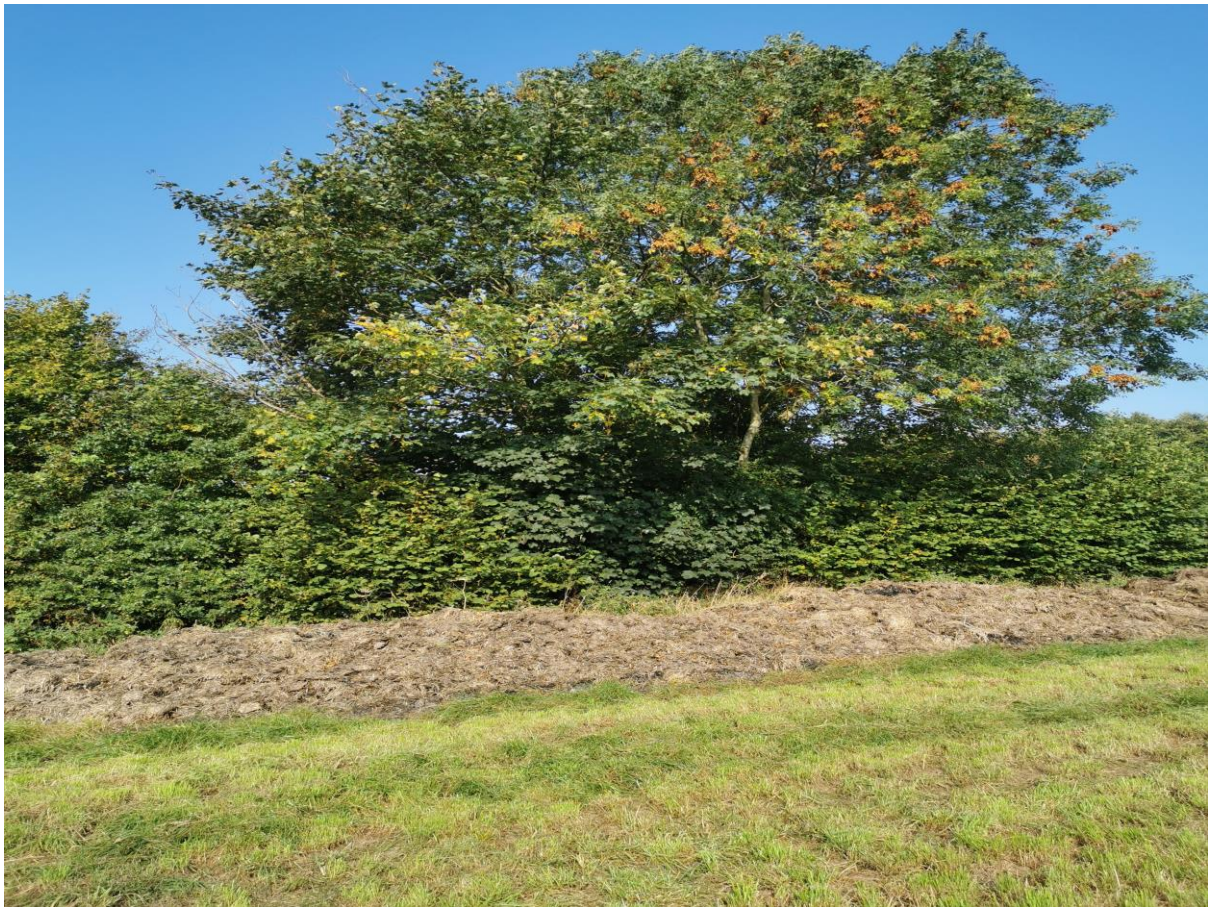
**Plate 1:** Showing T1 Common Ash (Right) and T2 Common Sycamore (Left)

**T1:** A multi-stemmed Common Ash tree situated with the hedgerow on the northern boundary. It is exhibiting a fair condition with no special merits.

**T2:** A Common Sycamore that is also situated within the hedgerow on the northern boundary and growing within close proximity of T1. It too is exhibiting a generally fair condition, with no special merits.

The overlaying of the RPA's of T1, T2 and T6 can be achieved without detriment to the trees future health and condition providing that no more than 20% of the RPA is overlaid, and the surfacing is of a suitable construction. The exact design specification of this surfacing is thought to be an engineering matter and this report refers the designers to BS 5837, section 7.4 *Permanent Hard Surfaces within an RPA*.

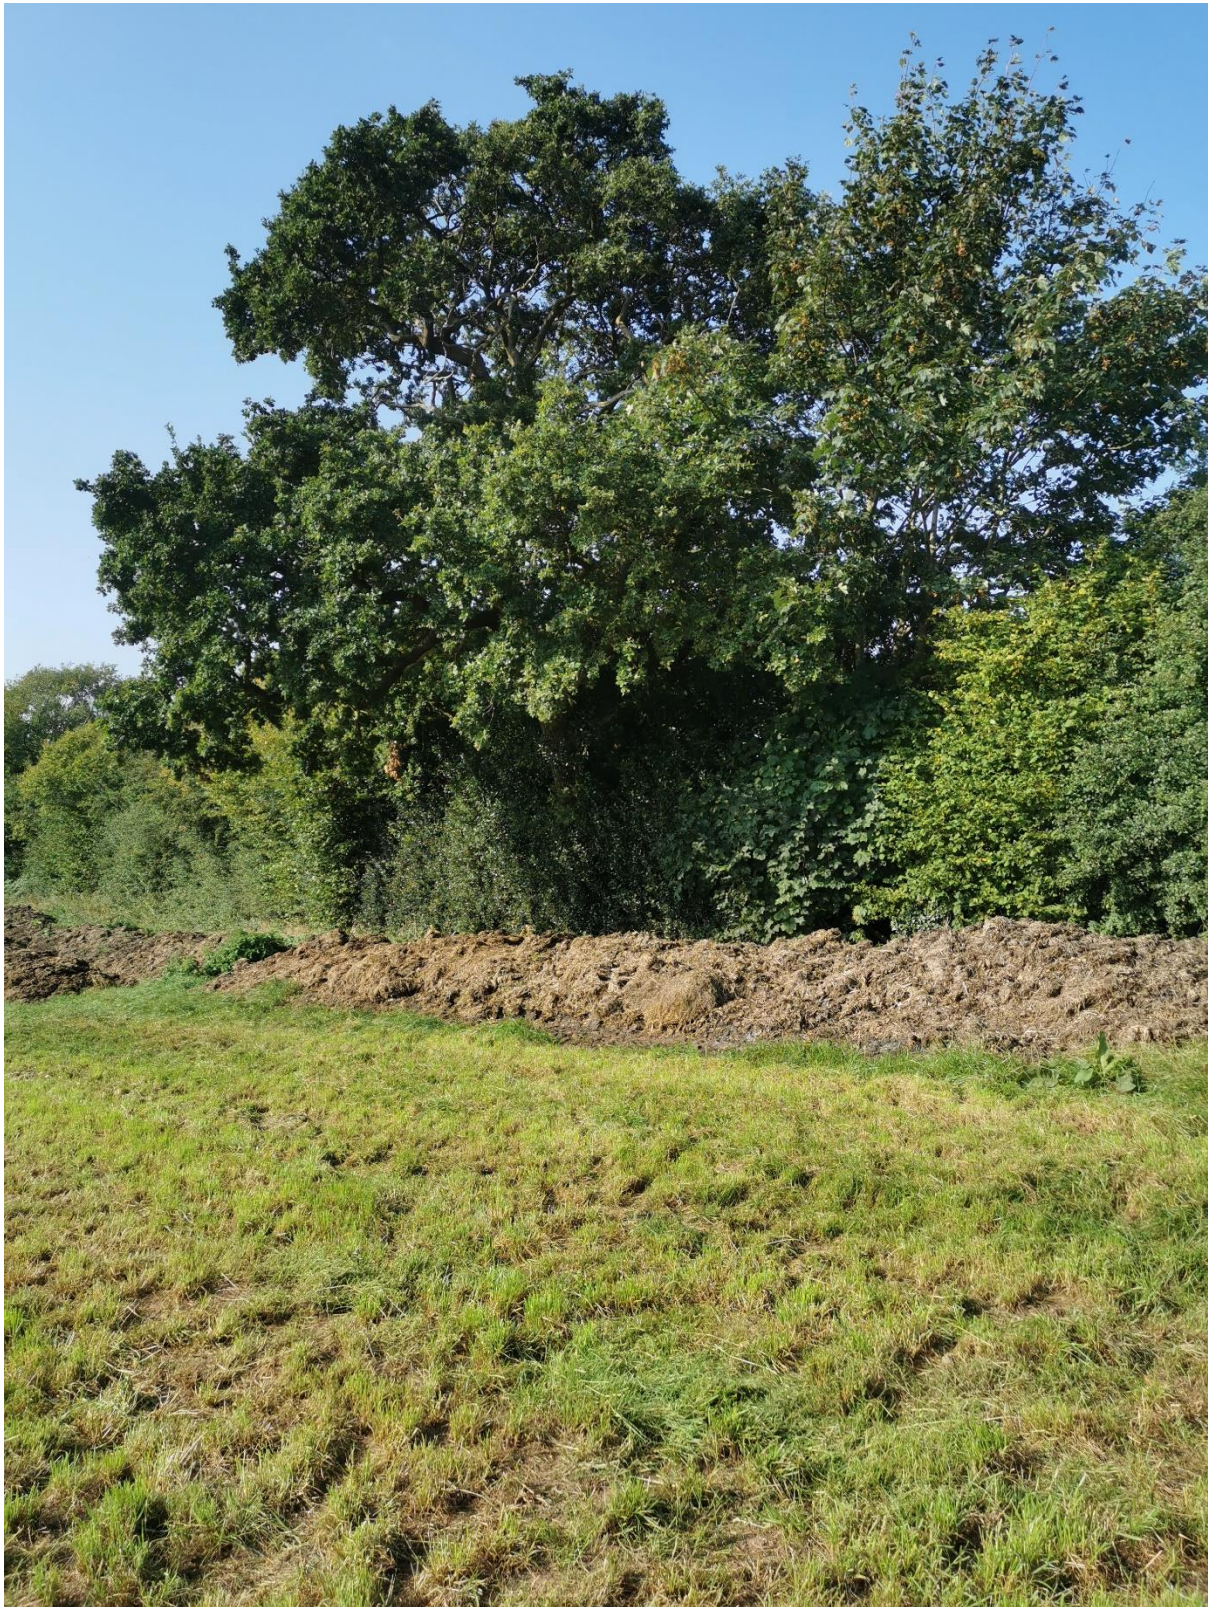
**Plate 2:** Showing T3 Common Sycamore (Right) and T4 English Oak (Left)

**T3:** Common Sycamore, again, situated within the hedgerow on the northern boundary. Once again, this tree is exhibiting a generally fair condition, with no special merits.

**T4:** A mature English Oak also within the hedgerow on the northern boundary. It is exhibiting good condition, with an asymmetrical crown. Some deadwood is present. It is a prominent feature within the hedgerow and surrounding landscape. This tree could be of a high ecological value and has been identified as a good specimen.

It is recommended that T4 and T6 are crown cleaned for deadwood in excess of 25mm.

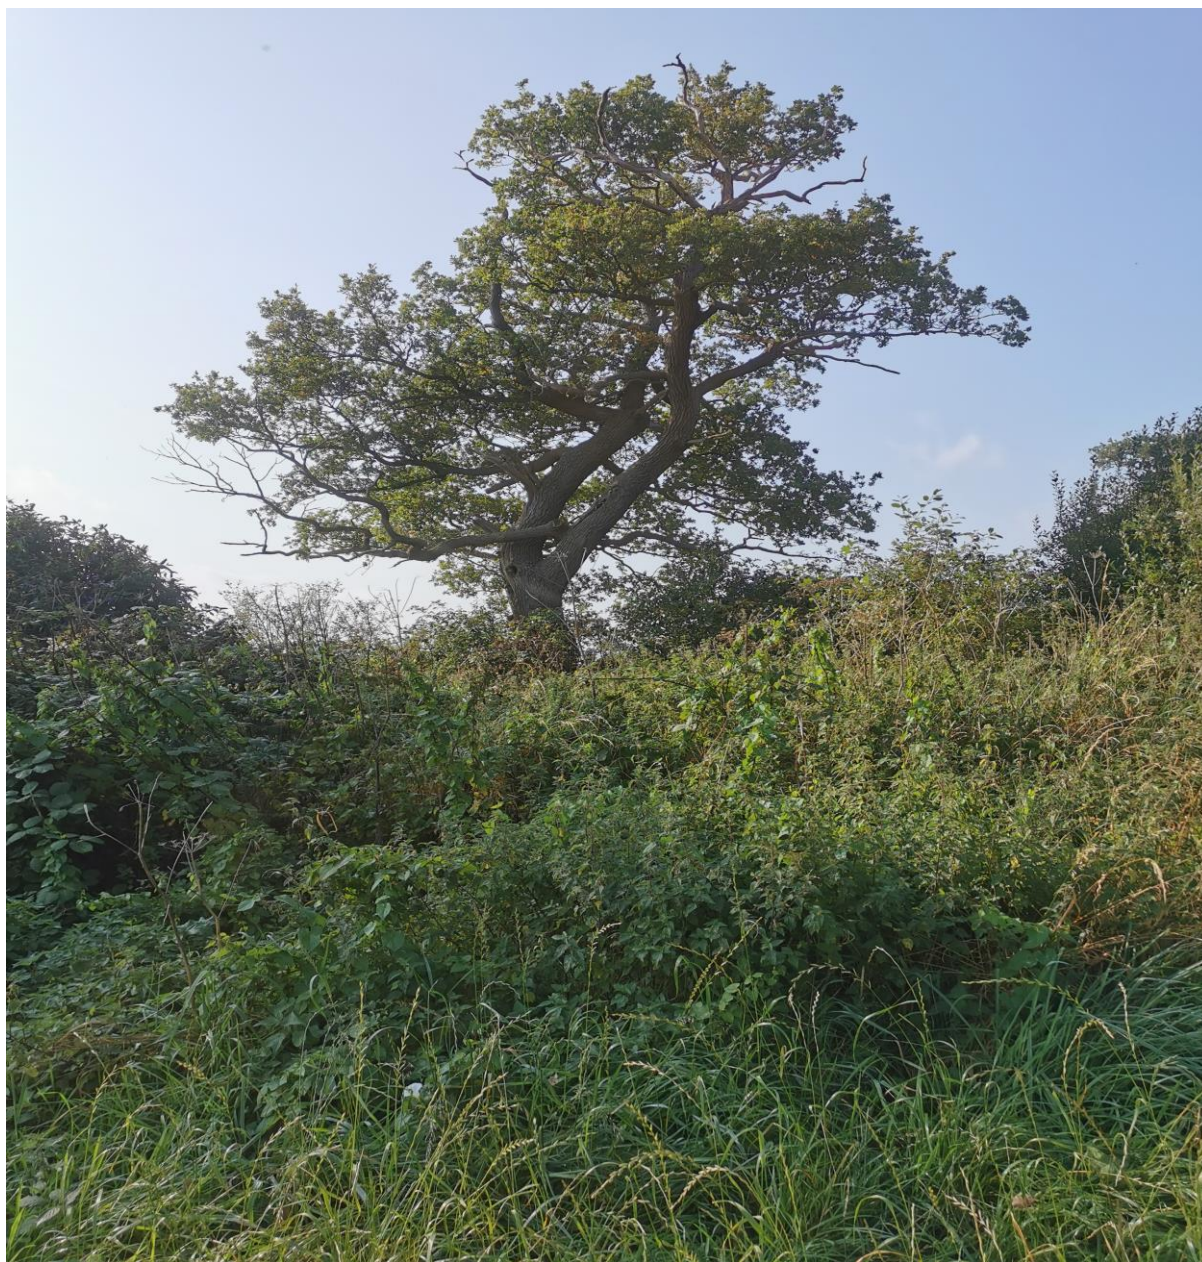
**T5:** Another mature English Oak, this time existing within the western boundary. It is exhibiting acute decline and dieback, with excessive deadwood present. The bark and cambium layers are missing in places. Once again, this tree could be of high ecological habitat value.

T5 has cracks and fractures present. Excessive deadwood and cavities were also noted. There is also extensive shedding of bark and cambium layers.

T5, a Mature English Oak. This tree is showing extensive decline, possibly acute oak decline. The bark and cambium layers are missing in places, with excessive deadwood present.

**Plate 4:** Showing T5, English Oak in decline.

T5, a mature English Oak, is recommended to be reduced to a standing deadwood habitat monolith. The entire crown should be removed and all major primary limbs reduced back to 3-4 meters in length producing a standing deadwood monolith, this should be done with the use of a MEWP as this tree may not be safe to climb. This will reduce the potential of collapse and/or major limb failure/ wind felling/ structural failure, while retaining this potentially valuable habitat. A bat survey of potential roosting features is recommended.

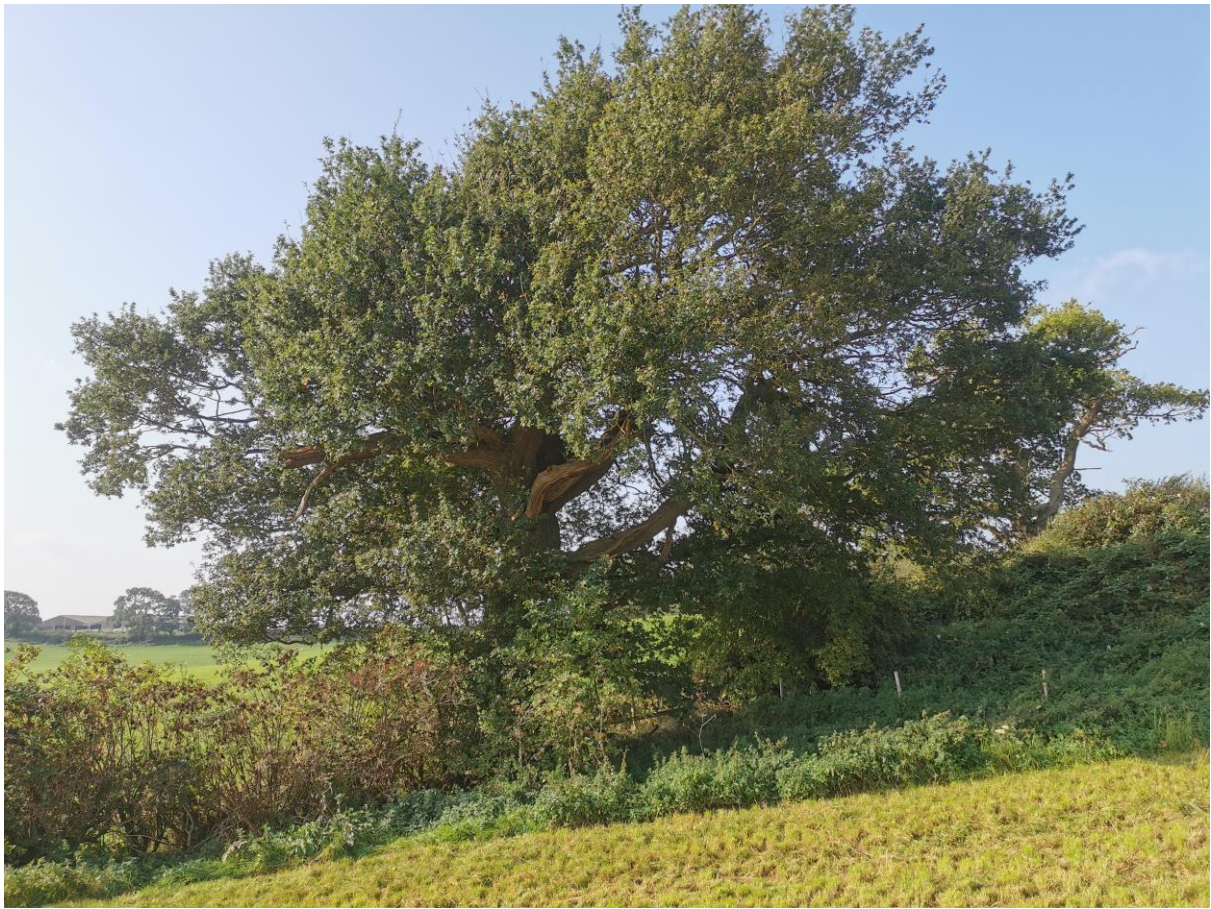
**Plate 5:** T6. English Oak.

**T6:** A mature English Oak also existing along the western boundary. It is a good quality, large specimen. A prominent landscape feature, it is exhibiting generally good condition, with an asymmetrical crown.

In summary, it is recommended that crown cleaning and deadwood removal (in excess of 25mm) is carried out on the two mature English Oak trees (T4 and T6). This is to reduce the chances of falling debris on the completed site and the occupants using it.

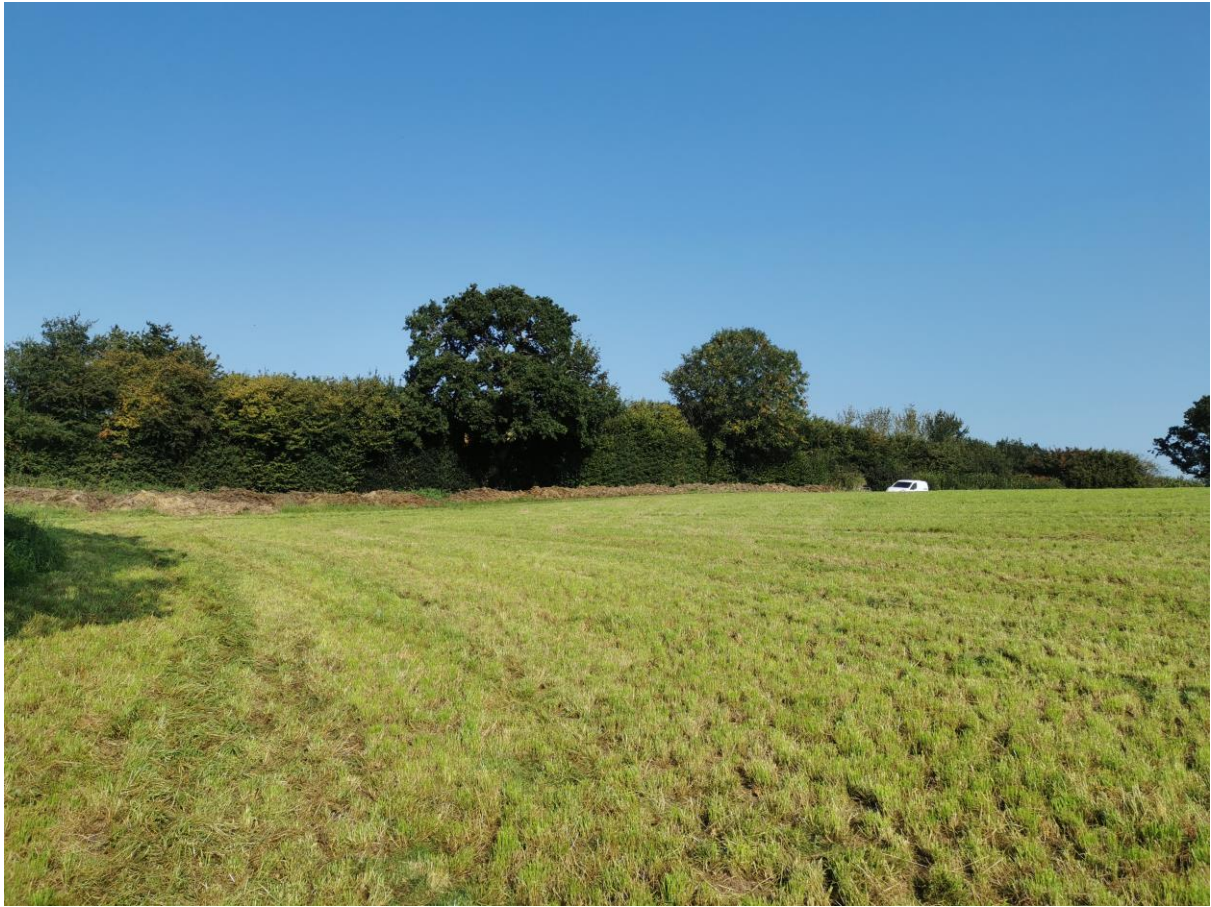
**G1:** A mixed species hedgerow bounding the northern and partial western area of the site. It is exhibiting generally good condition and is of ecological habitat value.

**Plate 6:** Showing G1 with T1, 2, 3, and T4 incorporated.
