## CENTRE 67 – 67 RHOSDDU ROAD

### POTENTIAL ROOST FEATURE (PRF) INSPECTION

Report Ref: EE.735.20.RH

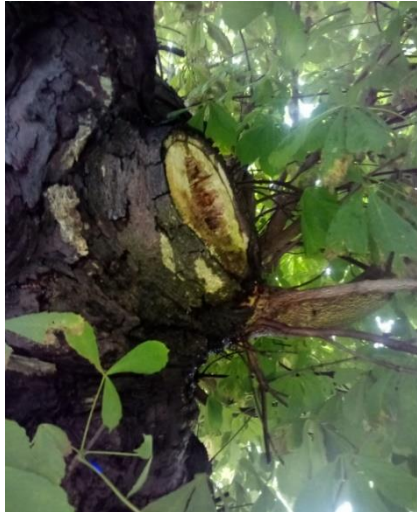
| Tree number | Species | | Preliminary Roost Feature Inspection | |
|---|---|--|---|---|
| T1 | Horse chestnut | | <p>One rot hole was inspected on the south west of the tree, this was at approximately 2.5 m in height. This rot hole was not deep and did not provide any roosting opportunities for bats.</p> <p>The tree could not be investigated any further due to the presence of chicks above the identified feature. It is possible there was another feature above the identified feature, however this could not be determined.</p> | |

- 4.1 Tree number 1 (T1) offered negligible roosting potential in the identified feature, however, it is possible that further potential was present which could not be inspected due to the presence of chicks in the tree.

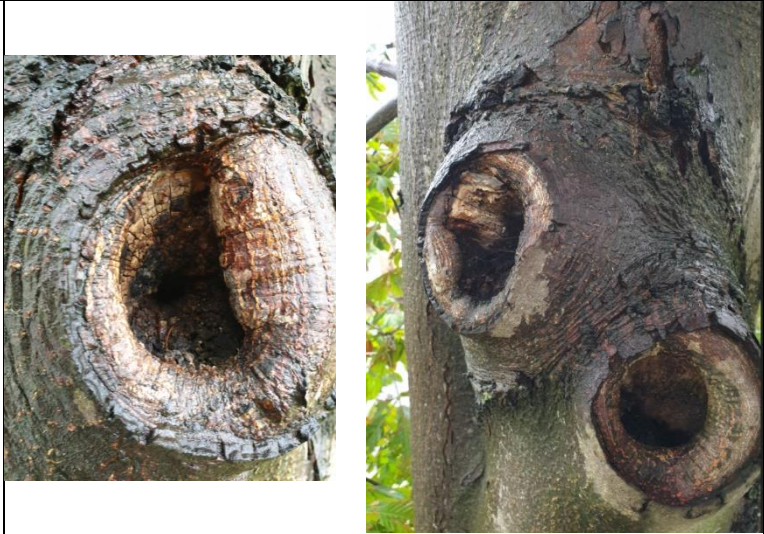
| 2 | Horse chestnut | | <p>There were five different features in this tree which were inspected. Three of these were small knot holes on the north of the tree – these were at between 3 – 4 m in height. None of these provided any roost opportunities.</p> | |

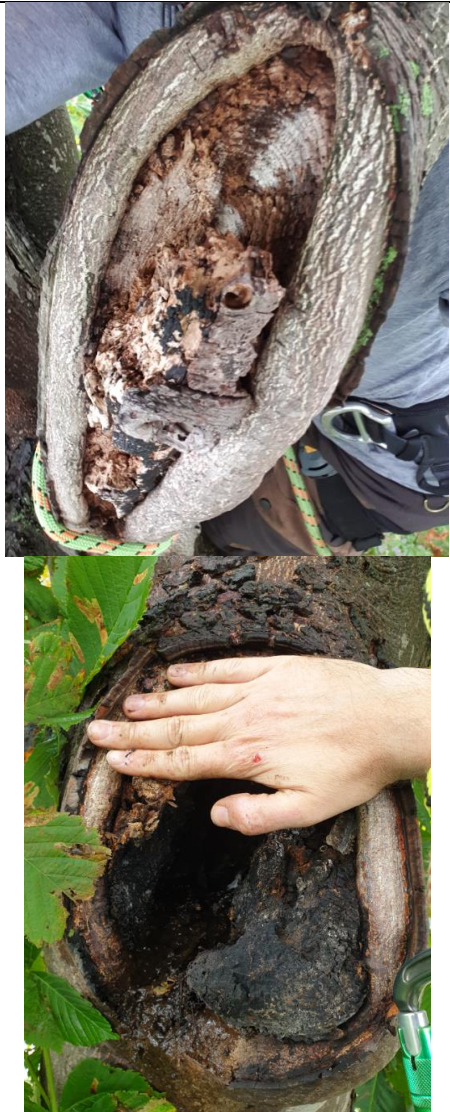
| 2 | Horse chestnut | | <p>The fourth feature was a split in the trunk – this was on the south side. This again offered no potential for roosting bats.</p> <p>The fifth feature (picture on the right) was a large knot hole or potentially a pruning wound again on the south side of the tree. This feature was approximately 6 inches wide and over 18 inches deep - approximately 12-14 inches horizontally into the branch stub/trunk and then another 4 inches up that could be inspected; the wound continued past this but it was not possible to view with the endoscope. The feature was smooth suggesting possible use by bats.</p> | |

- 4.2 Tree number 2 (T2) offered moderate potential for bats as there was a feature present which could be used by bats, the feature was smooth. No bat droppings were observed.

- 4.3 Even though T2 has potential for bats to roost, the tree is located further away from the building and the feature is on the south/south-western side of the tree; it is not felt that any further surveys are needed as disturbance would be reduced by facing away from the demolition. The site is in an urban area with frequent noise and disturbance, therefore if bats do use the feature, it is likely that they are accustomed to noise and disturbance - there was constant human activity during the whole period of the survey.

- 4.5 Following the PRF inspection no further surveys are required and the demolition can take place, however, mitigation in the form of lighting is required to reduce potential disturbance (4.6 and 4.7). A low level barrier should be installed around the trees (such as netlon or rope) to protect them during the works, ideally this fence off the root protection zone as defined by an arboriculturist, however most of the surrounding environment is hard standing.

- 4.6 Mitigation should be put in place to minimise any disturbance to these features, this should include lighting and also avoiding works within an hour of sunset or sunrise.
