## GREDDINGTON ARMS

# UPDATE PRELIMINARY ROOST ASSESSMENT AND EMERGENCE SURVEYS

Report Ref EE.711.RH

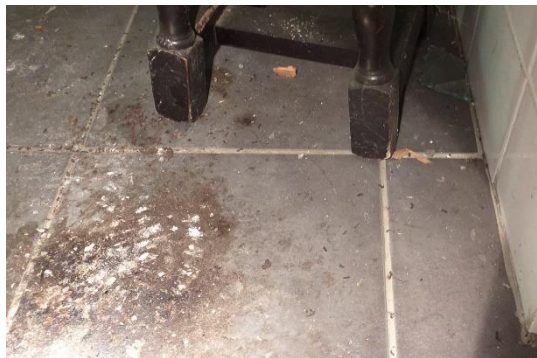
- 
- 4.4 Lesser horseshoe droppings were present in the downstairs of the main building, there were two accumulations, one in the ladies toilet, and one in the gentlemen's toilets. A lesser horseshoe was observed hanging up in the gentlemen's toilet (Photos 4.1 & 4.2). A small number of lesser horseshoe droppings were also found in the loft space (the loft hatch was off).

**PHOTO 4.1 – LESSER HORSESHOE DROPPINGS IN THE LADIES TOILET**

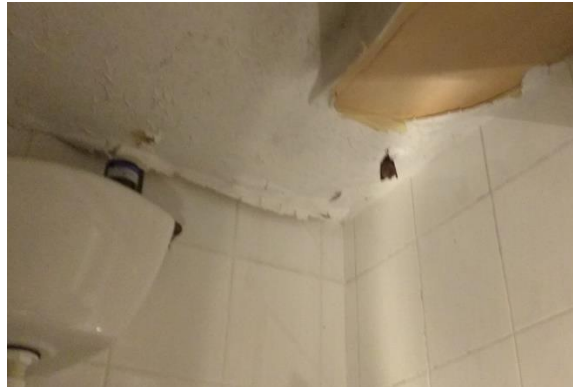
**PHOTOS 4.2 – LESSER HORSESHOE HANGING IN THE GENTLEMEN'S TOILET**
