# Preliminary Roost Assessment Briefing Note

Royal Mail Distribution Office, Wrexham, September 2020

*This briefing note has been prepared by CSA Environmental on behalf Faithful & Gould, in relation to the buildings at the Royal Mail Distribution Office, Wrexham (hereafter referred to as the 'Site'). It provides the results of the Preliminary Roost Assessment (PRA) for bats of the on-site structures to be demolished.*

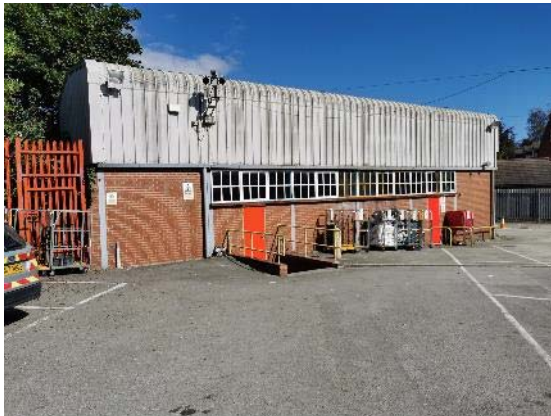
- 4.2 Building B1 was found to be of breeze block construction with a red brick outer skin with metal frame windows present along large stretches of the structure. The roof and upper section of the walls of the building were comprised of corrugated metal with plastic skylights present. Large metal folding doors located on the northern aspect of the building were open at the time of the survey. No gaps were noted in the mortar of the brick work but a small lifted section of metal sheeting was noted in the southern corner of the building but did not lead into any voids. There were numerous external security lights on the building and within the rest of the Site.

Photo 1. Exterior of building B1 with external security lighting.

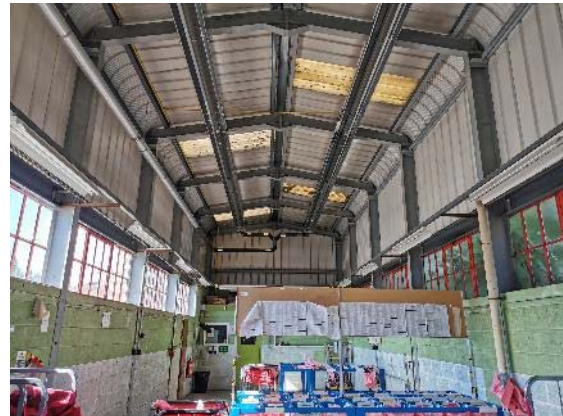
- 4.3 The internal inspection found the building to be in regular use and the roof structure to be steel framework with no insulation or roof voids present. The interior of the building was very light and airy. During the inspection the large steel doors were open slightly but this is locked up overnight and no access points were noted. No evidence of bats was found and the building is considered to have a '**Negligible**' potential to support roosting bats.

Photo 2. Interior of building B1 with steel frame roof structure, windows and sky lights.

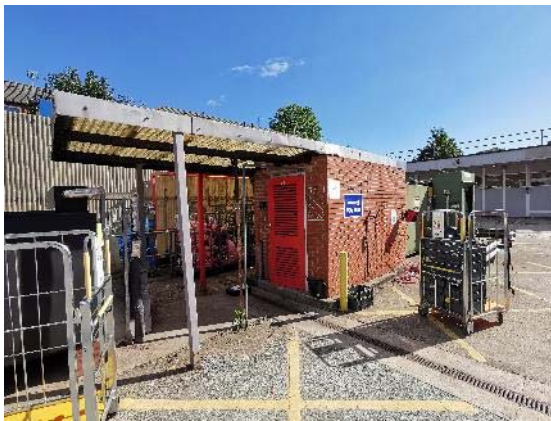
- 4.4 Building B2 includes number of structures such as a vehicle wash, and fuel tanks that are not suitable for roosting bats. There is one small building present which was subject also inspected. This building was found to be of red brick construction with a corrugated roof (half corrugated concrete material and the other half of clear corrugated plastic acting as a skylight. Bargeboards were present along the

northern and eastern aspect of the building only with a slight lifting. External security lighting is present with the Site which will affect the building.

Photo 3. Exterior of building B2.

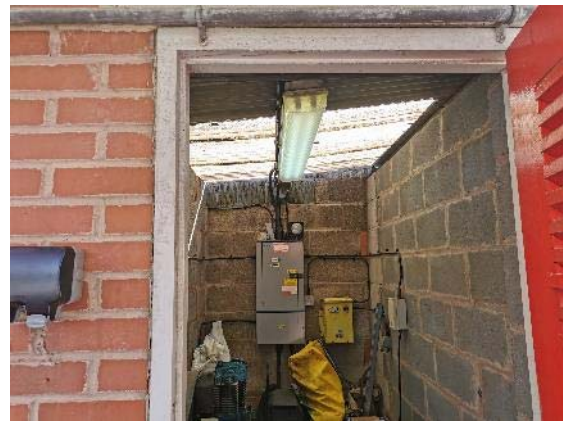
- 4.5 The internal inspection found the room to be in regular use and the room to be very light due the part plastic roof and internal lighting present that were on at the time of the inspection. A gap was noted above the door lintel and with a broken panel of the roof providing potential access to the interior of the building.
- 4.6 No evidence of bats was found and the building is considered to have a '**Negligible**' potential to support roosting bat due the limited roosting opportunities, the internal space of the building being so light and the security lighting present.

Photo 4. Interior of B2 with skylight.

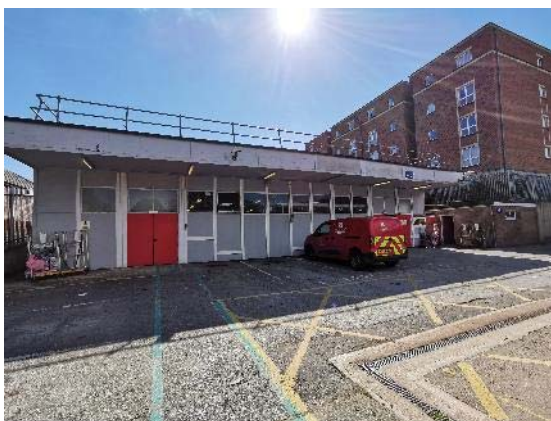
- 4.7 Building B3 is a timber and steel frame prefabricated building in current regular use a mail sorting office. The building has a flat roof and c. 2.5m overhang at the frontage on the western aspect and no access points were noted. The timber frame appeared to be in poor condition with some areas of wood rotten, however no access points were noted in these areas. External lighting was present on the building and within the wider Site.
- 4.8 The internal inspection found there to be a ceiling clad with plasterboard, it is assumed that as it is flat roofed no suitable roof void was present above. No potential access points were noted during the internal inspection and the area was well lit with natural and artificial lighting. With consideration of the above it is considered building B3 has '**Negligible**' potential to support roosting bats.

Photo 5. Frontage of building B3.

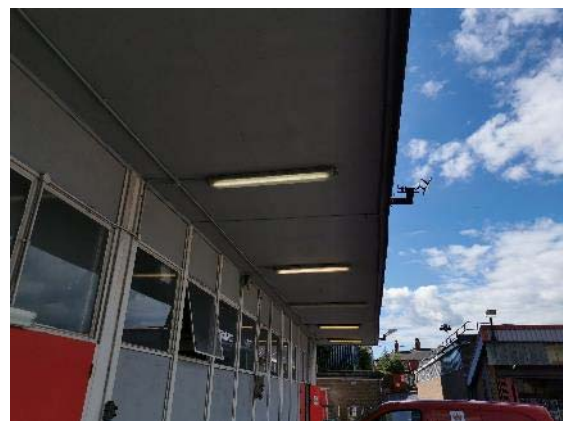
Photo 6. Underneath of overhang of building B3.
