REF: 2346/BR/MinLetRep/TG

## **RE: BETHANIA ROAD, ACREFAIR: MINING REPORT**

Mr Darren Hannaby (DH) is proposing to build a detached house on land adjacent to Bethania Road, Acrefair, near Wrexham.

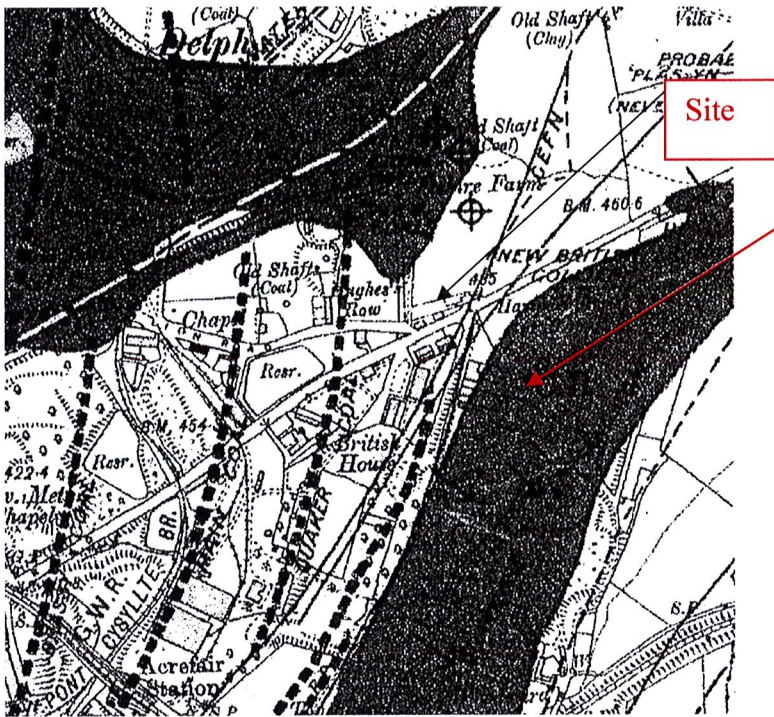
The 1:10,560 scale plan dated 1911 shows the Cefn Fault to be immediately east of the site trending in a NNE-SSW direction, with its downthrow to the south east, see below.

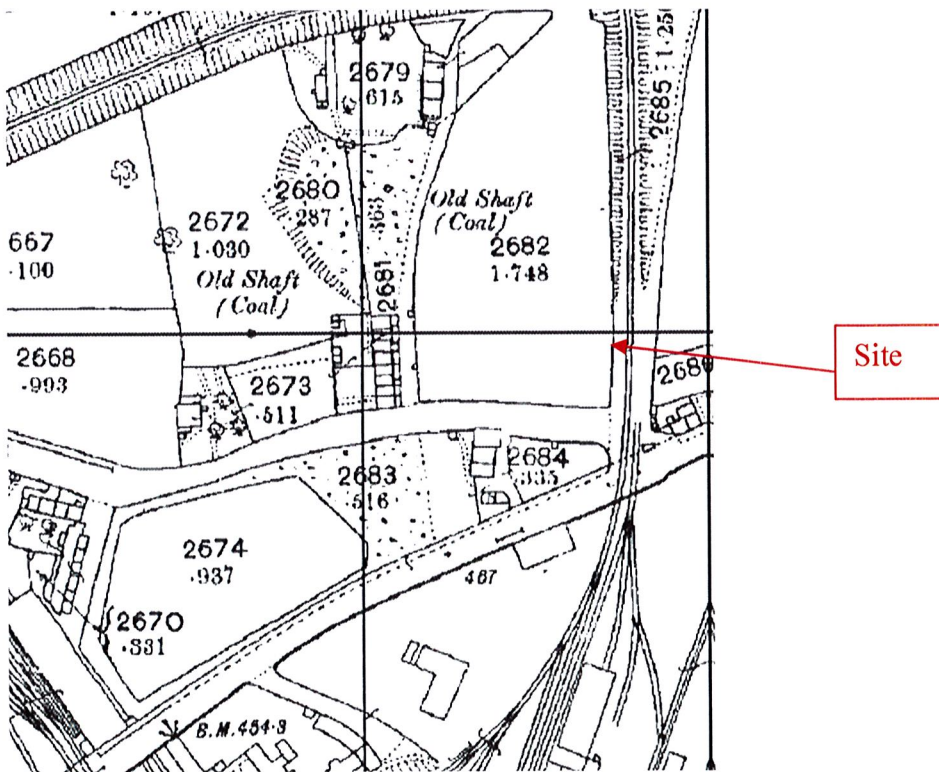
In addition, old shafts are shown to the north of the site, which are also shown on the 1874 OS plans, a copy of which is presented below.
