# Arboricultural Report

**Milking Parlour, Slurry Lagoon & Silage Area  
Merehead  
Hanmer  
Whitchurch  
SY13 3EJ**

29<sup>th</sup> August 2019

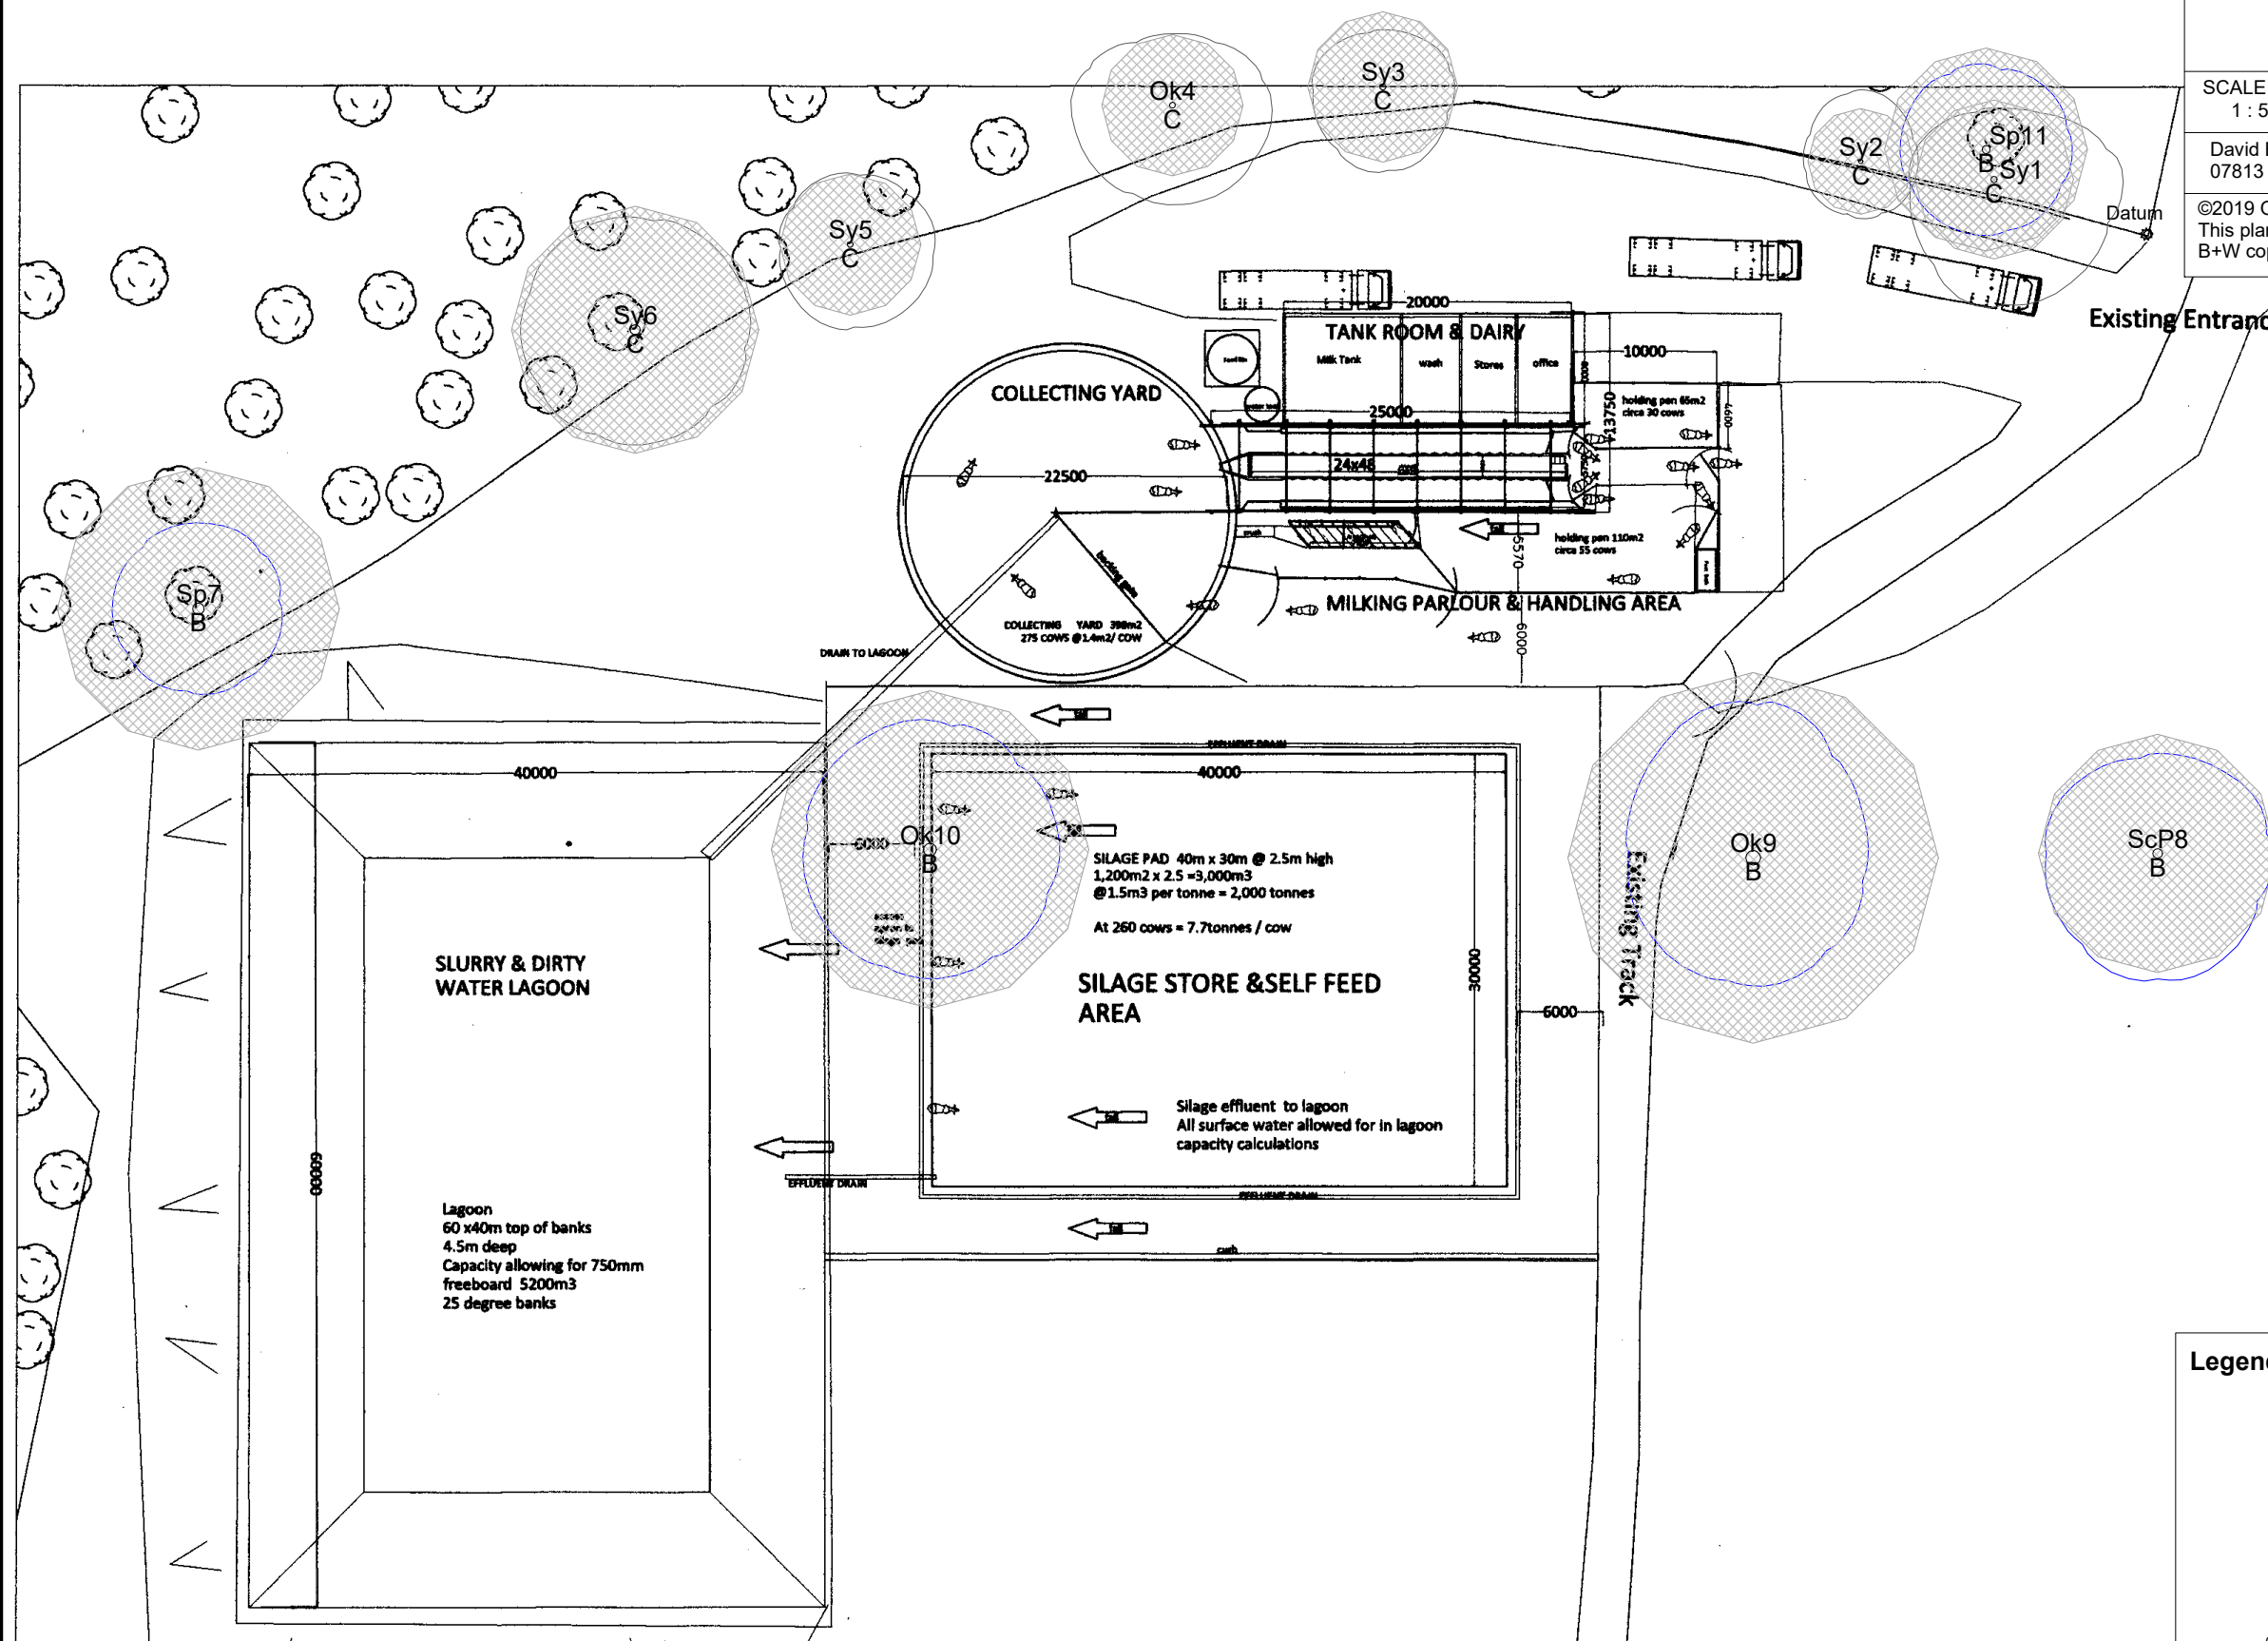
Map reference:  
PC19/333/TCP

- 8.1 Appendix A and B show the crown spread and root protection area (RPA) of each tree. The area covered by these items require careful consideration within the design and construction process as damage to the tree within these areas will be very harmful to it. These zones are primarily set aside for the tree.

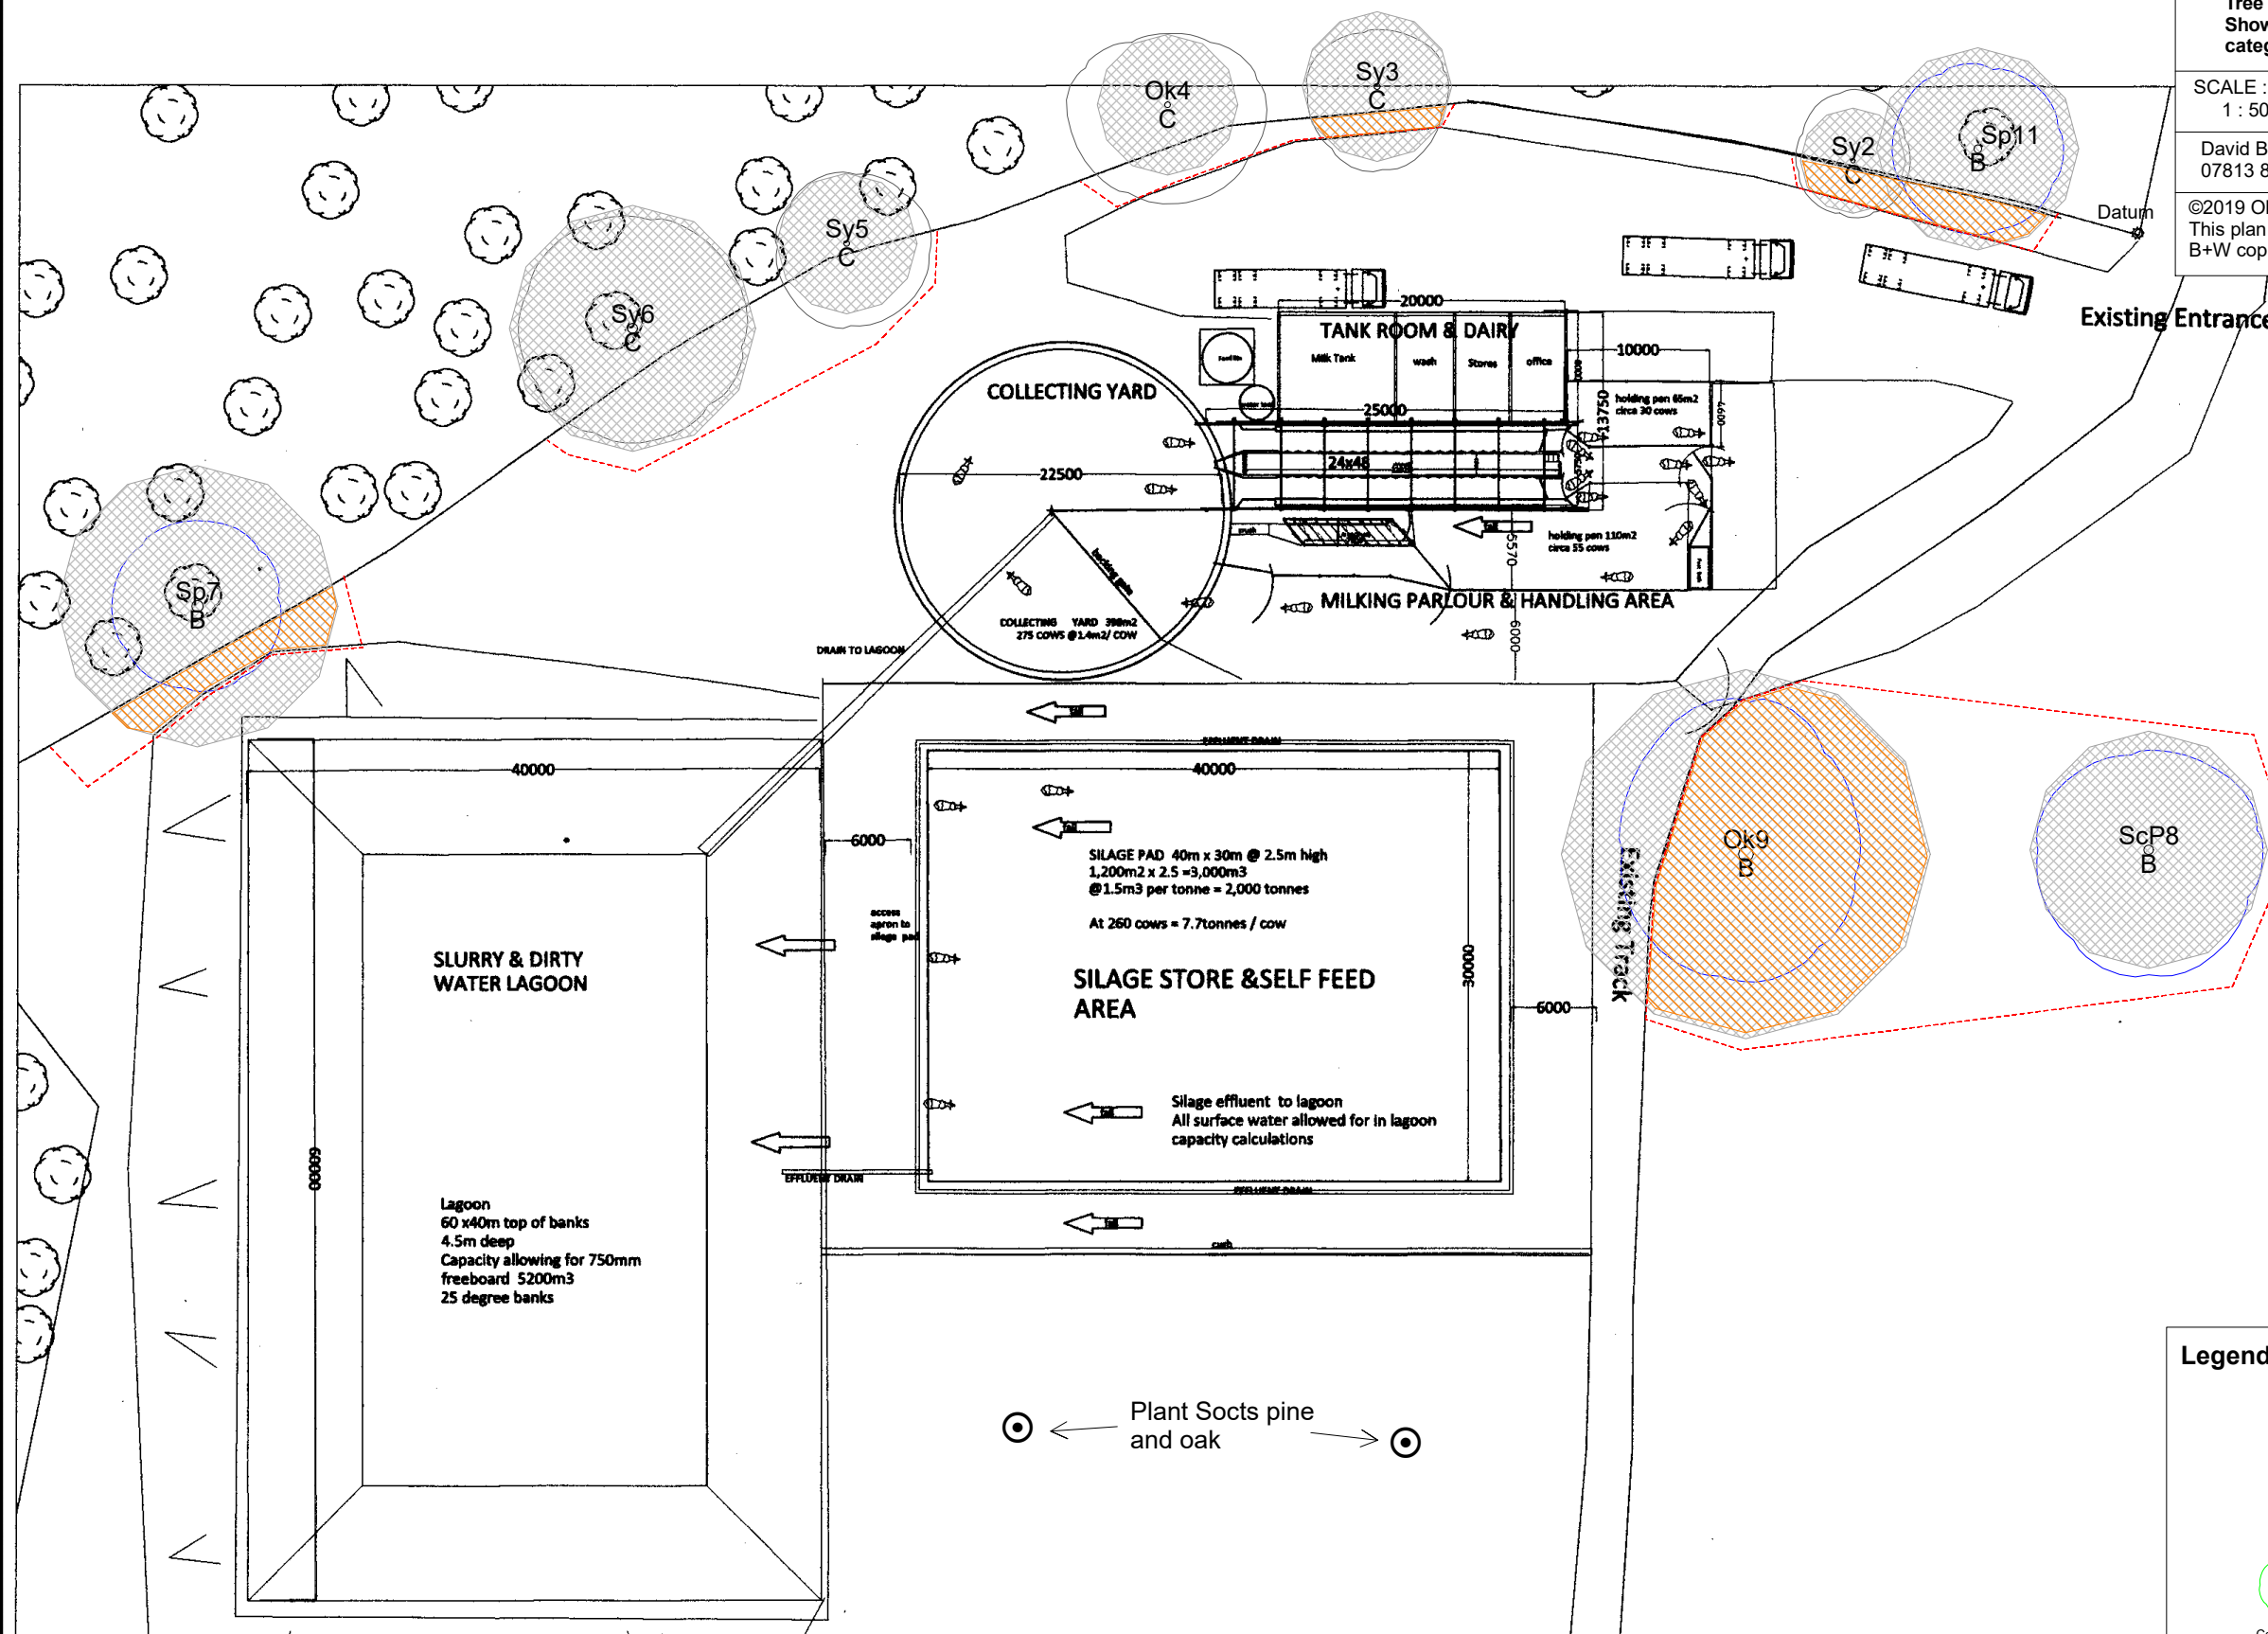
Map reference:  
PC19/333/TPP

- 8.4 The tree protection plan, Appendix B, shows how a protective fence, the design following that shown in BS5837:2012 Figures 2 and 3, Appendix D, will protect trees on the site. The fence is to be installed before any work begins on site including plant or material deliveries. It is to remain in place throughout construction and only be removed after all construction has finished. The fence could be linked to the security fence which will surround the site.

- 8.5 Protected RPAs are to be kept clear of refuse, materials, fuels and chemicals. These items should also be prevented from leaking into the RPAs. Protective fencing is to be robust and unbreachable, unless with the use of tools. Fencing should be attached to edges, or itself, to prevent it being circumvented. Should fencing be damaged it should be repaired immediately.
