REF: 2032/SCP/RepLet/mjs

31<sup>st</sup> January 2018

## **RE: SALEM CHAPEL, PONCIAU: SHALLOW MINING ASSESSMENT**

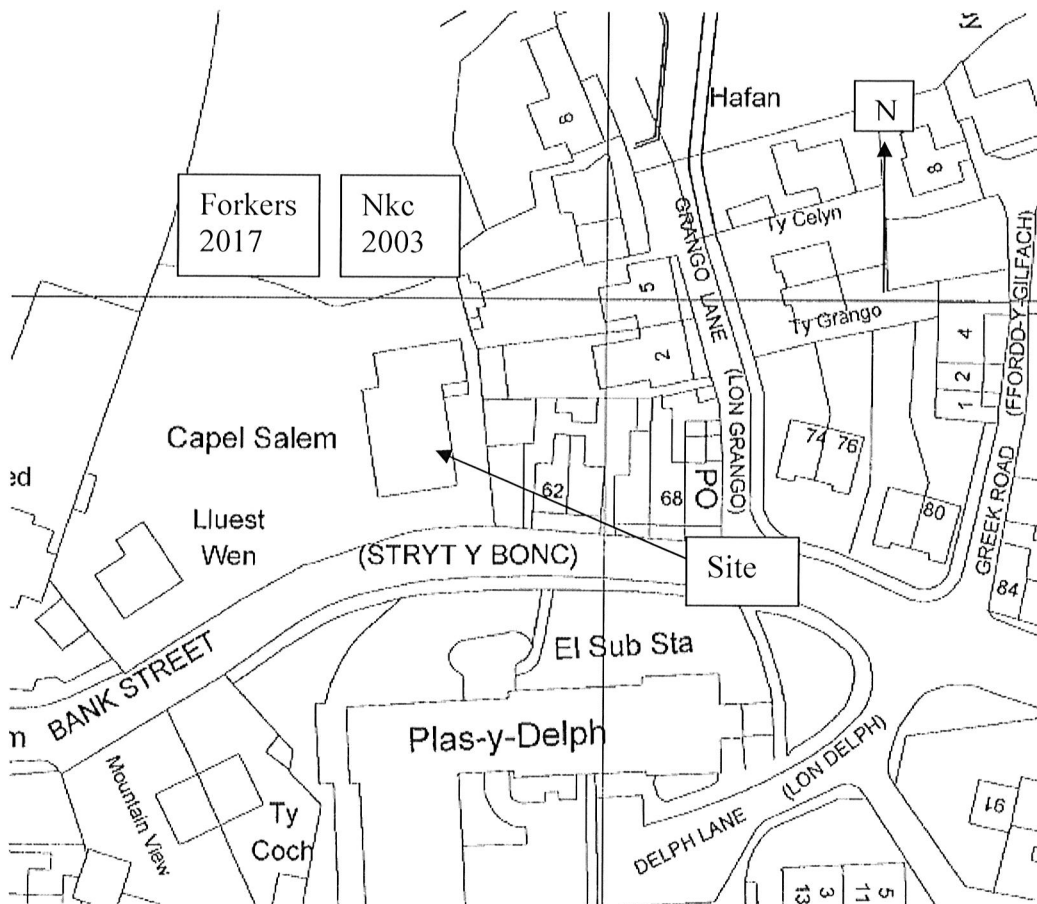
Nkc Geotechnical investigated the location of a property called Thorlie, in 2003, which is immediately adjacent to the northern site boundary, see above. The findings of the investigation are presented in Appendix B.

In December 2017 the site immediately west of Thorlie was drilled and grouted by Forkers under the supervision of GSL.

It proved the Brassey Coal seam to be at a similar depth to the investigation above. However, the Crank coal seam was encountered at a depth of around 14m. The drilling recorded abstraction ratios of around 50% for both seams, with the Brassey and Crank coal seams being grouted, with just over 35 tonnes of grout being taken.

The locations of both investigations are presented below.
