# Bradley Road Fire Station Wrexham

## Bat Survey Report

31 August 2017

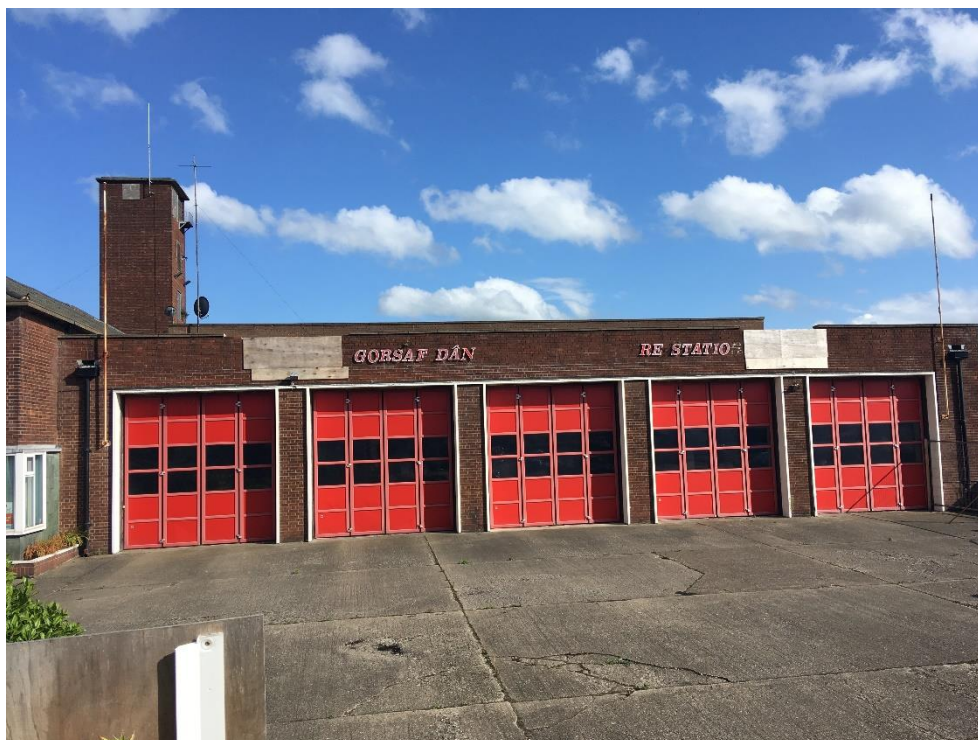
Building 1 was assessed as offering **negligible** bat roosting potential.

*Photograph 1- West Face of Building 1 (Building 4 in background)*

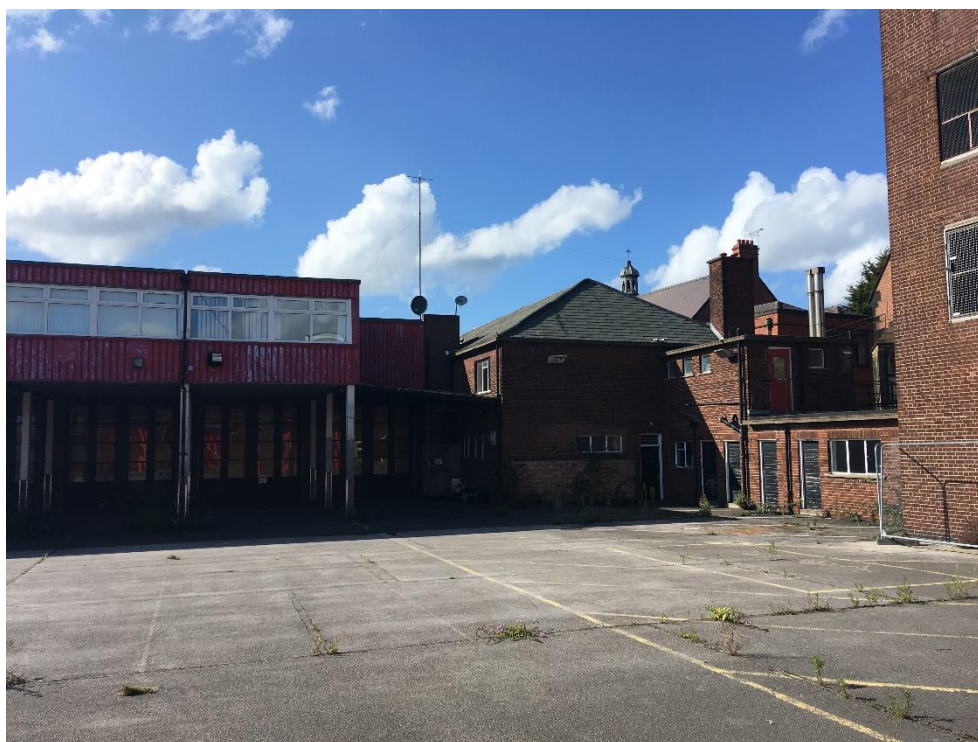
*Photograph 2- East faces of Buildings 1 & 2*

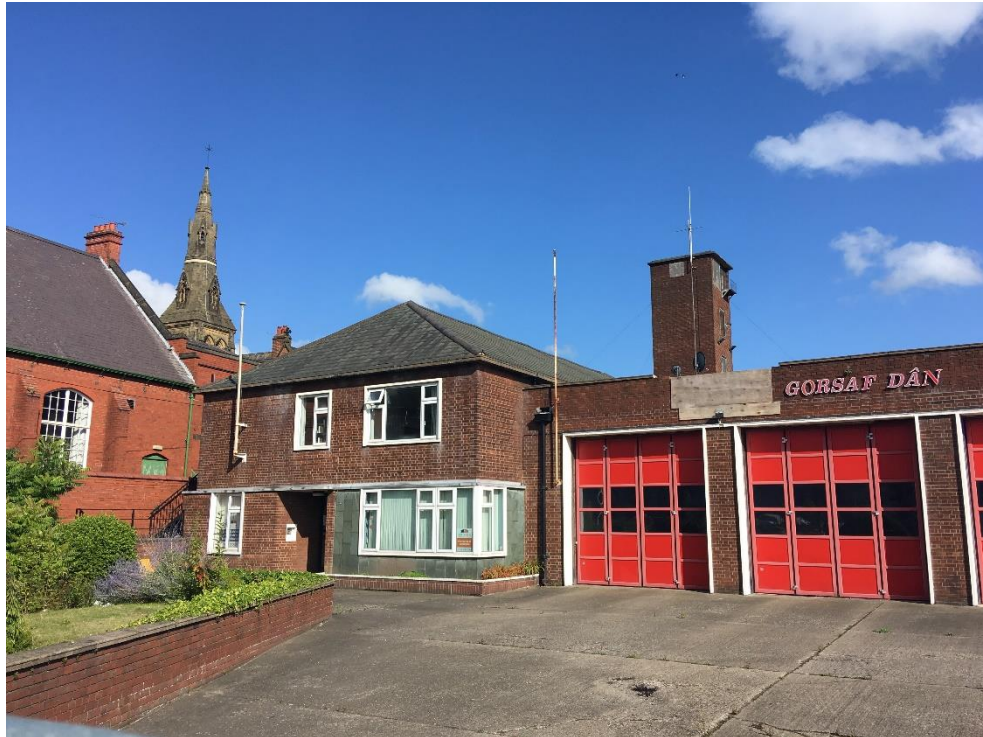
The roof and ridge tiles were also observed to be in good condition with no loose tiling or significant areas of missing mortar. Two slightly raised ridge tiles were identified on the roof, however such features are considered to offer only limited value potential bat roosting habitat (locations shown on Figure 2).

Building 2 was assessed as offering **negligible-low** bat roosting potential.

*Photograph 3- West face of Building 2*

Nevertheless, it is recommended that a precautionary approach is adopted during demolition works. It is recommended that prior to demolition, the ridge tiles of Building 2 are carefully removed by hand and the ridge is checked for bats prior to mechanical demolition.

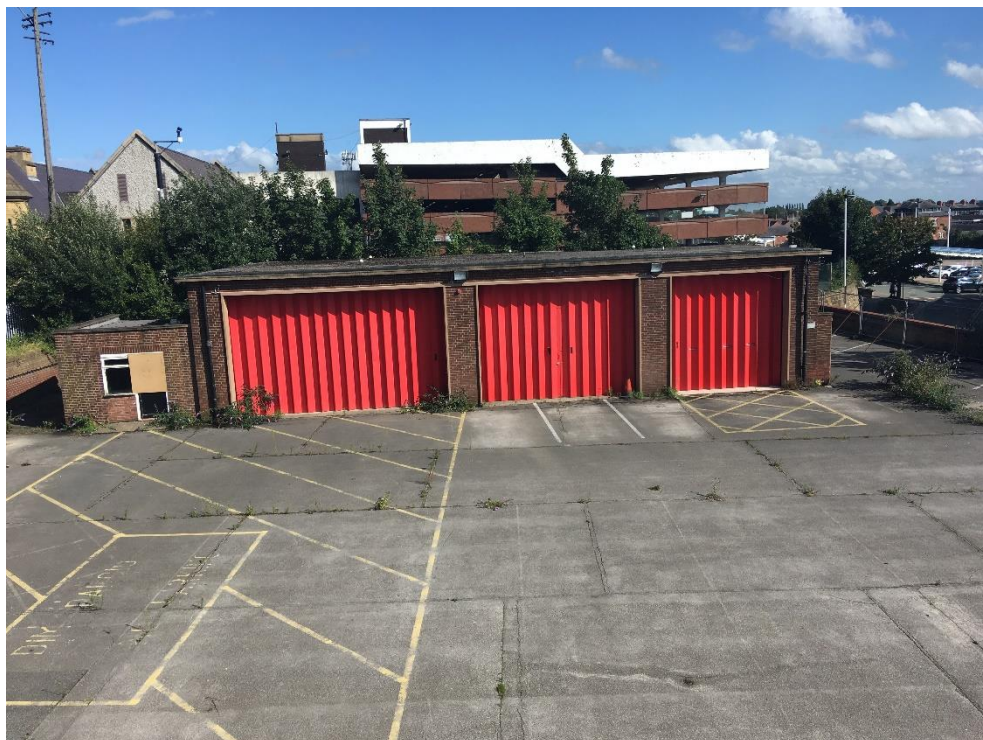
Building 3 was assessed as offering **negligible** bat roosting potential.

*Photograph 4- West face of Building 3*

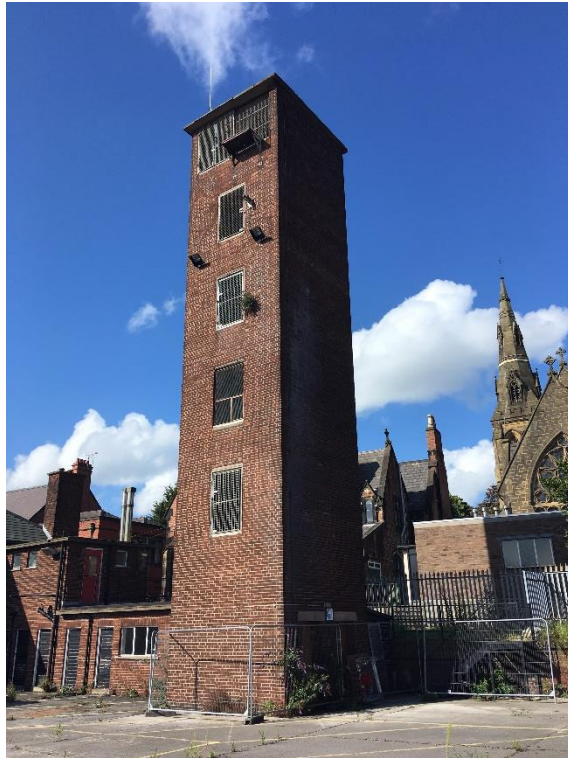
Building 5 was assessed as offering **negligible** bat roosting potential.

*Photograph 5- Building 5*

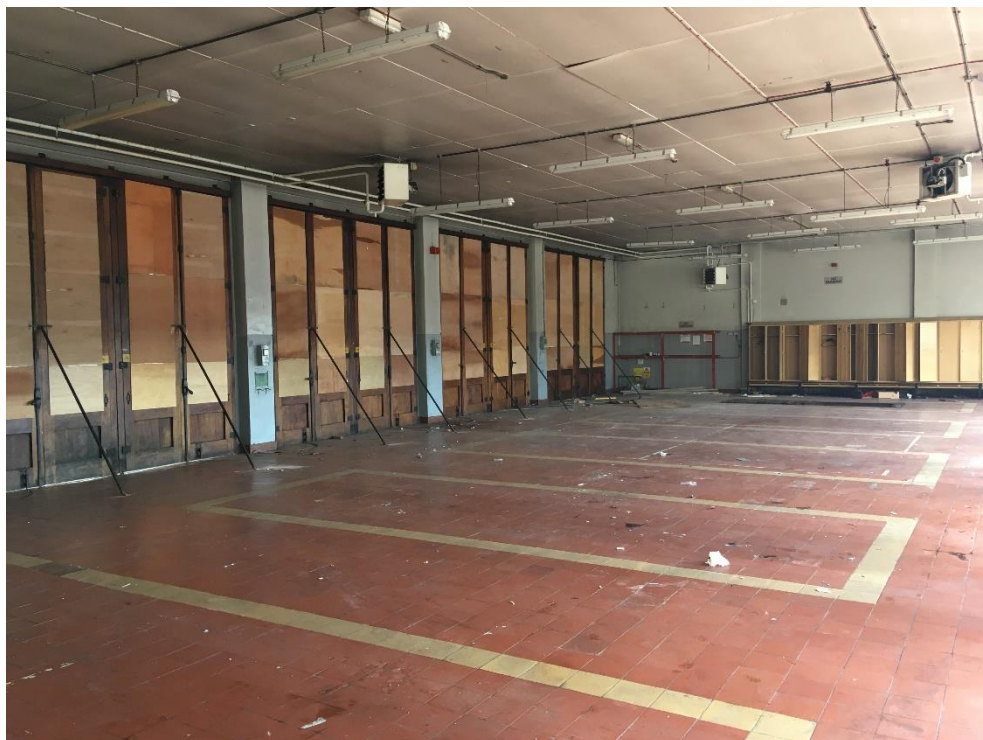
Internally the building does not have a loft void. The internal rooms are considered unsuitable for bats as they are both brightly lit and have well plastered walls and ceilings. The building does not offer any obvious potential bat roosting features internally.

*Photograph 6- Ground floor of Building 1*

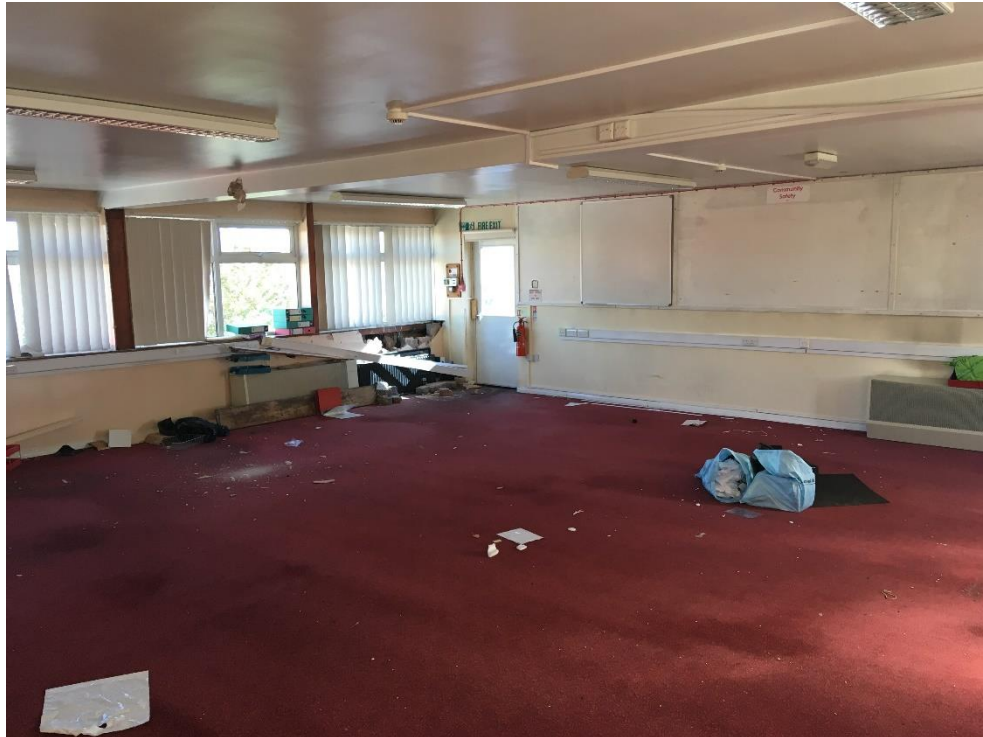
*Photograph 7- First floor of Building 1*

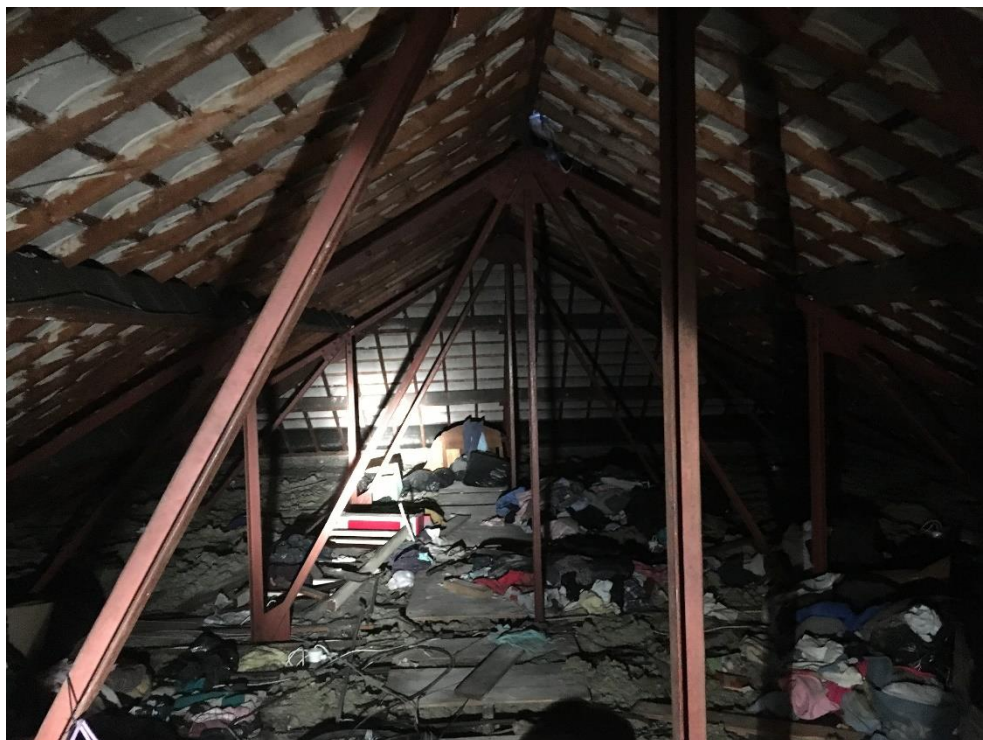
The roof is supported on a steel frame and the internal faces of the roof tiles have been torched with lime mortar. The lime mortar was observed to be intact providing a barrier to bats between the roof void and the underside of the tiles. The loft space has been lined with fibrous loft insulation and was found to be dark and warm.

The ridge beam was found to be cobwebbed and further cobwebs were present spanning the roof void. The cobwebs indicate that no bats or birds have flown within the interior of the roof void in the recent past.

*Photograph 8- Loft space of Building 2*
