## Arboricultural Assessment

(Incorporating Arboricultural Impact Assessment and  
 Tree Protection measures in accordance with BS5837:2012)

Project: Summerhill Farm

Date: August 2016

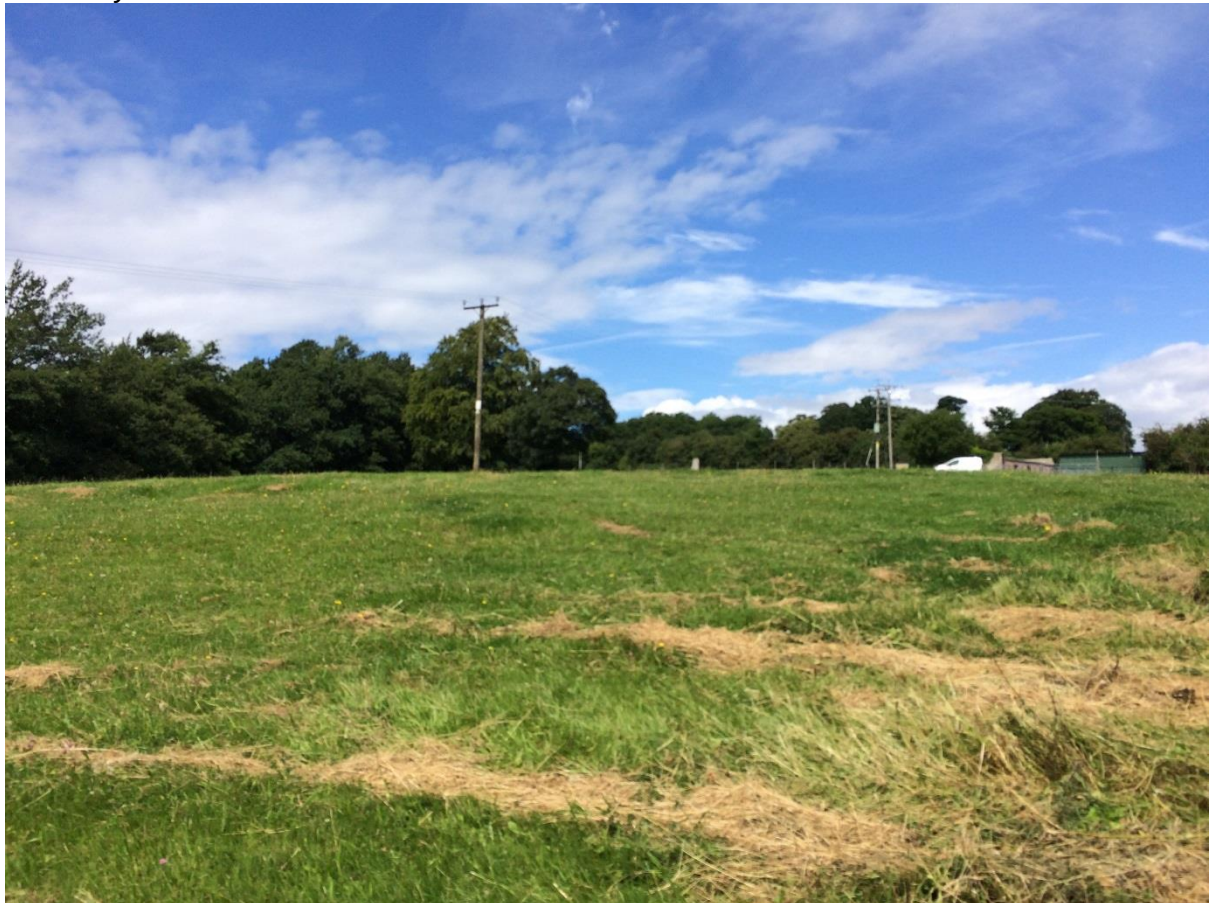
**Image 3.1** Generic view of the main body of the site looking towards the western boundary.

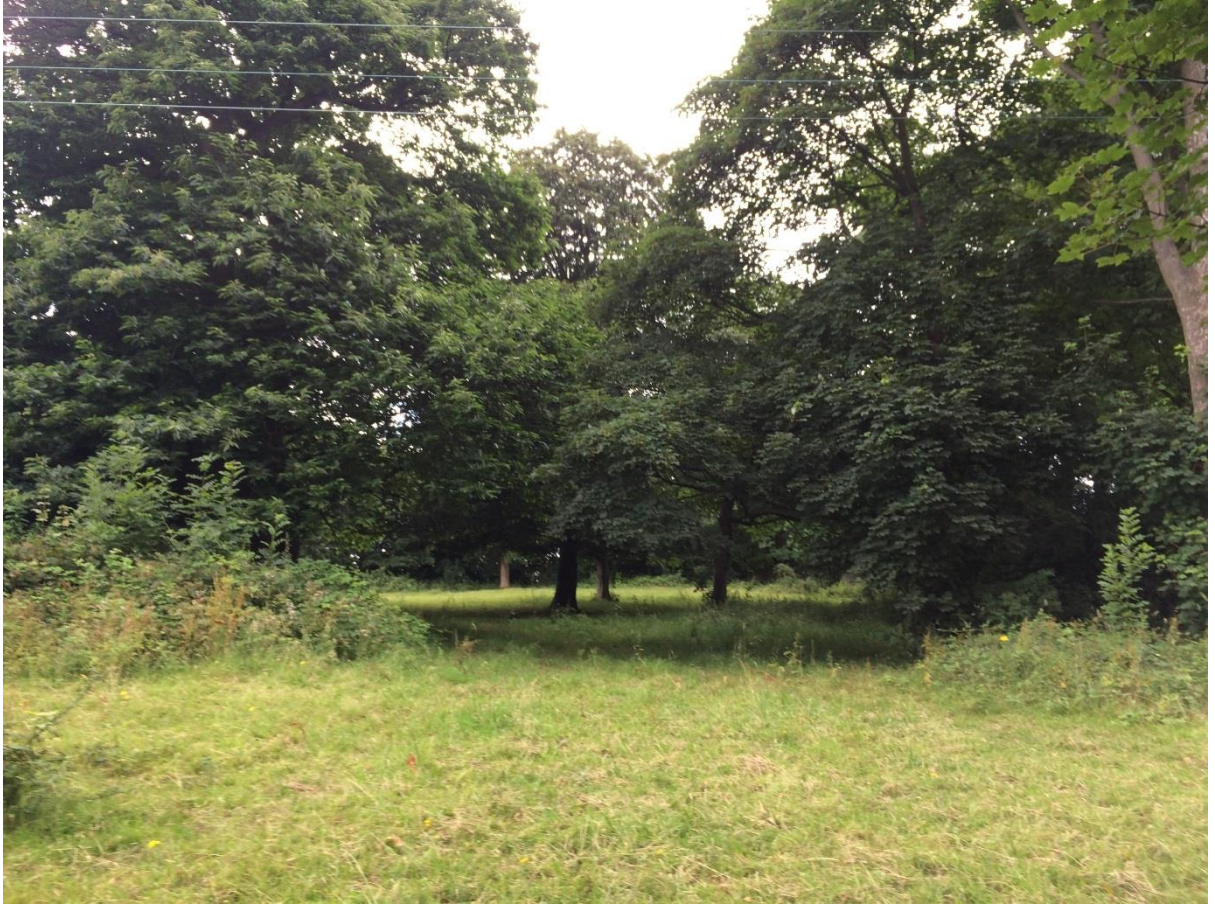
**Image 3.2** Wooded compartment to the north to be retained in situ.

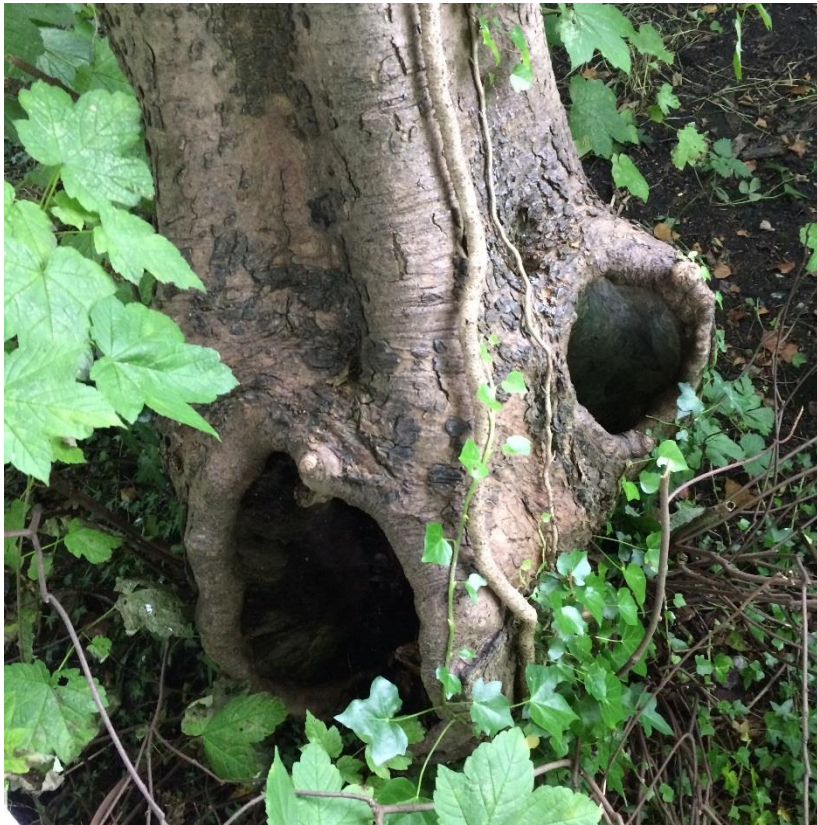
**Image 3.3** Basal cavity of mature sycamore (T26) situated close to the northern boundary of the site.

| <b>Client:</b> | Nigel Thorns Associates | | | | | | | | <b>Site:</b> | Summerhill Farm | | | | | | | |
|---|---|---|---|---|---|---|---|---|---|---|---|---|---|---|---|---|--|
| T28 | Sycamore | 13 | 410 | 6 | 0 | 6 | 6 | 2/N | 2 | Mature | Poor | Basal cavity extends into vertical decay coulomb beyond 500mm. | Fell to mitigate risk to adjacent property. | <10 | U | 1 | |

| Urgency | Tree number | Proposed works |
|---|---|---|
| Priority Grade 1<br>High Urgency | T28 - Sycamore | Fell to mitigate risk to adjacent property due to the presence of a significant basal cavity compromising structural integrity. |
