# **PLANNING APPLICATION FOR A PHOTOVOLTAIC SOLAR FARM AND ASSOCIATED INFRASTRUCTURE**

**LAND TO THE WEST OF ERLAS LANE, ERLAS HALL  
FARM, WREXHAM**

## **ARBORICULTURAL SURVEY, IMPACT ASSESSMENT AND PROTECTION PLAN**

**ON BEHALF OF LIGHTSOURCE RENEWABLE ENERGY LIMITED**

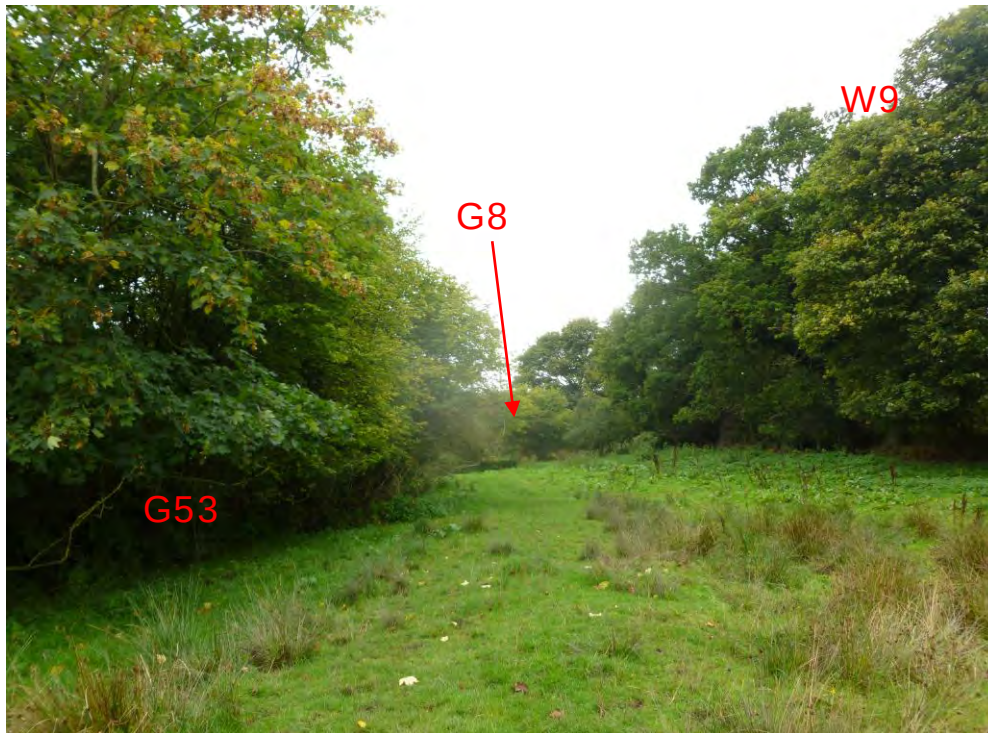
*Photoview 1:* View looking west towards the G8, W9 (Cat B) and G53 (Cat C) located to the south-west of the site.

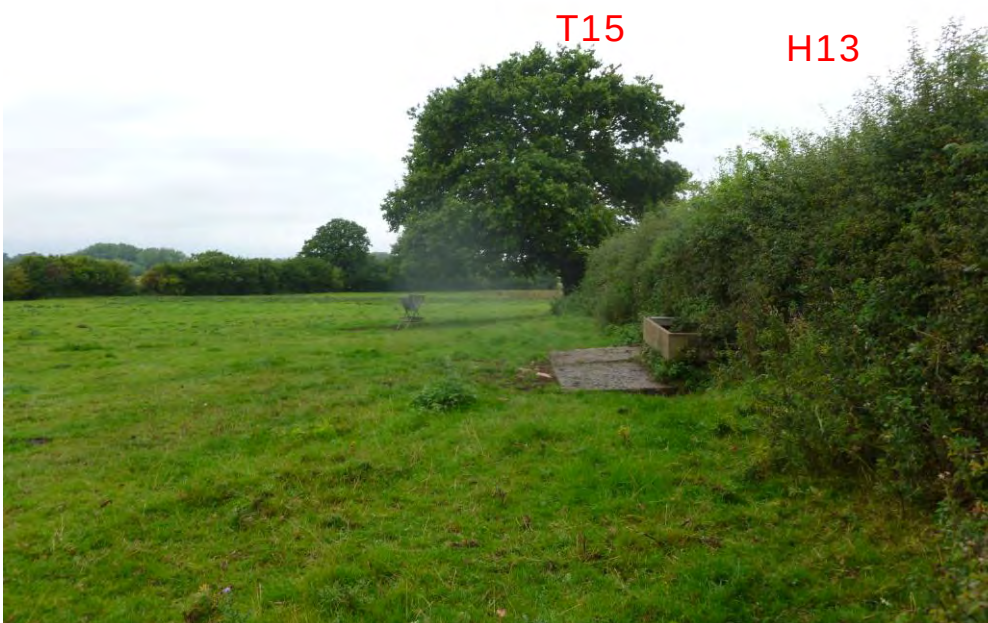
*Photoview 2:* View looking west along H13 (Cat B) towards T15 (Cat B).

| Date: 14.08.15 | | Site: Erlas Hall Farm | | | | | | | | | | | | Surveyor: MGP | | | Client: Lightsource Renewable Energy Limited | | | | | Job no: L.0360 | | | | | |
|---|---|---|---|---|---|---|---|---|---|---|---|---|---|---|---|---|---|---|---|---|---|---|---|---|---|---|--|
| T15 | Oak | 10.5 | - | 650 | # | 6 | - | 8 | - | 8 | - | 7 | - | N/A | - | N/A | 2 | - | M | Moderate deadwood, evidence of past failures, crack and hollowing stem obscured by vegetation on north west side. Reasonably dense canopy. | Fair | Fair | 20+ | B1 | 7.8 | 191 | |

- 11.8 It is also recommended that where the internal access road encroaches into the outer RPAs of T15, G23, T39, T40 and T42, construction should utilise a suitable above ground load bearing cellular confinement system as set out within an Arboricultural method Statement.

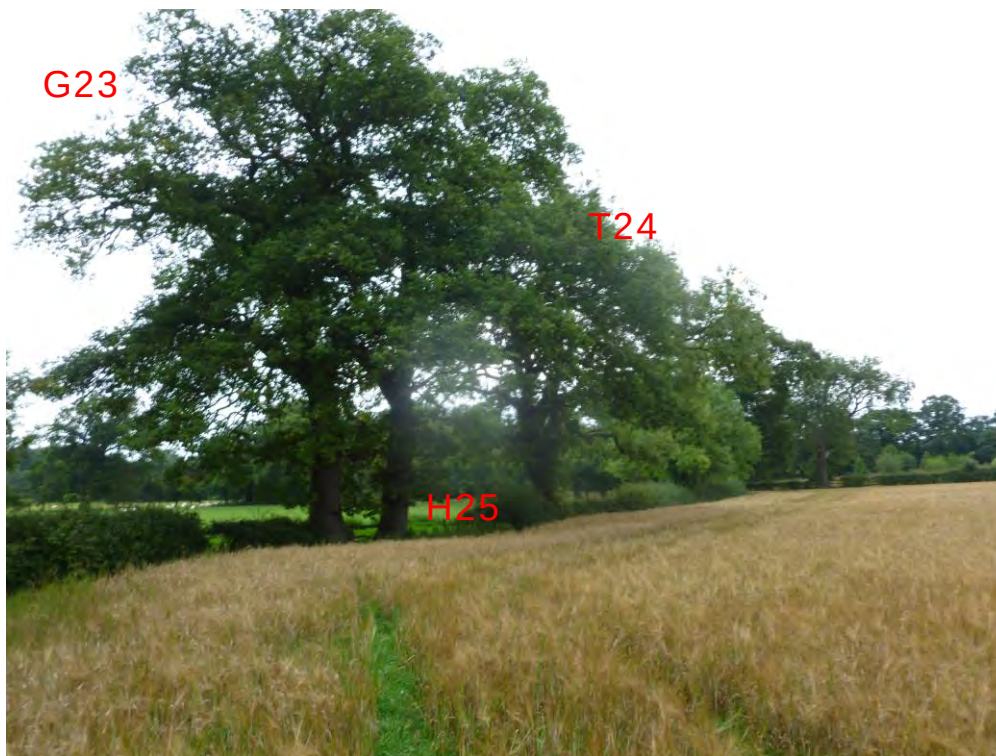
*Photoview 3:* View looking southeast towards H25 (Cat C), G23 (Cat B) and T24 (Cat C). The proposed maintenance access is to run through H25 to the north of G23 (left of frame).

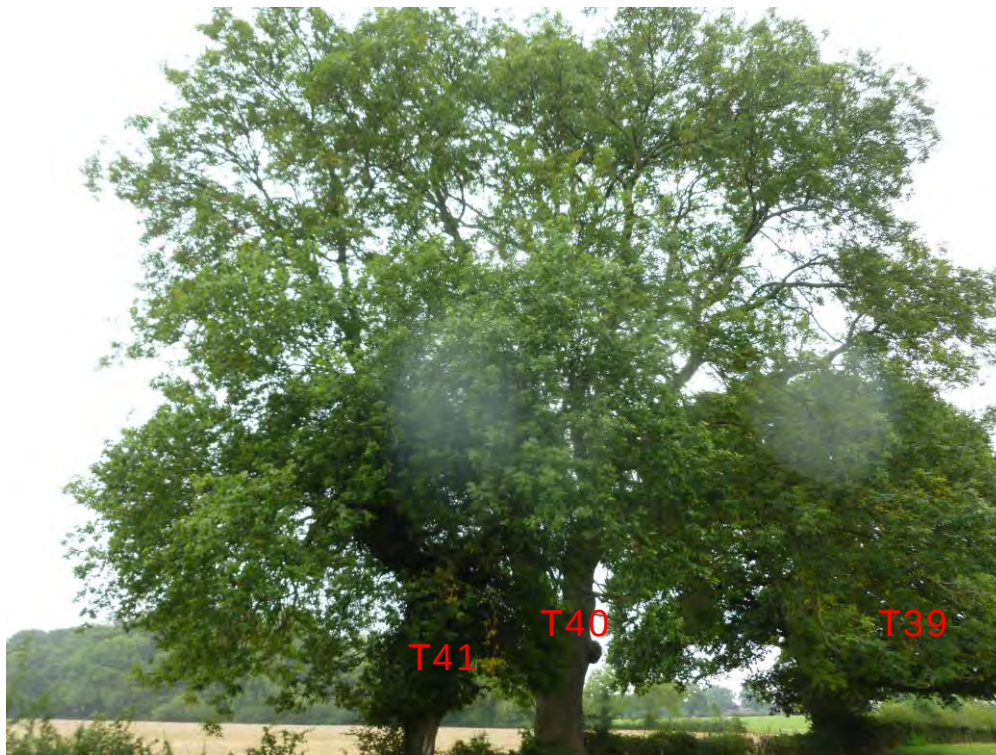
*Photoview 4:* View looking north towards T39 (Cat A), T40 (Cat B), and T41 (Cat C).

| No | Species | Quality | Arboricultural effects (direct and indirect) of proposed design - description | Unadjusted scale of effect | Unadjusted significance of effect (scale effects x quality) | Recommended mitigation | Adjusted scale of effect following mitigation | Adjusted significance of effect (adj .scale effects x quality) | Tree removal required |
|---|---|---|---|---|---|---|---|---|---|
| T39 | Oak | A1 | Potential direct impacts from construction. Potential root damage from internal access road construction. Minor pruning required to outer canopy to ensure clearance of internal access road. | Medium | Major | Site security fencing to act as tree protection fencing to BS5837:2012 to be installed prior to main construction. Access road within the RPA to be installed using a no dig methodology, employing an appropriate above ground cellular confinement system. Pruning works to be carried out in accordance with BS3998:2010 | Low | Moderate | No |
| T40 | Ash (Common) | B1 | Potential direct impacts from construction. Potential root damage from internal access road construction. Minor pruning required to outer canopy to ensure clearance of internal access road. | Medium | Moderate | Site security fencing to act as tree protection fencing to BS5837:2012 to be installed prior to main construction. Access road within the RPA to be installed using a no dig methodology, employing an appropriate above ground cellular confinement system. Pruning works to be carried out in accordance with BS3998:2010 | Low | Minor | No |

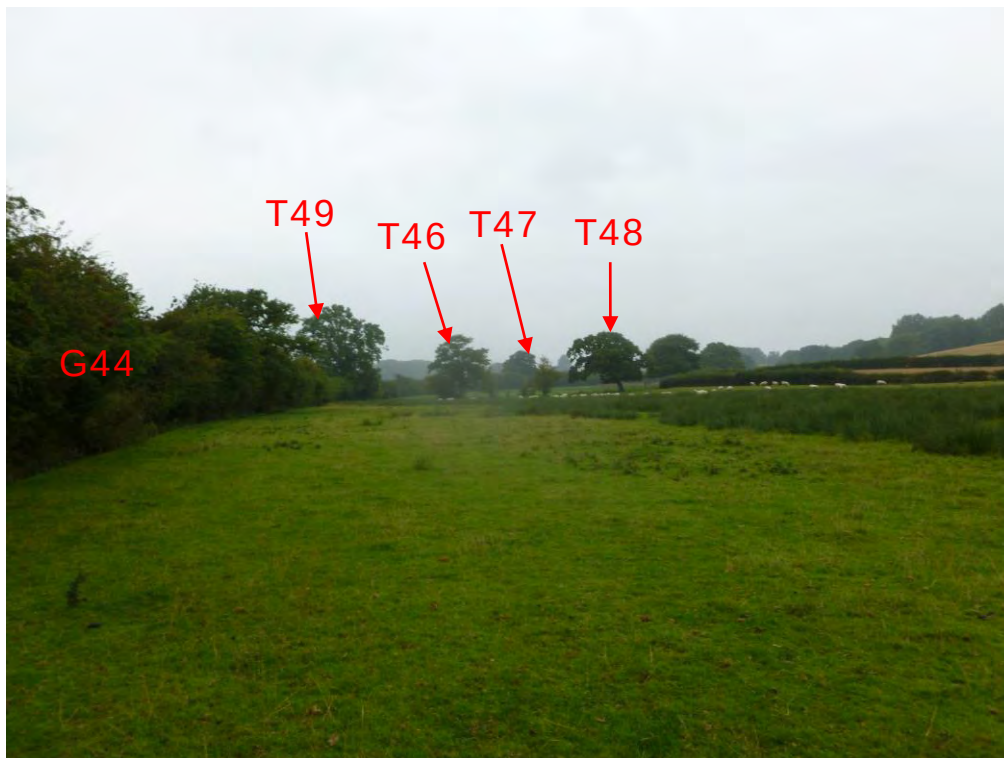
*Photoview 5:* View looking west towards G44 (Cat C), T46 (Cat B), T47 (Cat C), T48 (Cat B), and T49 (Cat B).

| Ref | Species | Height | Est | Stem dia | Est | Spread | | | | | | | | Crown clearance height | | | | Life stage | General observations<br>Physiological and structural condition.<br>Preliminary management recommendations | Structural Condition | Physiological Condition | ULE | Quality grading | RPA radius | RPA area | |
|---|---|---|---|---|---|---|---|---|---|---|---|---|---|---|---|---|---|---|---|---|---|---|---|---|---|---|
| T49 | Ash (Common) | 19 | - | 900 | # | 9 | - | 8 | - | 9 | - | 9 | - | N/A | - | N/A | 1.5 | - | M | Dense ivy on stem and into crown, unable to inspect base, spreading canopy, some thinning and deadwood, evidence of past failures | Fair | Fair | 20+ | B1 | 10.8 | 366 |

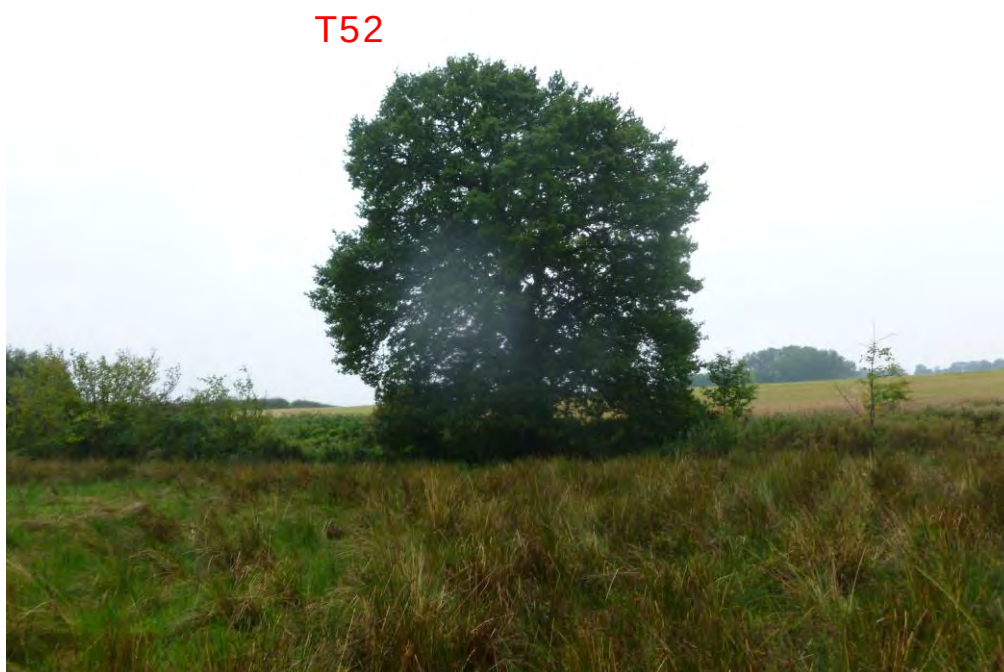
*Photoview 6:* View looking south with T52 (Cat B) within the centre of the frame.
