**Mr Dave Lewis**

Laburnum Cottage, Horseman's Green, Wrexham

**Bat Survey Report**

June 2015

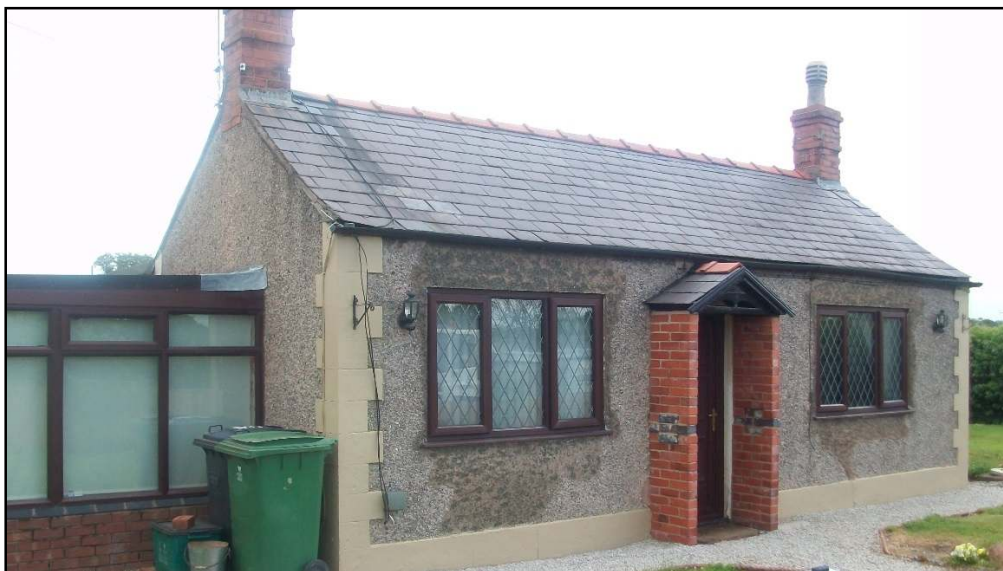
**Plate 1** – Shows the southern elevation of B1a.

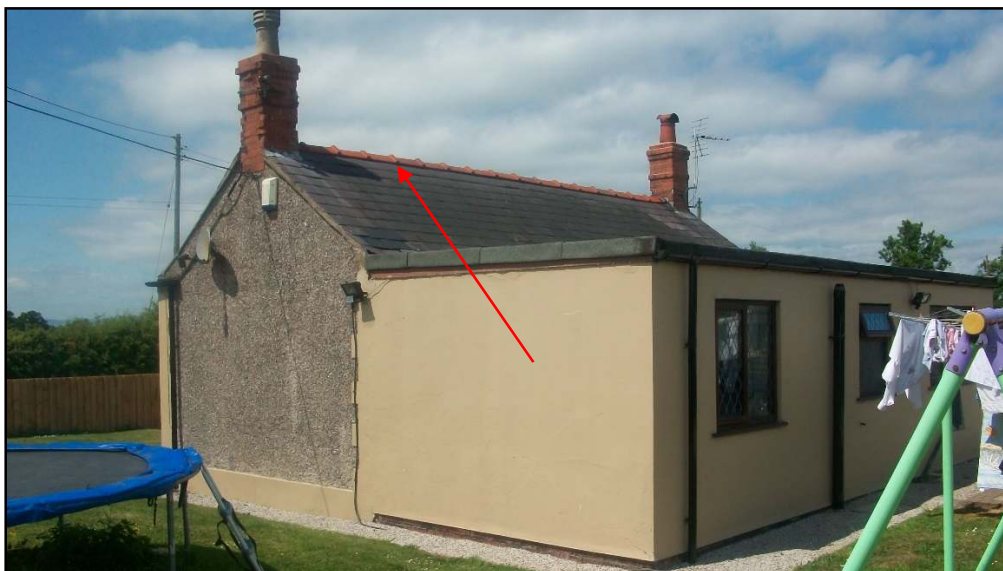
3.5 The only potential access points comprised gaps under the ridge tiles and one raised tile by the guttering. No further potentially usable roosting habitat was found in association with this building.

**Plate 2** – Showing the northern and eastern aspects of B1a and B1b and potential access points

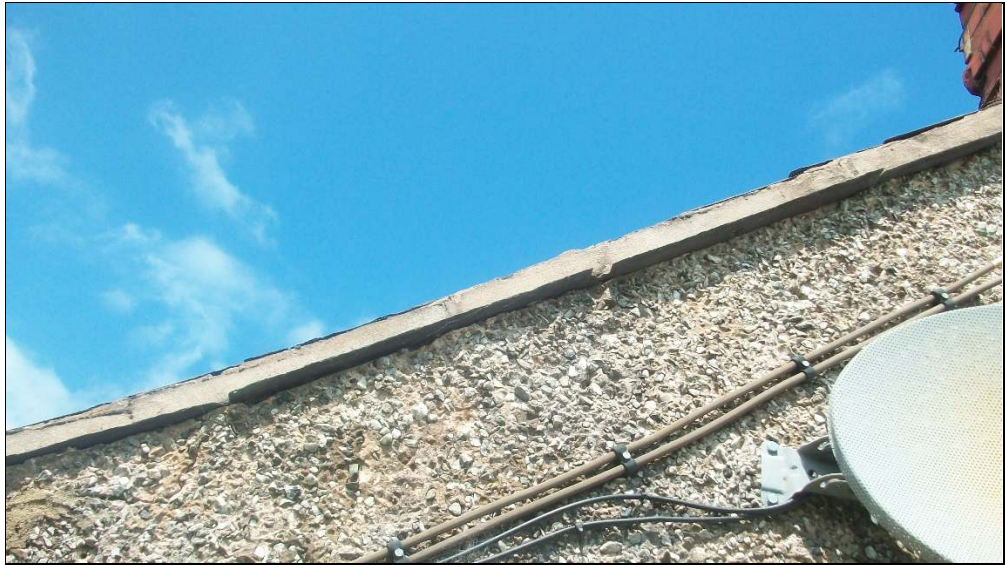
**Plate 3** – Showing the well-sealed eaves and no potential access points

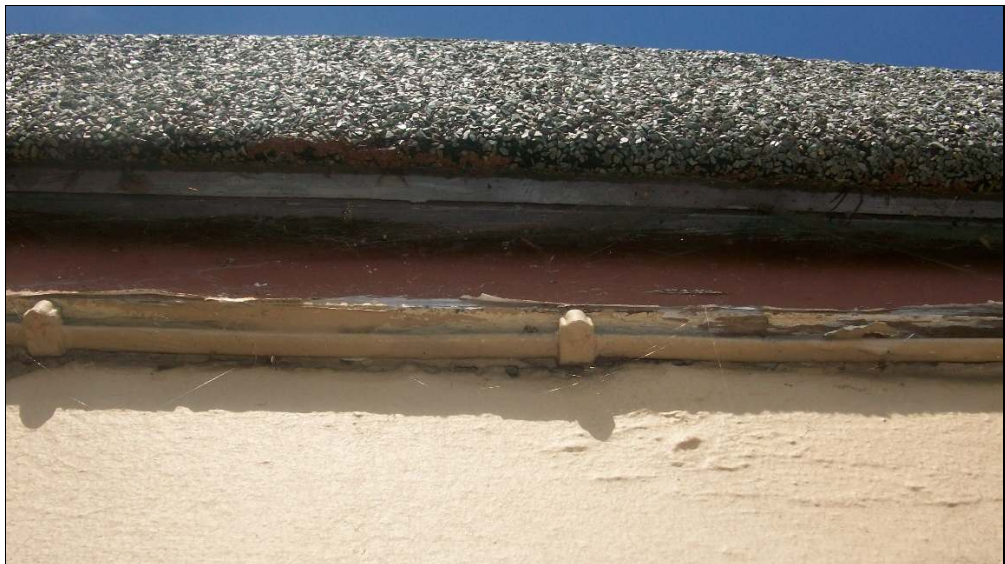
3.7 Building B1b comprised a single storey flat roofed extension with felt roof. Facia boards were present but the occasional gaps that were present were covered in cobwebs and did not allow bat access.

**Plate 4** – Showing the fascia boards of B1b. No gaps present.

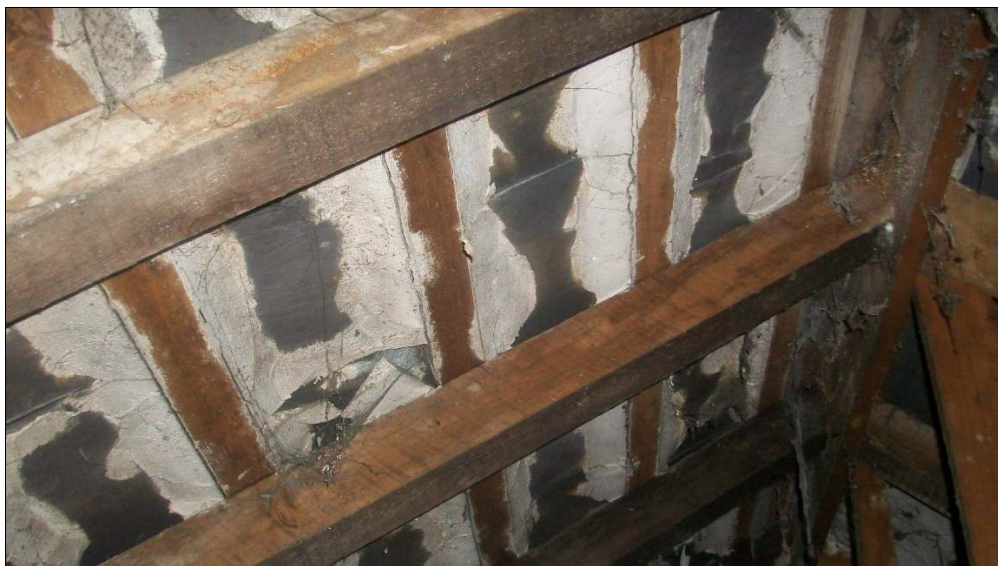
**Plate 5** – Showing the interior of the roof void, note the mortar present on the back of the tiles, eliminating any potential bat access.

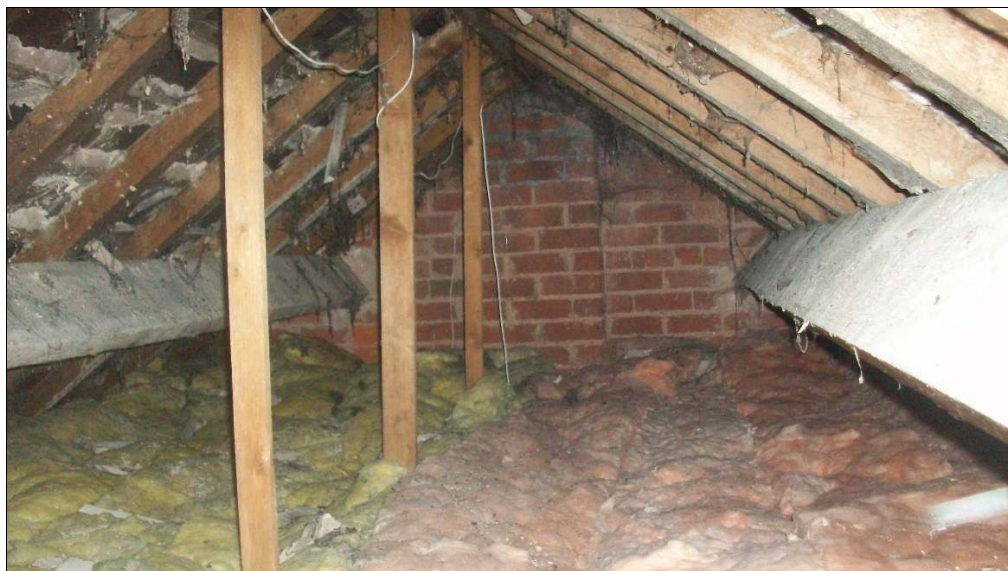
**Plate 6** – The roof void within B1a, note the extensive amount of cobwebs

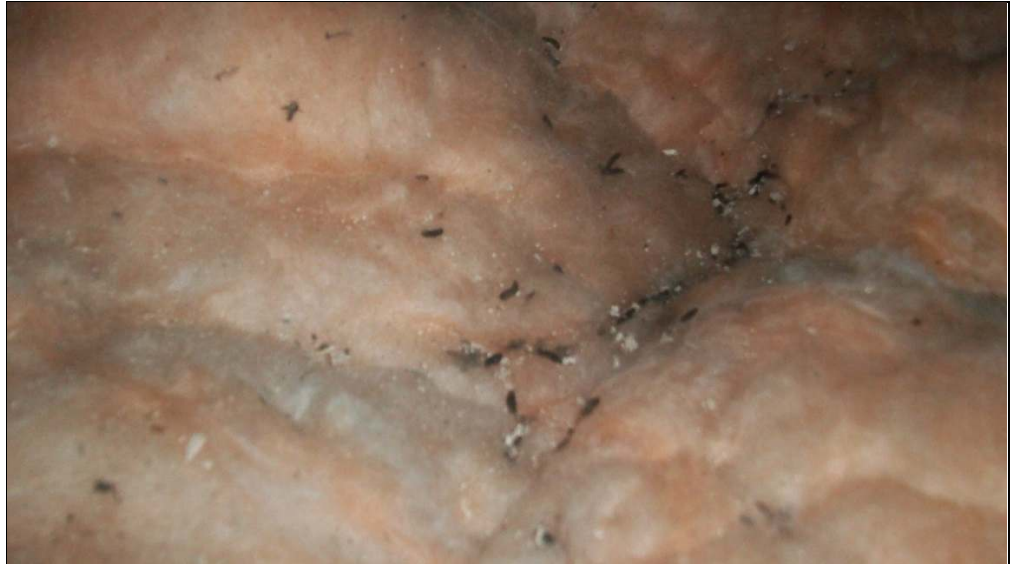
3.6 An accumulation of 19 small bat droppings were seen within the loft space below the ridge of the roof (plate 7). These appeared old but determining the age of bat droppings is difficult. As such an Emergence Survey was conducted to ascertain if bats are using the property.

- 4.2 However, an accumulation of 19 small bat droppings were seen within the loft space of the cottage. Roosting potential in association with the surveyed building were primarily limited to gaps beneath ridge tiles, which corresponds to the location of the droppings within the loft. During the nocturnal survey no bats were observed emerging from buildings and bat activity in the vicinity of the site was found to be very low. The bat droppings were considered to not be recent when assessed during the Visual Assessment, this is supported by the fact no bats were seen emerging from the property and the very low numbers of bats recorded during the survey. It is also considered that these pipistrelle bats, recorded commuting through the site, some 40, 44 and 74 minutes after sunset, emerged from roosts earlier in the evening some distance from the site, as pipistrelle bats are known to generally emerge earlier in the evening (sunset to 30min after sunset). It is considered that bats are no longer use this building as a regular roost.

**Plate 7** – Accumulation of bat droppings found within the roof void of B1a

- 4.5 As some roosting opportunities exist and a historic roost has been identified within the property, provision within the new building works should be incorporated to maintain these features. The inclusion of the below features will maintain, if not enhance the opportunities for the small local population of bats.

- 4.8 Enhancement measures
- Installation of one Ibstock bat ecohome into the western gable end of the property.
  - Installation of one roosting feature under the ridge tiles
