**LAND OFF PONT ADAM CRESCENT  
RUABON, WREXHAM**

**PRELIMINARY BAT SURVEY REPORT**

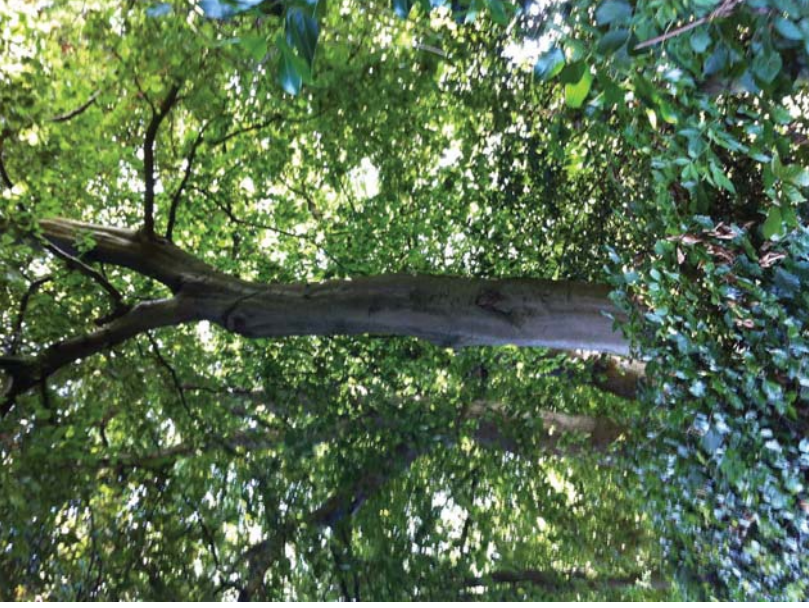
| T6 | <i>Fagus sylvatica</i> | A young beech tree without any ivy cover. The lower branches have been removed and cut off flush with trunk. | 3 | |

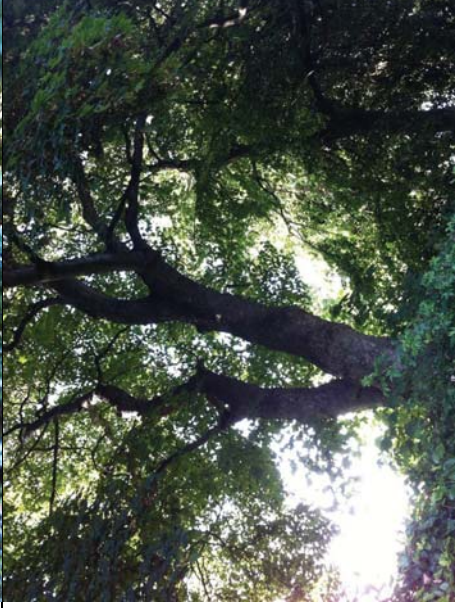
| T7 | <i>Acer pseudoplatanus</i> | A mature sycamore tree, with two co-dominant trunks. Several lower branches have been removed and one upper branch is rotten, revealing a hole at the base. The hole appears to be blind. The tree has no ivy cover. Category 2 because other holes may be present, which cannot be seen from this vantage point. | 2 | |

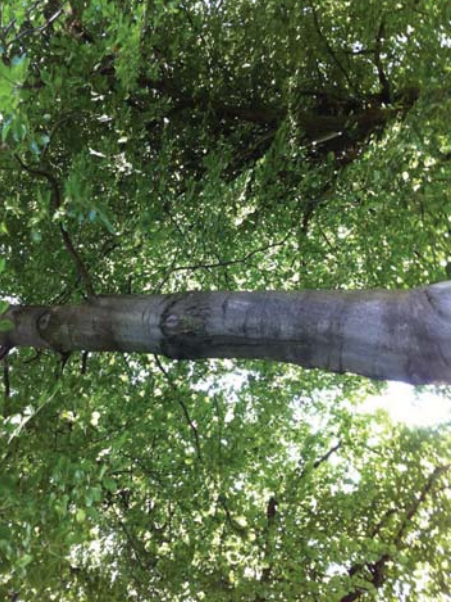
| T8 | <i>Fagus sylvatica</i> | Mature, standard beech tree, with the lower branches removed and cut off flush with the trunk. No obvious holes. | 3 | |

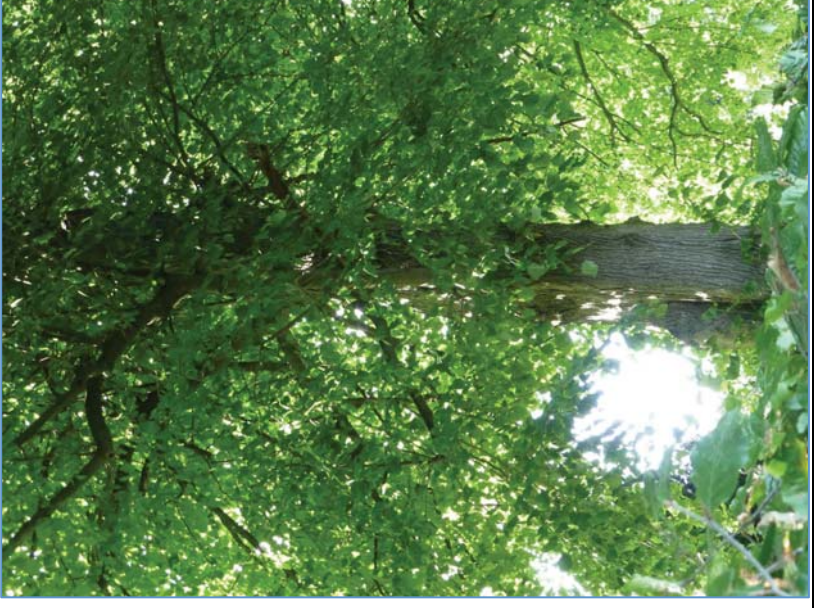
| T9 | <i>Tilia x europaea</i> | Mature lime tree, without any epicormic growth. Standard habit, without any broken branches or obvious holes. Located on adjacent property. | 3 | |

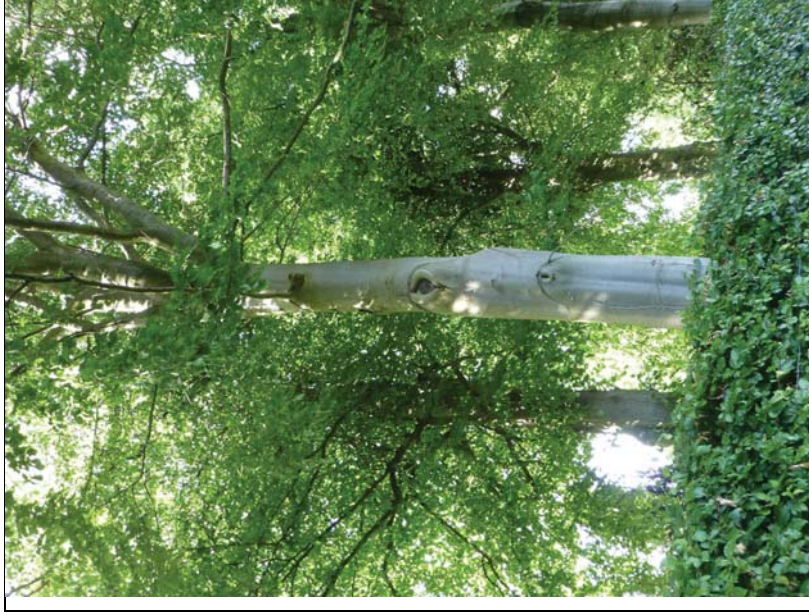
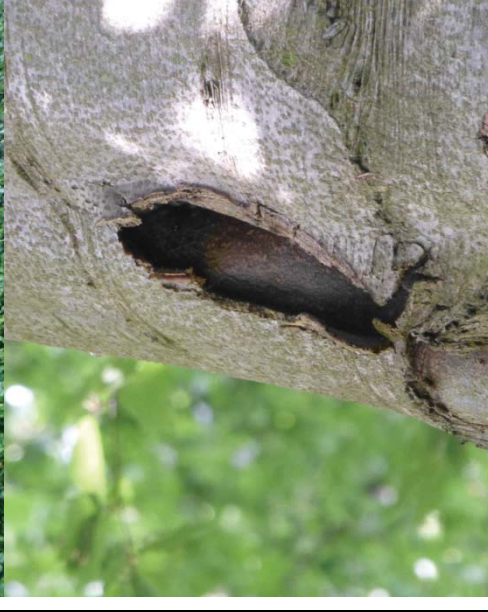
T10

- 4.1.3 The silver birch trees along the western boundary were too small to have much bat potential. However there were two beech trees (T10 and T16) that had reasonably large cavities and could be used by bats. These were assessed as being Category 2 trees. A mature sweet chestnut (T11) was located approximately five metres from the hedgerow. This has the gnarled bark that is so characteristic of sweet chestnut trees. No holes could be seen from the site, but the tree was classed as being Category 2 as a precaution. None of these trees will be felled as a result of the proposed development, but it could potentially have an impact upon any bats that were roosting in the tree cavities.

A mature beech tree growing in the middle of the beech hedge. Located on property boundary. A hole measuring approximately 8x12cm can be seen on the opposite side of the trunk, facing the other property. The tree has no ivy cover. Some lower branches have been removed and a major limb has been removed @ 3m above ground level. It was difficult to see how deep the hole was due to the orientation of the tree. The tree may have to be checked to determine whether bats are using the obvious hole.

2, possibly 1.

- 5.1.8 A number of beech trees (T10 and T16), along the western boundary have cavities with bat potential. They are unlikely to be affected by the proposed development and no bat activity was detected in this area. However, further surveys may be necessary if any of these trees will be affected by the proposed development.

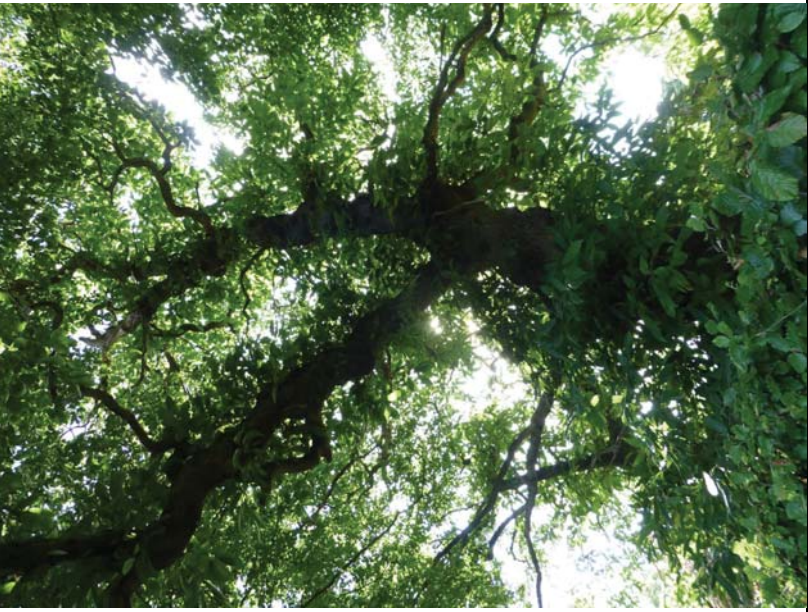
| T11 | <i>Castanea sativa</i> | <p>Sweet chestnut with gnarled bark. No ivy cover, but some epicormic growth, which partly obscures the trunk. Some of the branches are rotting at the tips, with peeling bark. One upper branch appears to be missing. Precautionary category 2, but the tree is located on the adjacent property and will not be affected by the proposed development. No holes were apparent from the site.</p> | 2 | |

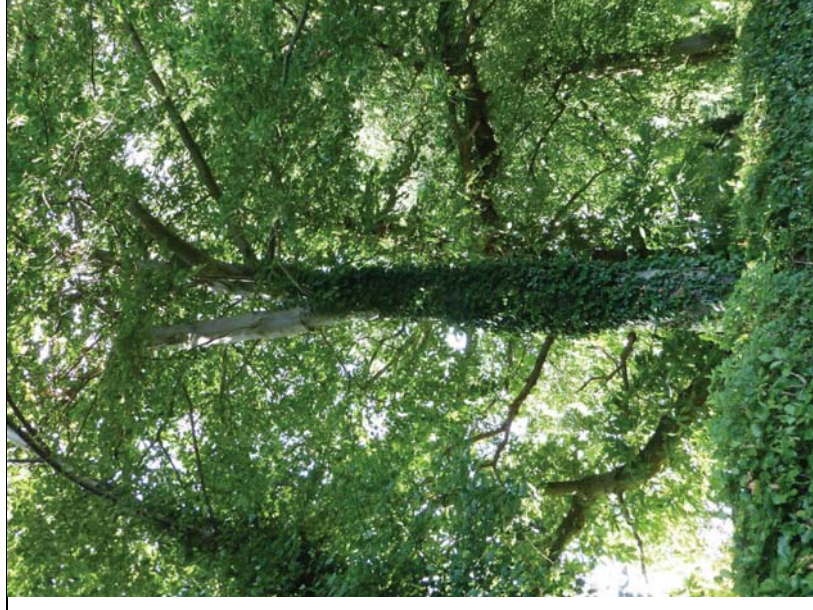
T12

Young beech tree with ivy covering the lower part of the trunk. No obvious broken branches or holes. Probably unsuitable for bats, due to small size.

2/3

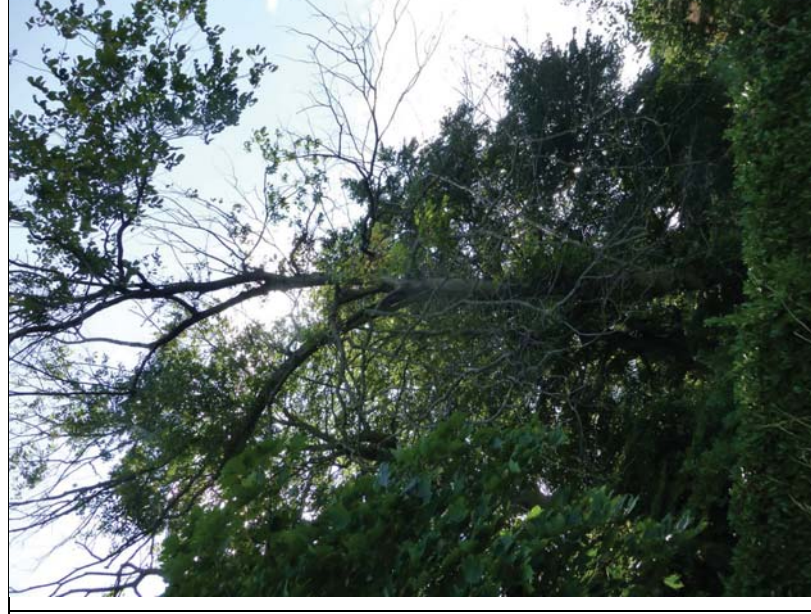
T14

Dying elm tree. No obvious holes or broken branches, but most of the foliage has been lost and only a few of the smaller branches appear to be alive. No peeling bark.

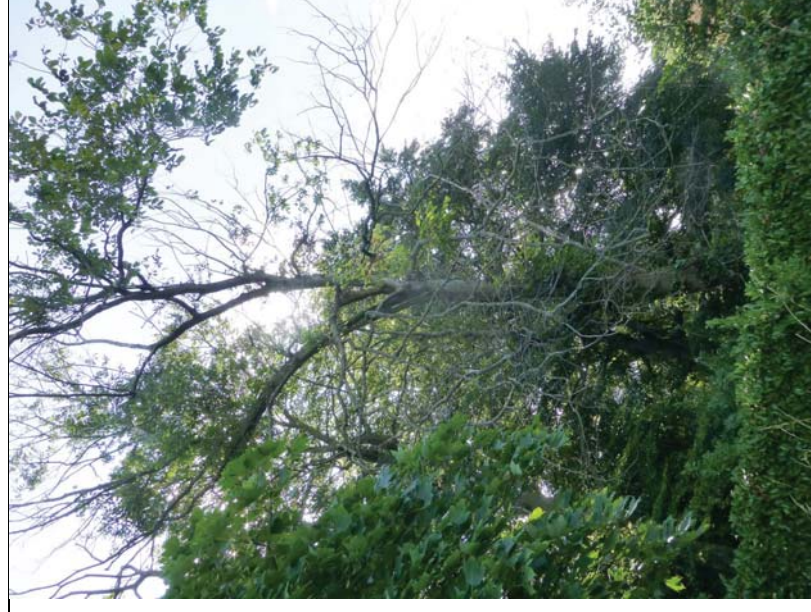
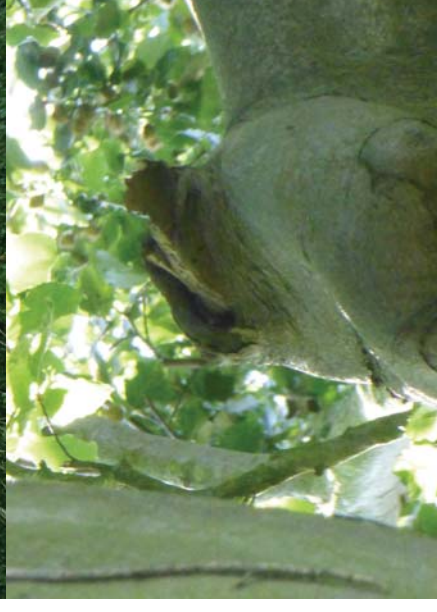
T16

Multi stemmed beech tree with missing branches and at least one hole. Difficult to inspect because it is located on the adjacent property. A small hole can be seen at a height of approximately 4m. The hole was obscured by a branch and could not be fully assessed.

2

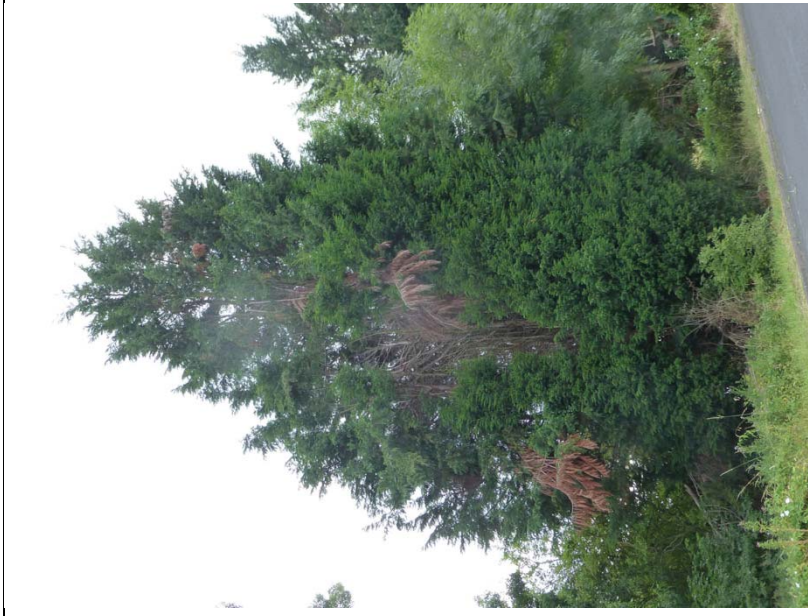
T23

Unattractive Leyland cypress with  
evidence of storm damage in upper  
canopy.

- 5.1.7 There are a large number of young trees along the northern boundary to the site. The mature Leyland cypresses (T23 and T24) have limited bat potential and can be safely felled. The young pedunculate oak trees (T27, T28, T30 and T31) on the other hand have wildlife value and should be retained.

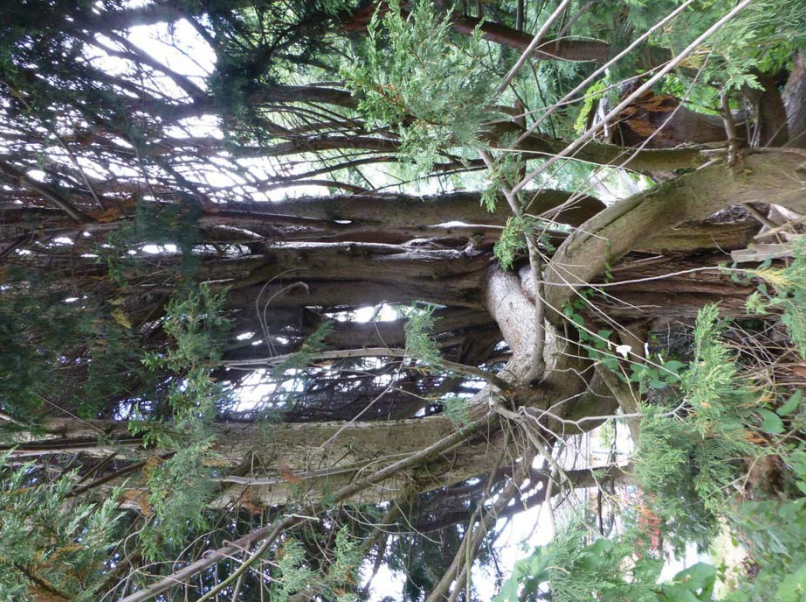
| T24 | X <i>Cuprocyparis leylandii</i> | <p>Multi-stemmed Leyland cypress. One of the lower branches has been broken off by recent storms, leaving a major gap in the treeline. No obvious holes, although bats could potentially find shelter in the gaps between conjoined stems.</p> | 3 | |

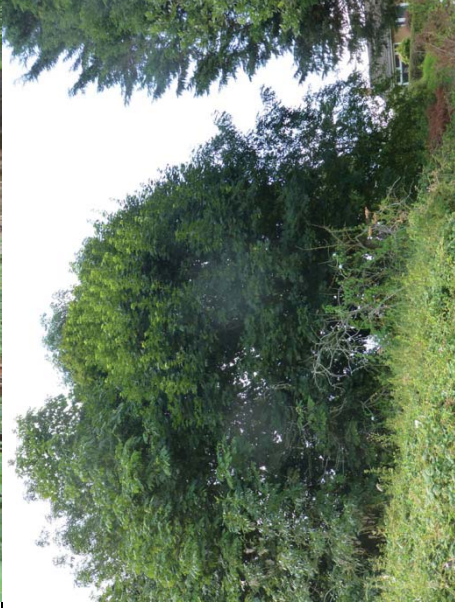
| T25 | <i>Acer palmatum</i> | <p>Norway maple with rotting trunk and missing lower branch. Probably the result of a garden fire being set too close to the tree. An upper branch is also missing and there is a hole at approximately 4m above ground level. Precautionary Category 1. Check with a ladder.</p> | 1 | |

- 5.1.5 The dead, multi-stemmed ash tree (T34) appears to have low bat potential bat potential and can be safely removed.
- 5.1.6 Tree 25, a badly damaged Norway maple, is located near the Pont Adam Crescent. The base of the trunk shows evidence of having been damaged by a fire and the upper part of the trunk is rotting. The tree was provisionally rated as category 1, due to the large cavity and its potential for use by bats. However the cavity is pointing upwards and probably fills with water in the winter. The cavity should be inspected by a SQE with an endoscope before the tree is felled.

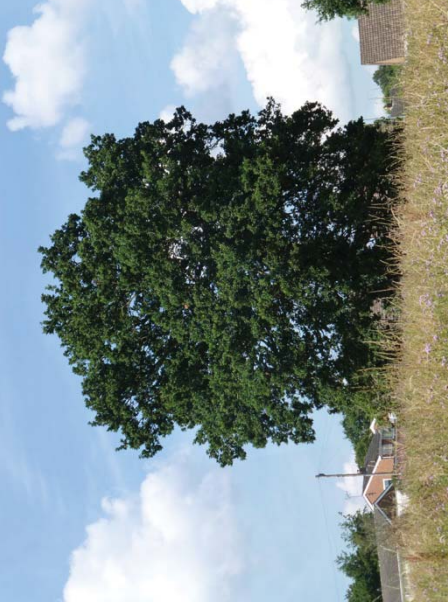
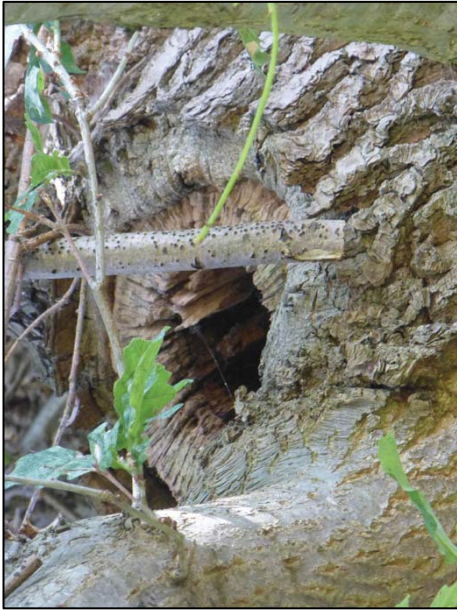
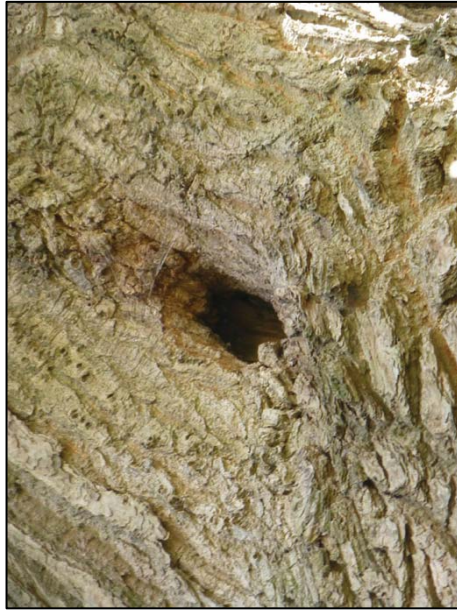
- 3.1.1 The Preliminary Ecological Appraisal (Enzygo, 2014) suggested that the large sessile oak (T32 in Tree Solutions report) had high potential for a bat roost. Enzygo Ltd. rated this tree as being Category 1\*, according to the Bat Conservation Trust's *Best Practice Guidelines* (Hundt, 2012). A Category 1\* tree is described as having "multiple, highly suitable features capable of supporting larger roosts". The current tree condition survey (see Appendix C) has confirmed that the oak tree has several features that could be used by bats and is a Category 1\* tree.

- 3.2.3 The large sessile oak (T32) was monitored for two hours, by two experienced ecologists. The isolated location of the tree meant that it was possible to see it silhouetted against the sky, which greatly increased the chances of seeing bats if they were present. A soprano pipistrelle *Pipistrellus pygmaeus* was heard calling on two occasions and a common pipistrelle *P. pipistrellus* on a single occasion. All of these calls were very brief and the bats were not seen. A noctule *Nyctalus noctula* was heard briefly on two occasions to the west of the site. These were probably commuting across the site. On no occasion were bats seen leaving or returning the tree.

| T32 | Quercus petraea | Large, mature, sessile oak tree. The tree is generally in good condition, although it has a few missing or rotten branches. There are five significant holes and several other cavities that could have bat potential. It has high bat potential. | 1* | |

- 5.1.2 Enzygo Ltd. classified the old sessile oak tree (T32) as a Category 1\* tree, with potential to support a larger bat roost. We agree with this assessment, but there was no evidence that bats were using the tree when the dawn activity survey was carried out. The tree has considerable amenity value and should be retained. A large, rotten branch is currently suspended above another branch. This should be removed for health and safety reasons and lowered to the ground for inspection by a suitably qualified ecologist (SQE) before it is discarded.

- 5.1.3 Bright lights are known to deter bats from roosting in trees, even if they have high potential as roosts. Street lighting and domestic security lights may also disturb bats that are already roosting. Street lighting should therefore be directed away from the tree and, to prevent any damage to the roots, no excavation should take place within at least 10m of the trunk.

- 5.1.4 While there was no evidence that bats were roosting in the oak tree during the dusk survey, we cannot discount that they may use it in the future. The tree has high potential for bats and we were surprised that they were absent. The tree survey indicated that T32 had a crown that extended for approximately 7m from the centre of the trunk (Tree Solution Ltd., 2014). The Bat Conservation Trust recommend that trees with high bat potential should be surrounded by a buffer zone of 1.5 times the diameter of the tree canopy (Gunnell *et al*, 2012).

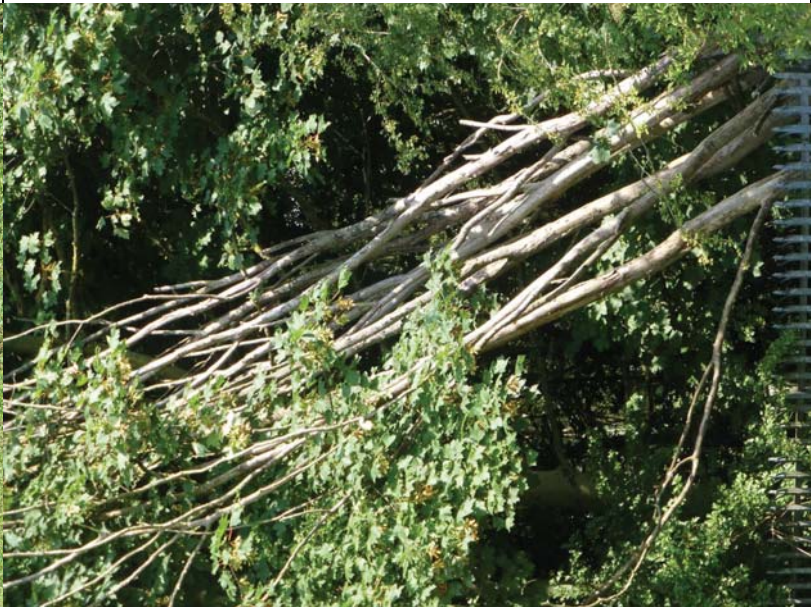
| T34 | <i>Fraxinus excelsior</i> | Dead tree, next to T21. Timber has split and the bark is peeling off the trunk. It could have bat potential, but there are better trees available nearby. No holes. New tree and not marked on tree survey map. | 2 | |
