# Old Oak Tree Care

## Land to south of Lane End, Penley, Wrexham

**P/2014/0392**

19<sup>th</sup> November 2014

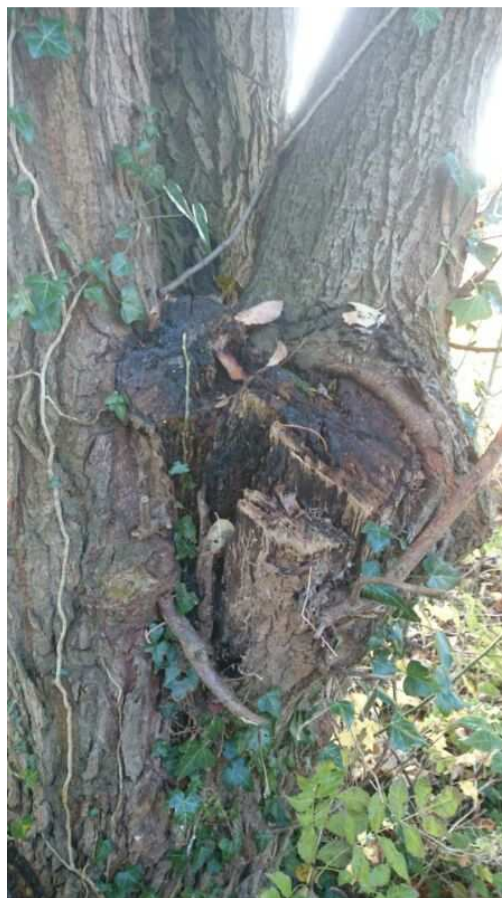
- 2) 521 is a large Goat willow tree and can be seen from a number of properties in the vicinity. Goat willows are short lived trees that have a propensity for failure when reaching maturity. This tree appeared to be in good health and had grown to a considerable size without failing. I was concerned about what appeared to be a large stem that had been removed from the tree on the northern side. I was apprehensive of decay spreading from this relatively new wound and also as there was a distinct lack of reaction wood around the entire wound.

Picture 1 Wound at base of 521

I therefore originally gave the tree a C category as I could not see it lasting any more than 20 years and with the wound reducing its structural integrity.

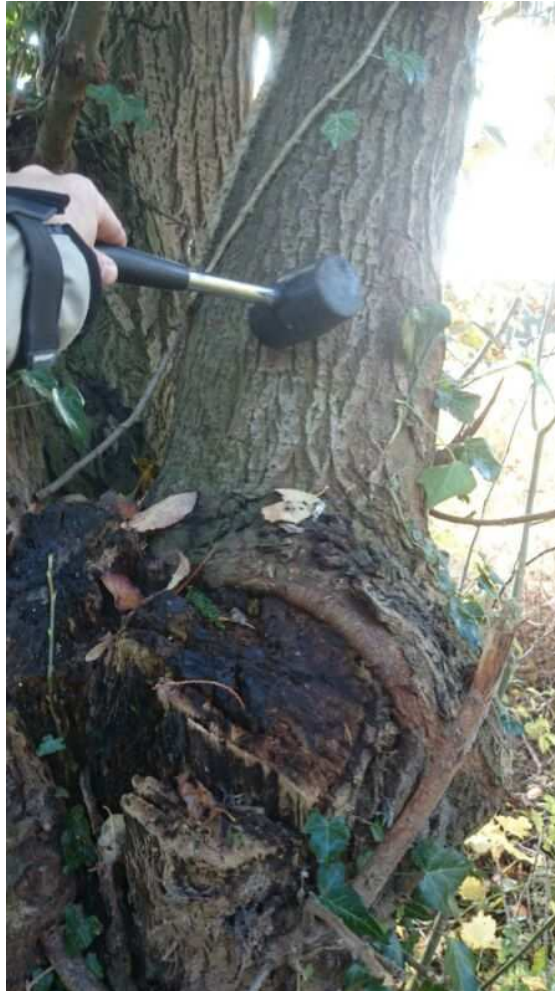
When I revisited the site I used a rubber mallet to sound out any perceived decay pockets. I detected a long area of unsound wood leading up the right stem indicating that internal decay was moving up this stem. I did not detect any other dysfunctional area. It won't be long before this branch breaks and it will be certainly exacerbated by the removal of the large macrocarpas next to it as wind dynamics around the tree will change and failures will be more likely.

Picture 2 Stem where decay was found on 521

Given the poor compartmentalisation attributed to all willow trees I would expect this decay to spread to the other two stems in the near future and would expect a major failure within 10 years. I have therefore re-categorised this tree as a Cat U tree to be removed.

It would be wrong to allow development to take place when anyone might be harmed by a tree that has been recognised as being at risk of failure. Therefore if any development takes place at the site then this tree must be felled.

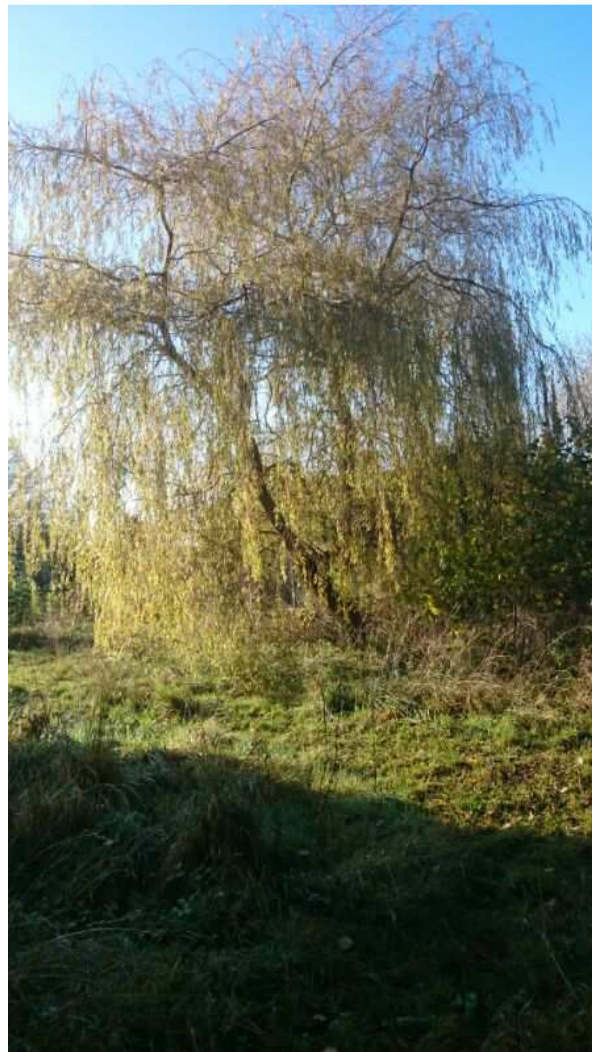
- 3) The hazel tree to the far south east has been plotted and give a number of 529. The garage that would have been on this trees RPA has been removed from the plan.
- 4) We were very conscious of trying to save at least one of the significant trees on site and 525, the weeping willow appeared to be the easiest to retain. With careful removal of the building next to it, improvement of the exposed soil, some pruning of the tree and the use of a Three dimensional cellular confinement system (TDCCS) with a porous surface dressing, the tree could be retained and provide a central feature to the cul-de-sac.

In many ways the weeping willow will be a good tree for this a clearance for vehicles below will be an important factor. The very soft stems that hang from this tree would be pruned back by regular vehicle movements below it, most likely by the weekly refuse collection.

Picture 3 The weeping willow 525

The oversized TDCCS would allow further growth of the tree to be supported and roots would be able to migrate freely to other parts of the development that would provide good rooting medium.

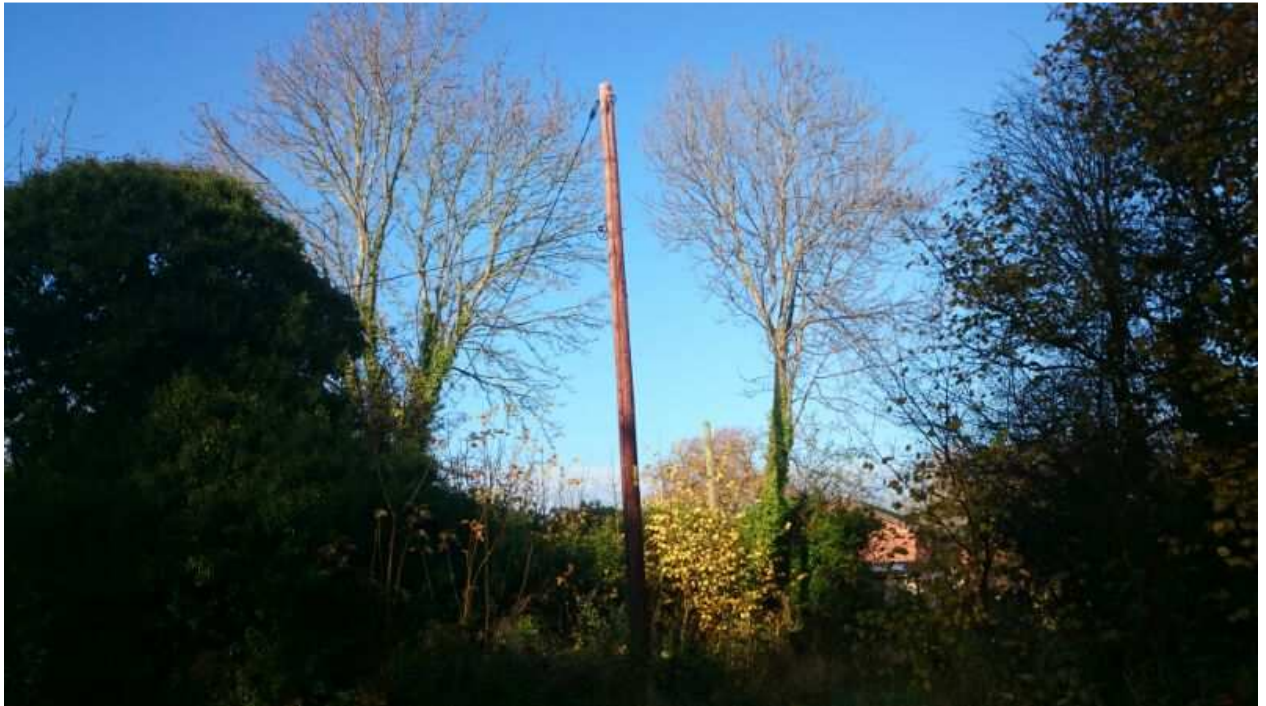
- 5) I disagreed that 527 was a tree anything other than a C category tree. It was quite visible from the north but apart from this, the views of it were unremarkable (Picture 4).

Picture 4 The two ash trees at the entrance. 527 on the left.

This tree is within half a metre of the wall of a large disused building. In the vicinity of the tree, the wall was structurally sound indicating direct root action had not damaged it. I had originally thought that the wall and foundations would have prevented the majority of root growth underneath this building and remain of this belief.

The tree occupies a space which would be ideal for a building and retention of the tree will prevent this whilst meaning there is very little reason to demolish the existing buildings. Added to this, ash tree 526 is 10 metres to the west and is scheduled to be retained. This tree is smaller but of better single stemmed form and will soon grow to take over the lost amenity of 527 but in a position where its long term retention is possible.

I am therefore, at ease in specifying that this tree should be removed despite its limited amenity value which will soon be replaced by 526.
