# Old Oak Tree Care

Report Reference: OOTC/PC14/4

## Arboricultural Report

Land to north of Tudor Drive  
Penley  
Wrexham

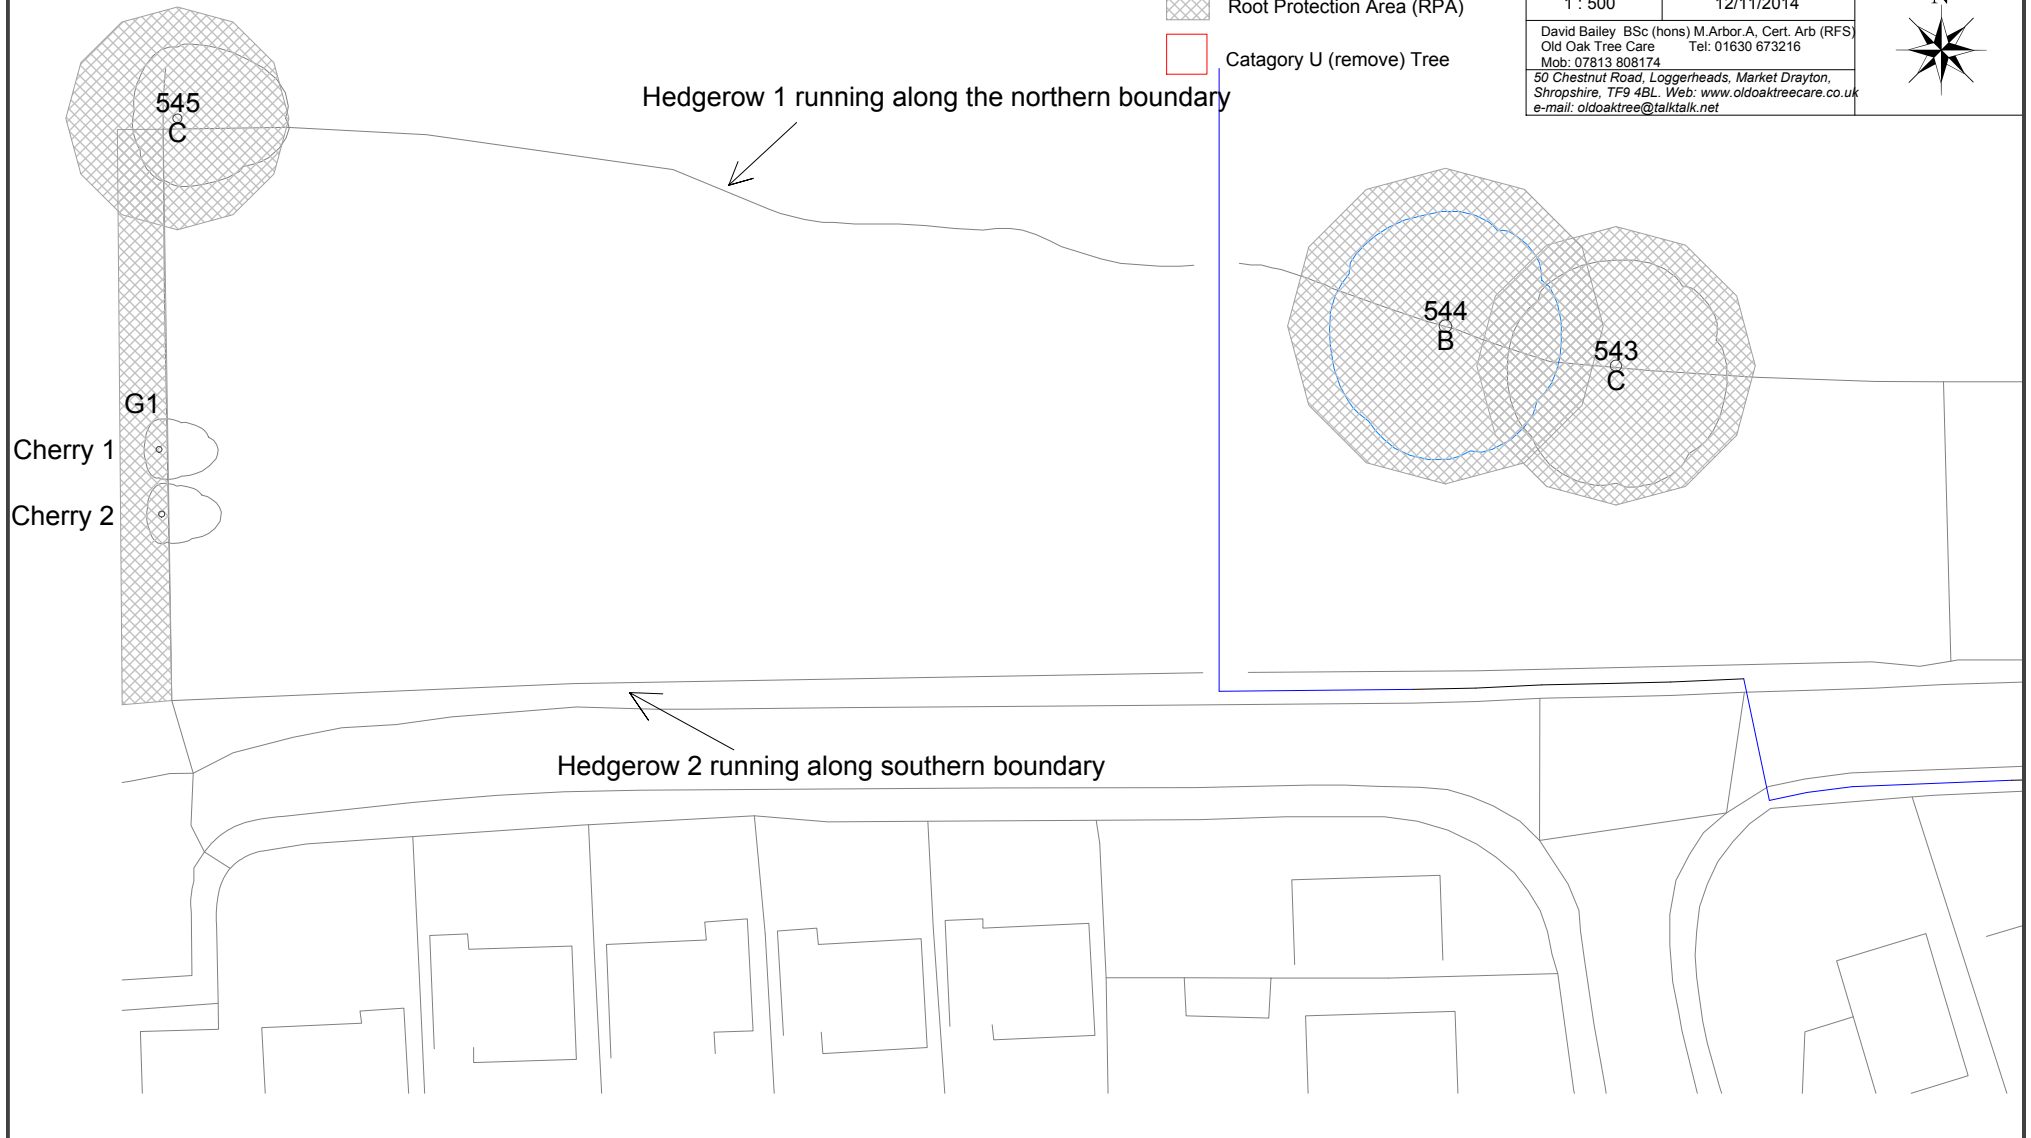
## Tree Constraints Plan version 1 Tree categories and Root Protection Areas (RPA's)

| Notes | Tree appears to be in decline. Profusion of dead wood and dying back tips indicate poor health. | | | | |

| Notes | Branch removed to south at approx. 5 metres has introduced decay down the stem. Tree appears to be compensating well for the decay. | | | | |

A number of generally young and elongated woodland trees on the far side of a deep ditch consisting of Cherry, Scots Pine and Sycamore. The ditch will present a major obstacle to root penetration into the site.

Of concern to any development on the site are two cherry trees as shown on the TCP. These tall and leggy trees overhang the site and are liable to be weak. Removal of these trees will be necessary.

- 8.1 Remove the deadwood from 543.
- 8.2 Remove the two cherries from G1 that overhang the site.
- 8.3 Remove Hedgerow 2.

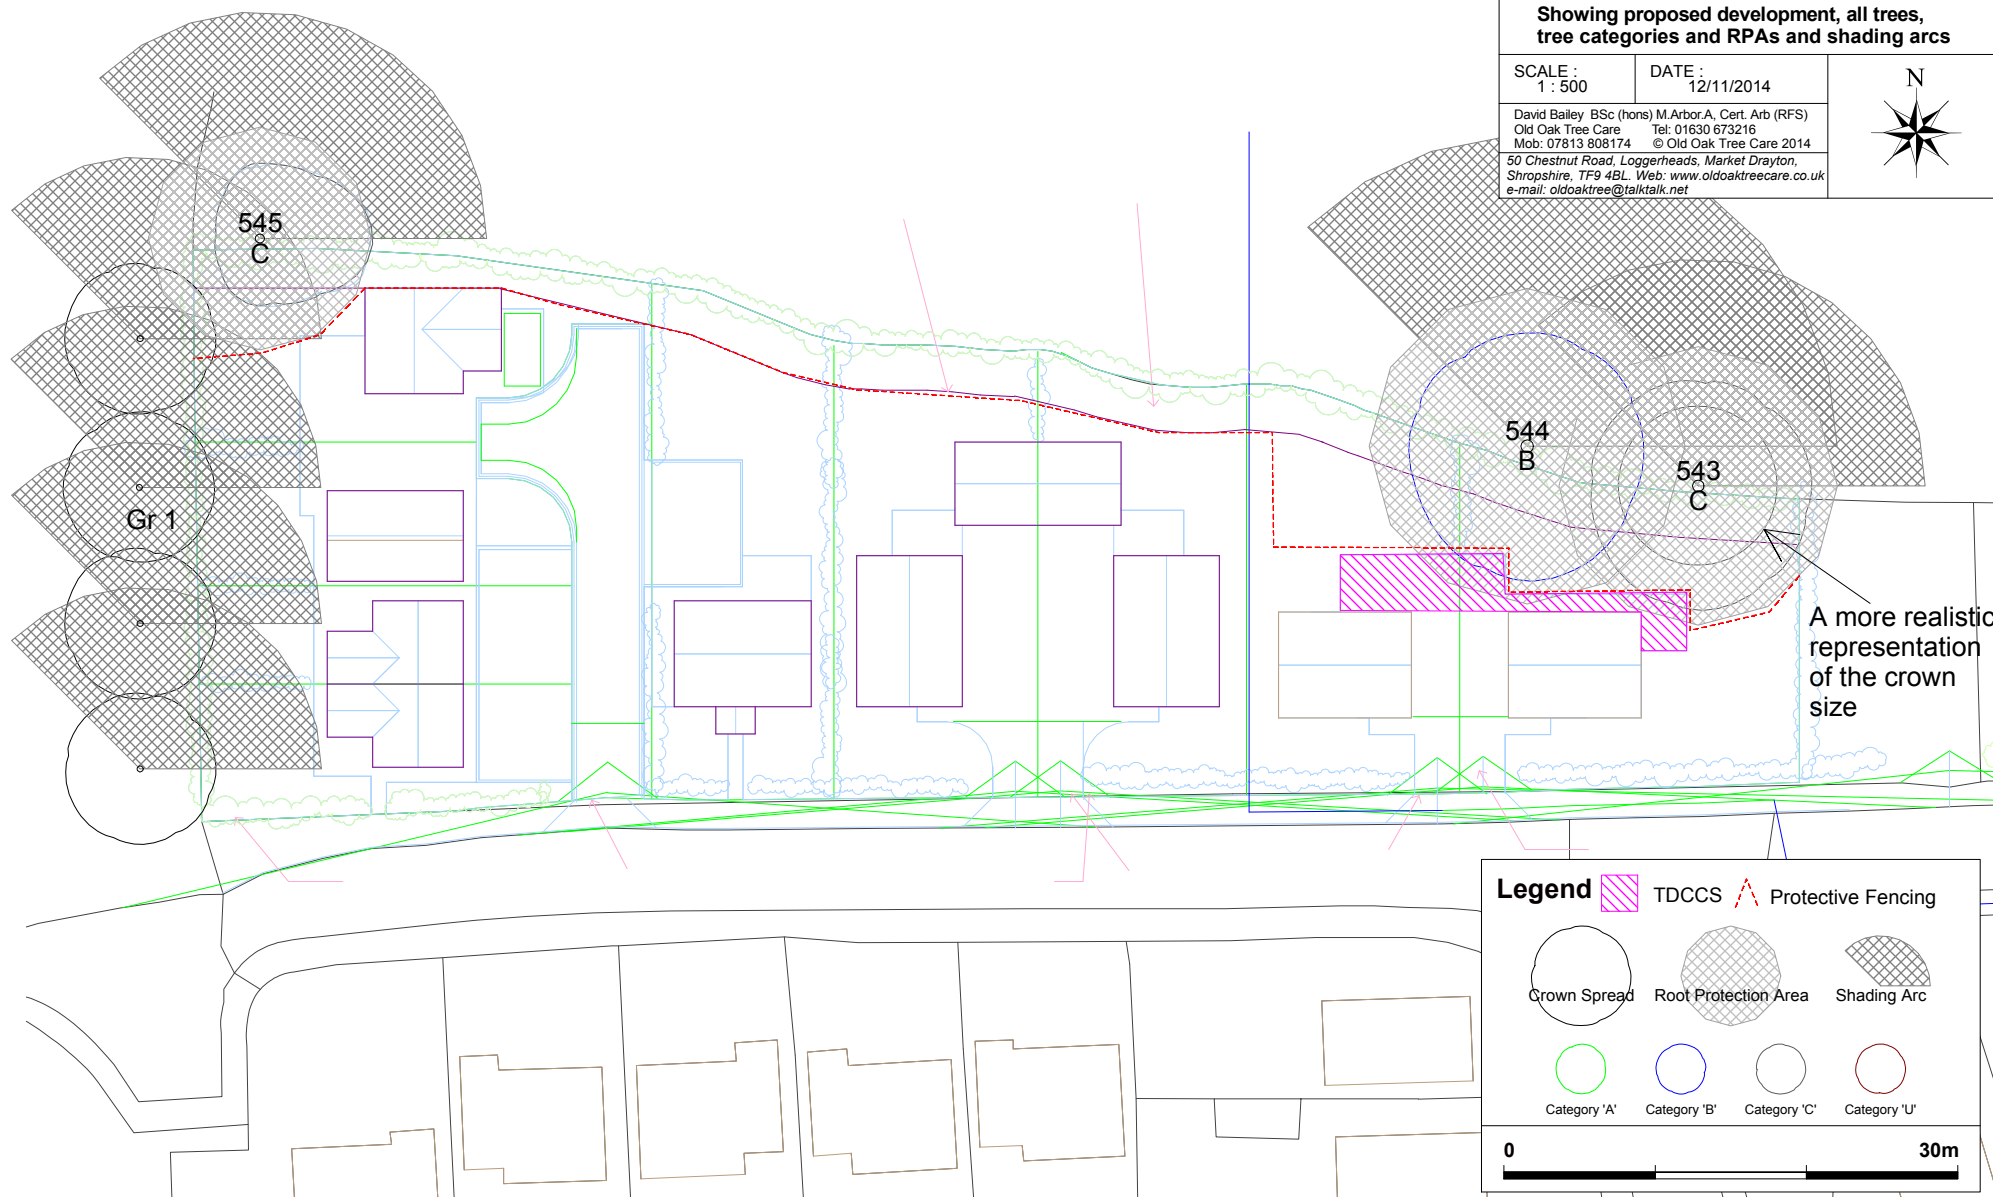
**Tree Protection Plan v2**  
**Showing proposed development, all trees,**  
**tree categories and RPAs and shading arcs**

- 10.1 The buildings are clear of the trees RPAs but some pathways and service areas are within the RPA of 543 and 544
- 10.2 The use of a three dimensional cellular confinement system (TDCCS), shown in pink on Appendix B, will prevent damage to roots or soil where incursions into the RPA are necessary. A checklist for the use of Cell Web, a well known TDCCS is found in Appendix E.
- 10.3 The use of the TDCCS is slight and on the edge of the trees RPAs. At most the TDCCS will reach 2.5 metres into the RPA of 544 covering less than 5% in total. It would be acceptable to use a non porous top layer to this TDCCS
- 10.4 The TDCCS should be constructed before any construction work begins. If this is not possible, then the protective fencing should remain around the full RPA until the point where the TDCCS is to be installed and then moved back to the position as shown in Appendix B.

- 11.9 \*I have drawn tree shading arcs on Appendix B using tree heights of 12 metres. It is clear that the gardens will be considerably shaded, but all gardens will receive some direct sunlight. This is also true for the houses. Given the nature of the tree is Group 1, the woodland is not a wall of green but offers views into it, therefore offering interest and variety.\*
