**British Standards 5837:2012 Tree Survey  
Arboricultural Impact Assessment,  
Arboricultural Method Statement &  
Tree Protection Plan**

**Marstons, Kingsmill PH  
Kingsmill Road, Wrexham  
for  
Urbanacity Ltd.**

**Report Reference: JH0814KINGSKMB**

**October 2014**

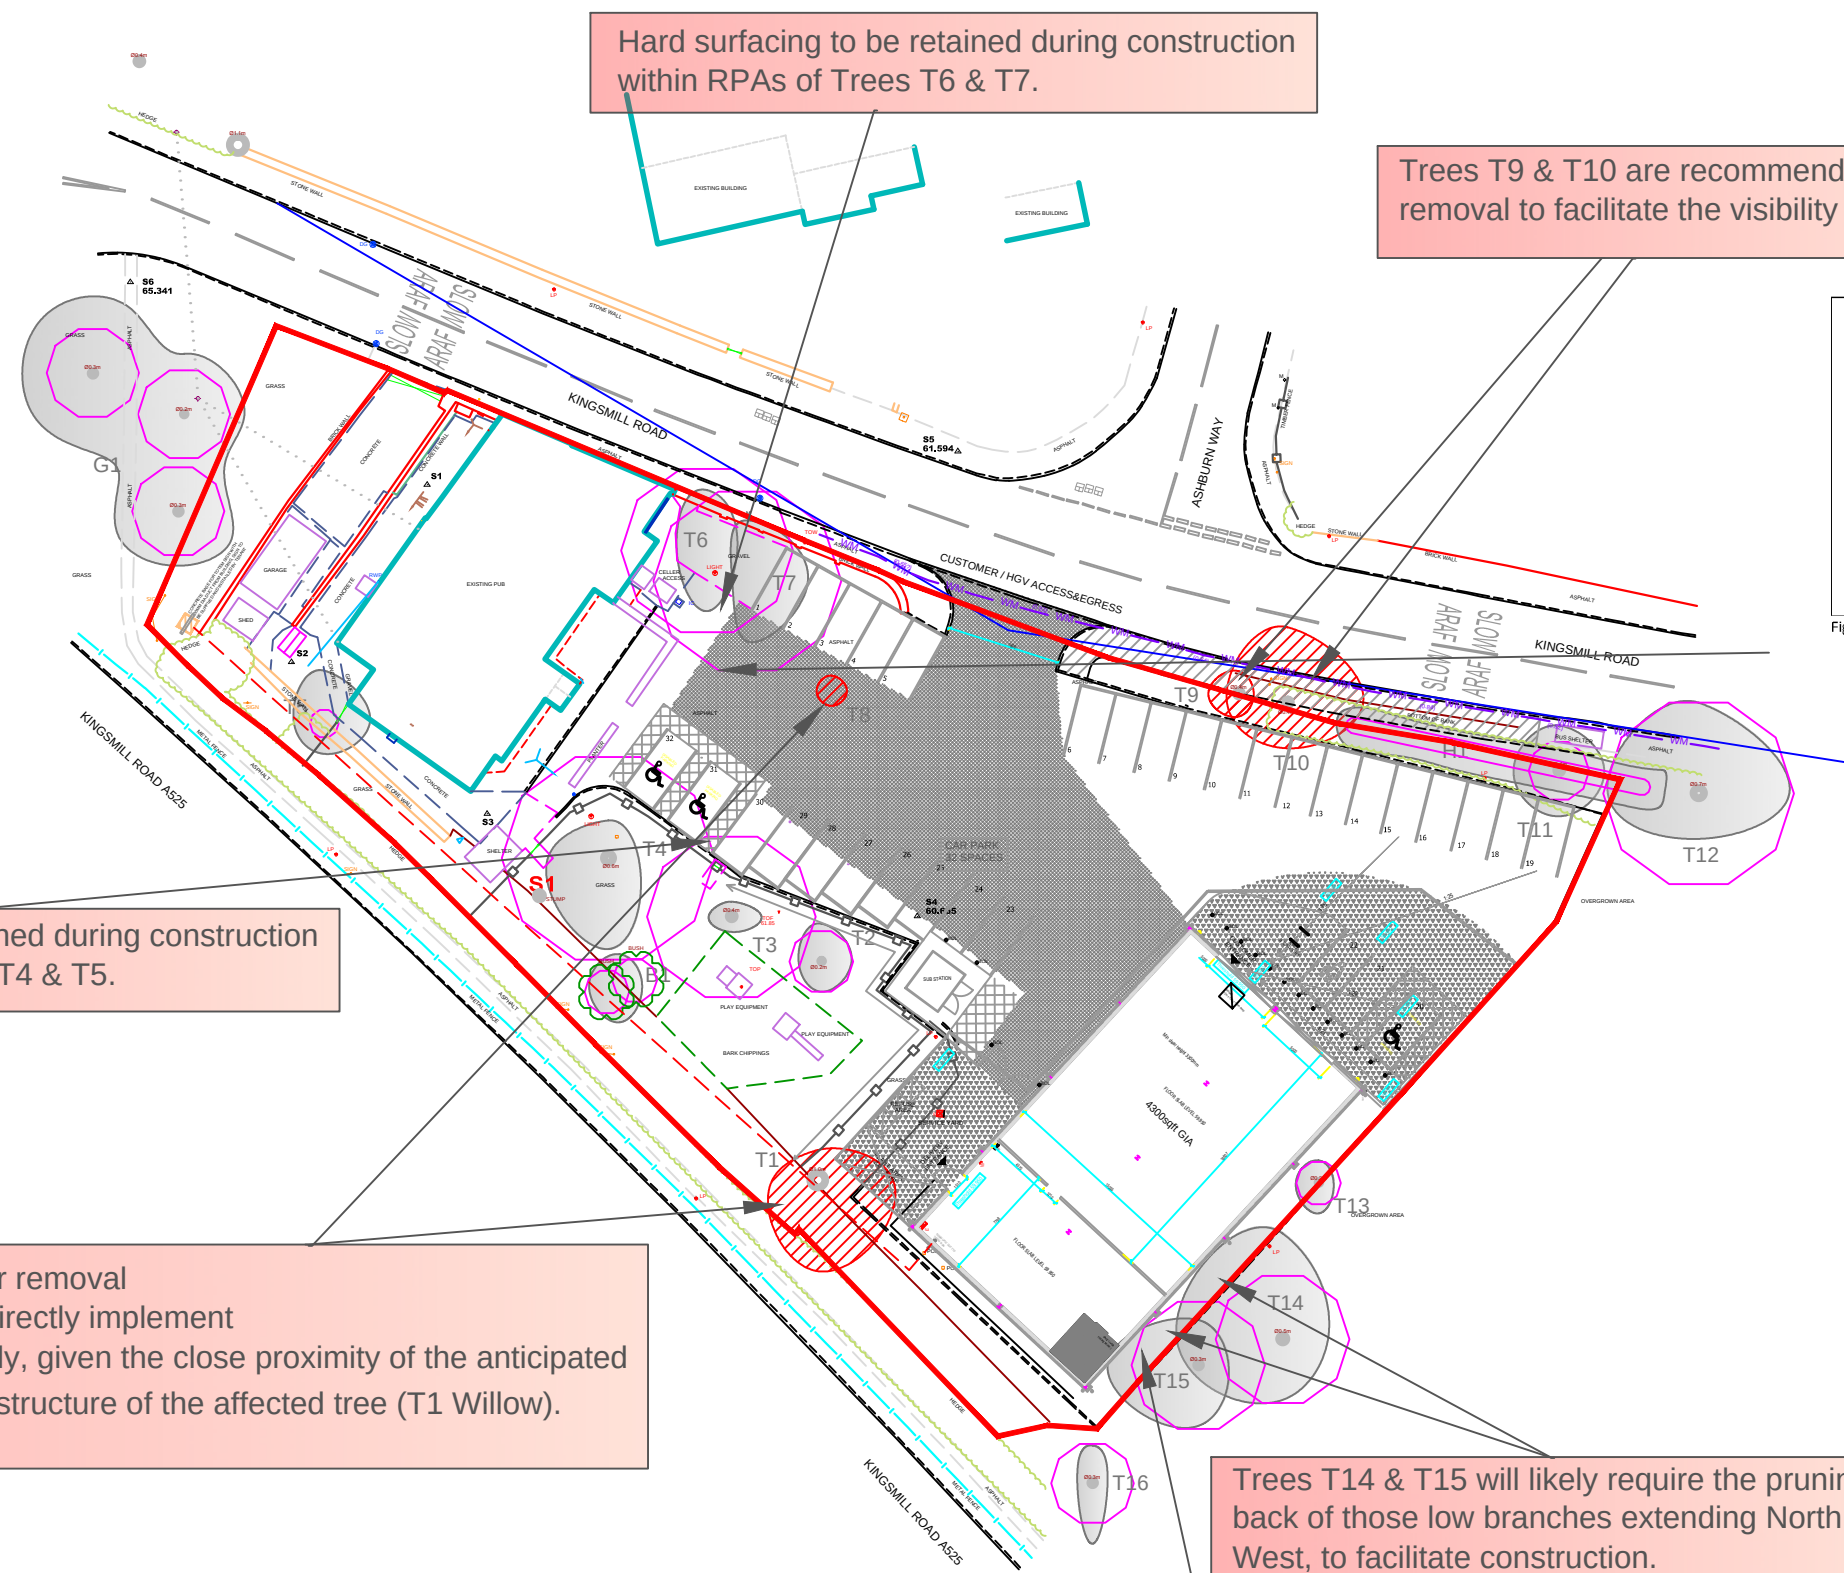
Hard surfacing to be retained during construction within RPAs of Trees T6 & T7.

Trees T9 & T10 are recommended for removal to facilitate the visibility splay

Hard surfacing to be retained during construction within RPAs of Trees T3, T4 & T5.

Trees T1 & T8 are recommended for removal to facilitate the construction. i.e. to directly implement the proposals (T8 Yew) and indirectly, given the close proximity of the anticipated construction and the relatively poor structure of the affected tree (T1 Willow).

Tree and Ground protection measures to be adopted in accordance with specifications and recommended practices detailed in sections 6 & 7 of Report JH0814KINGSKMB
