**Cheshire Ecology Ltd.**

**LAND OFF SUMMERHILL ROAD  
GWERSYLLT, WREXHAM**

**PRELIMINARY BAT SURVEY REPORT**

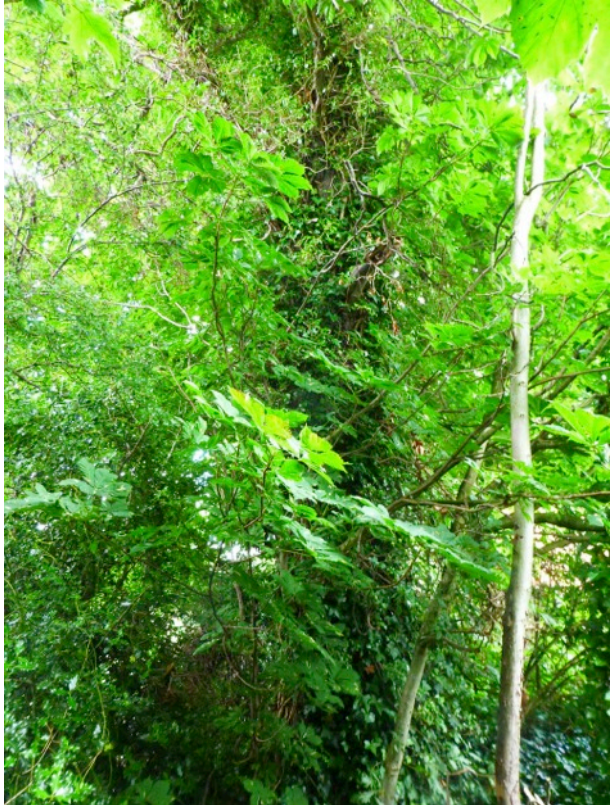
| | Species | Description | Category | Photograph |
|---|---|---|---|---|
| T2 | <i>Aesculus hippocastanum</i> | Mature horse-chestnut tree with moderate ivy cover. One small branch has a hole. Another broken branch is rotting at the end. Check with ladder before felling. | 2 | |

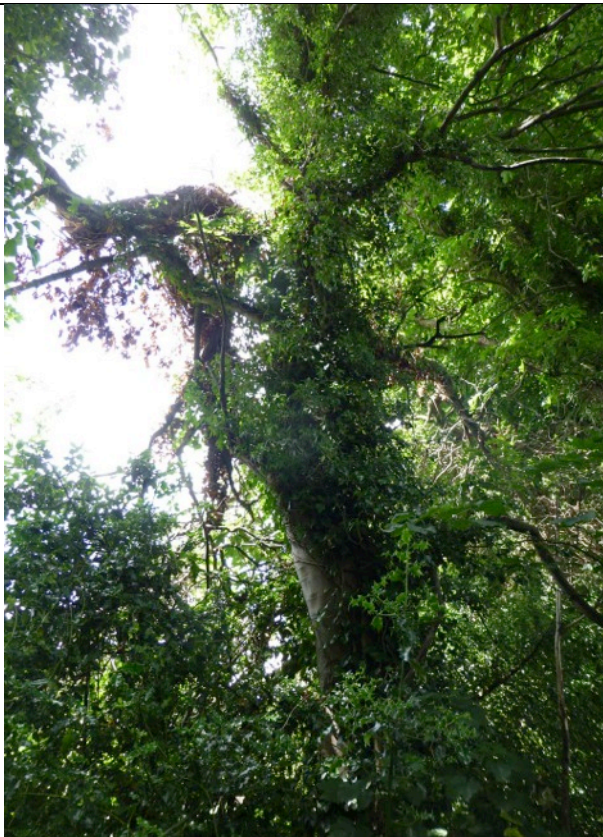
| T3 | <i>Acer pseudoplatanus</i> | Sycamore with moderate ivy cover. One lower branch has been ripped off. | 2 | |

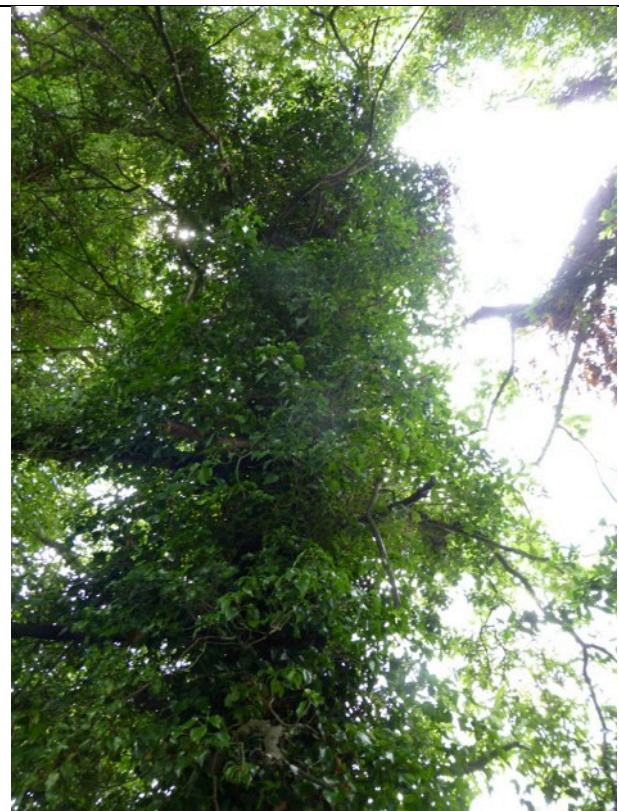
| T4 | <i>Quercus petraea.</i> | Small sessile oak. Very difficult to see due to the surrounding trees, but the top appears to be missing. Category 1 due to heavy ivy cover. | 1 | |

- 5.1.3 The tree survey (Tree Solutions Ltd., 2014) recommended that two oak trees (trees T4 and T7) should be felled. There are four oak trees on site, including one sessile oak *Quercus petraea*, one hybrid oak *Q. x rosacea* and two unidentified oaks (both of these were obscured by sycamore and horse chestnut trees at the time of the survey). The oak trees are probably survivors from the original hedgerow that surrounded the site before Gwersyllt Hill Hall was built. We recommend that these trees are retained and the surrounding sycamore trees should be removed instead. The sycamore is an introduced species, while the oaks are native and have considerably greater value for wildlife.

- 5.1.4 However we do accept that the poor growing conditions have meant that these trees have deteriorated and may need felling for health and safety reasons. Depending upon their condition it would probably be necessary to conduct a dusk and dawn bat survey on each tree before they were felled.

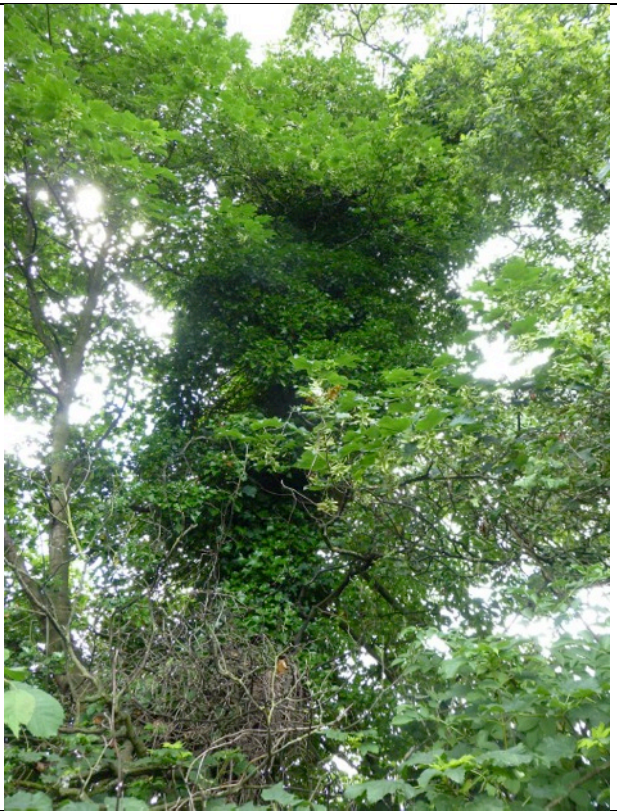
| T5 | <i>Acer pseudoplatanus</i> | A sycamore tree with extremely heavy ivy cover. | 1 | |

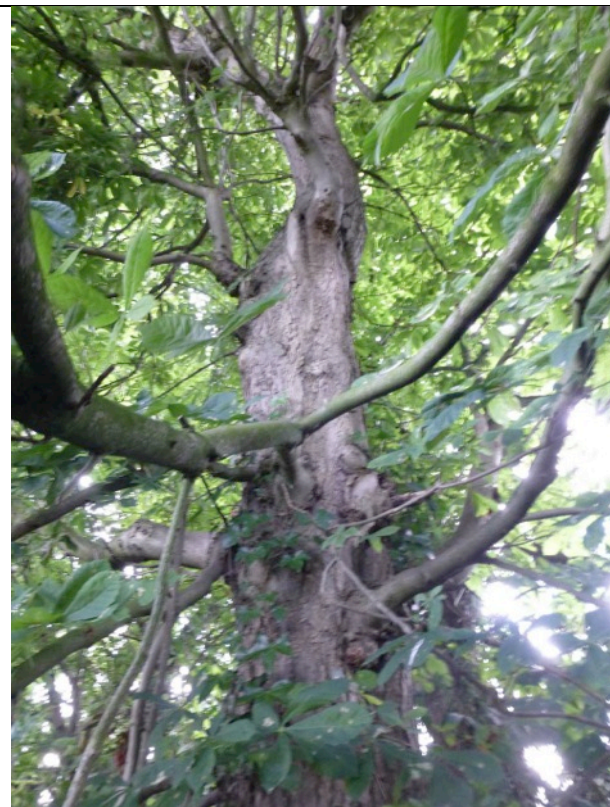
| T6 | <i>Aesculus hippocastanum</i> | Horse chestnut. The tree has had several smaller branches removed, leaving holes where the cut wood has decayed. There is no ivy cover. The holes are approximately 2.5m above ground level. Check with endoscope and soft fell. | 2 | |

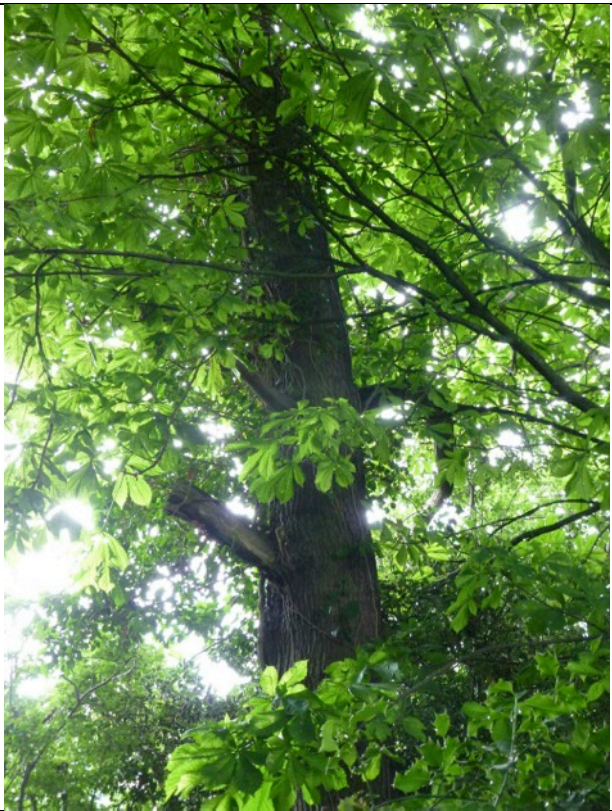
| T7 | <i>Quercus sp.</i> | Standard oak tree. One of the lower branches has been removed, leaving jagged timber. Some ivy cover. Difficult to see the top of the tree due to surrounding trees. Retain if possible and removing surrounding sycamores. Cautionary Category 1 due to access problems. Needs further inspection, preferably from adjacent field. | 1 | |

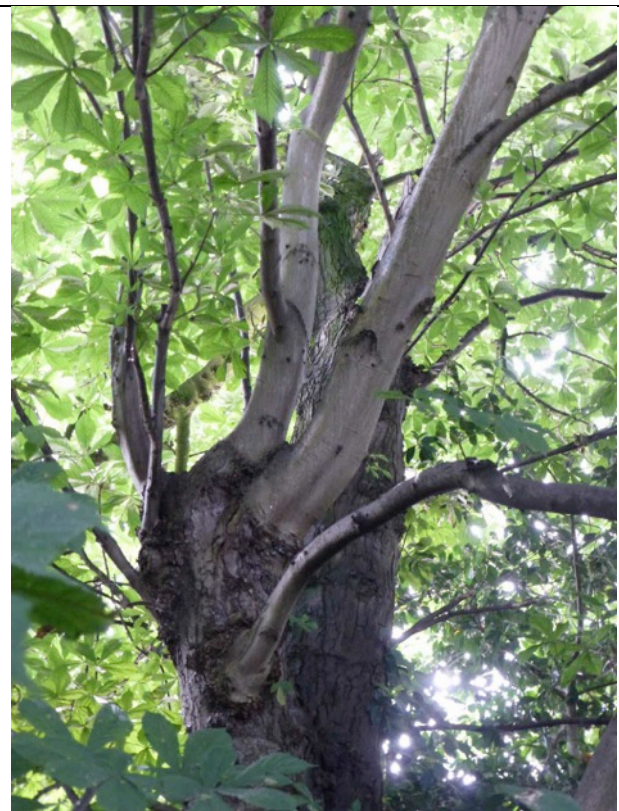
| T8 | <i>Aesculus hippocastanum</i> | Horse chestnut with epicormic growth. Some of the upper branches have been lost and could have cavities. However, these are facing upwards and are probably full of water. The tree needs to be climbed to determine whether the holes are dry or filled with water. Check with a ladder. | 2 | |

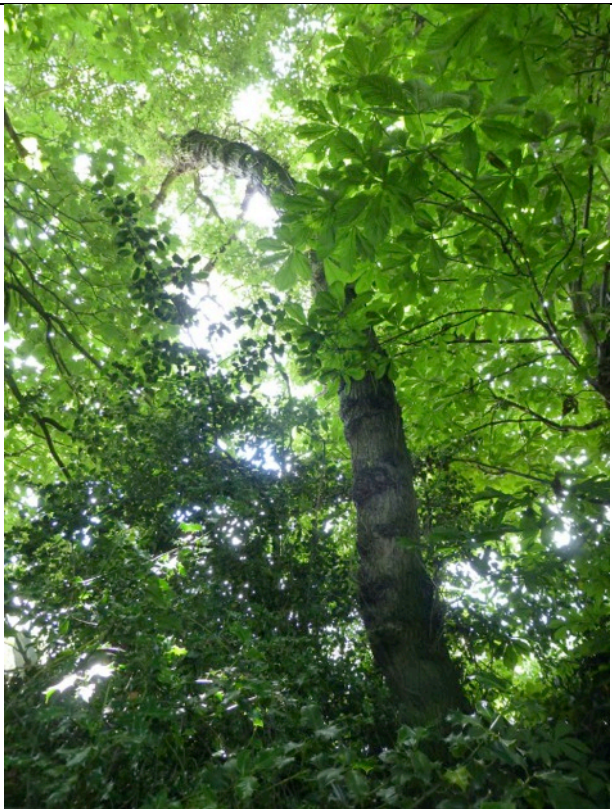
| T9 | <i>Quercus sp.</i> | Small, weak-growing oak tree. Again probably a former hedgerow tree. No obvious sign of holes, but it was difficult to tell with all of the sycamore foliage. This tree should be retained if possible. | 2 | |

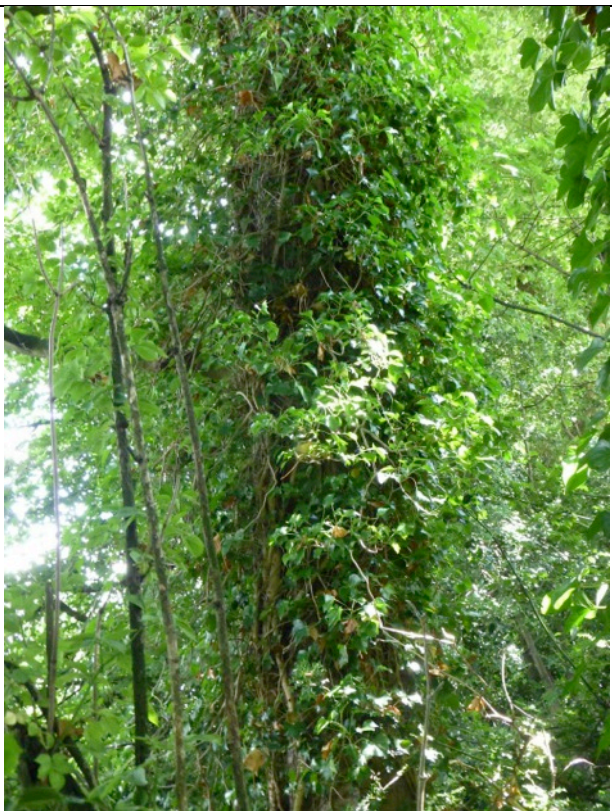
| T10 | <i>Acer pseudoplatanus</i> | A large mature sycamore with dense ivy cover. One branch has a hole, but it may not be deep enough to be useful to a bat. | 2 | |

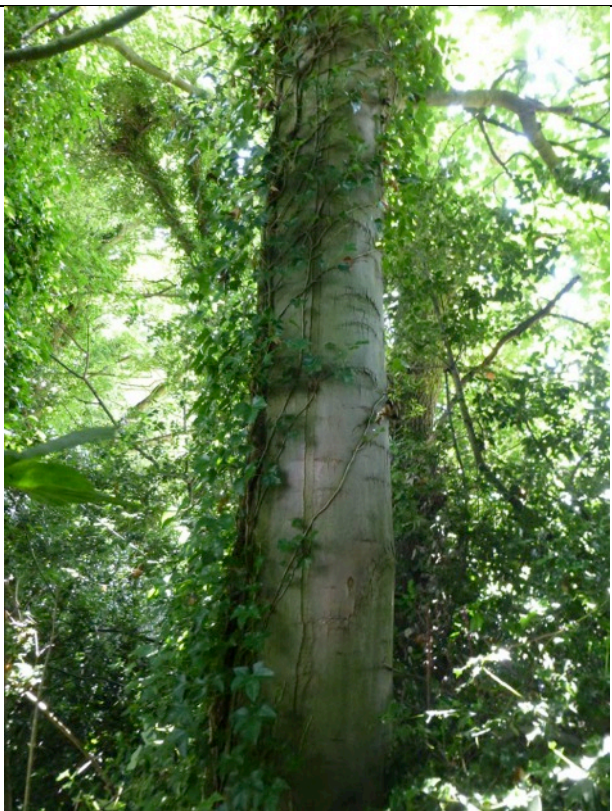
| T11 | <i>Acer pseudoplatanus</i> | Standard sycamore with small amount of ivy cover. No bat potential. | 3 | |

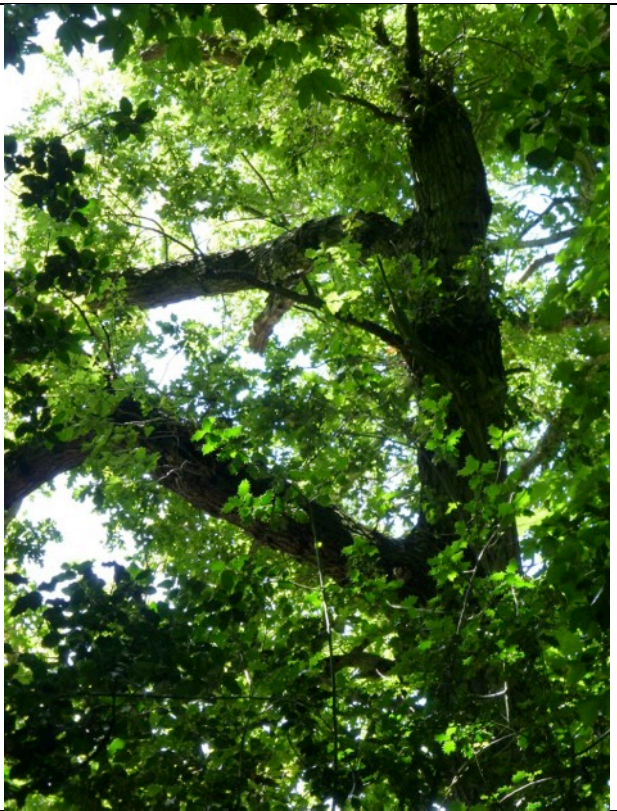
| T12 | <i>Quercus sp.</i> | Senescent oak with missing upper branches and rotting timber. The oak is probably one of the original hedgerow trees and should be preserved if possible. The adjacent sycamores should be felled to increase the amount of light available. Difficult to see due to the surrounding vegetation, but there appear to be woodpecker holes one of the upper branches. Requires further investigation before it is felled. | 1 | |

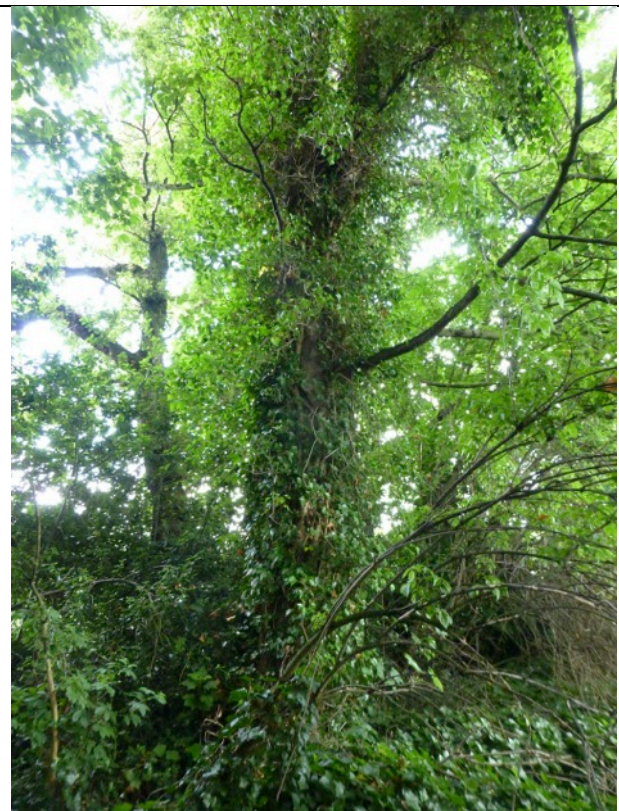
| T13 | <i>Acer pseudoplatanus</i> | Sycamore tree with split trunk, forming a y-shape. The tree has quite a lot of ivy cover but no sign of holes or missing branches. | 2 | |

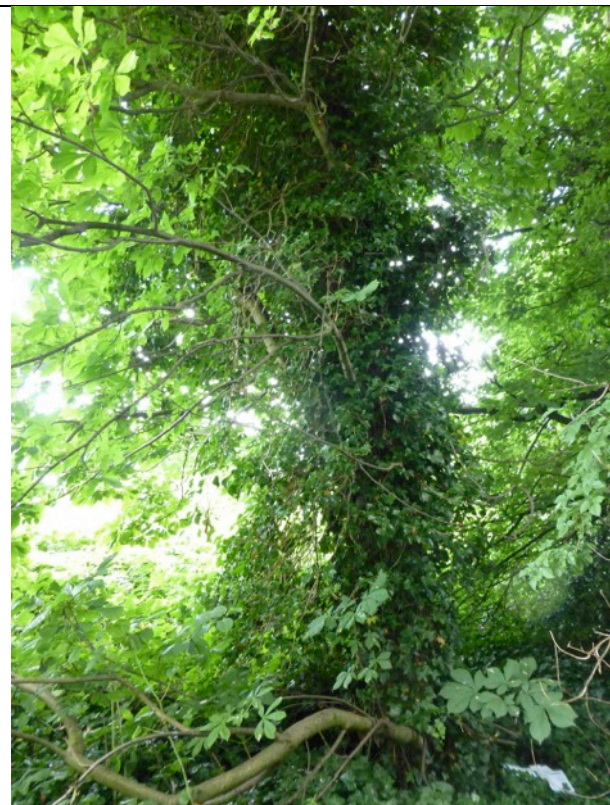
| T14 | <i>Aesculus hippocastanum</i> | Standard horse chestnut with many lower branches and dense ivy cover. Not possible to see holes in the trunk due to the extensive growth of Japanese knotweed on the site and the dense ivy cover. | 2 | |

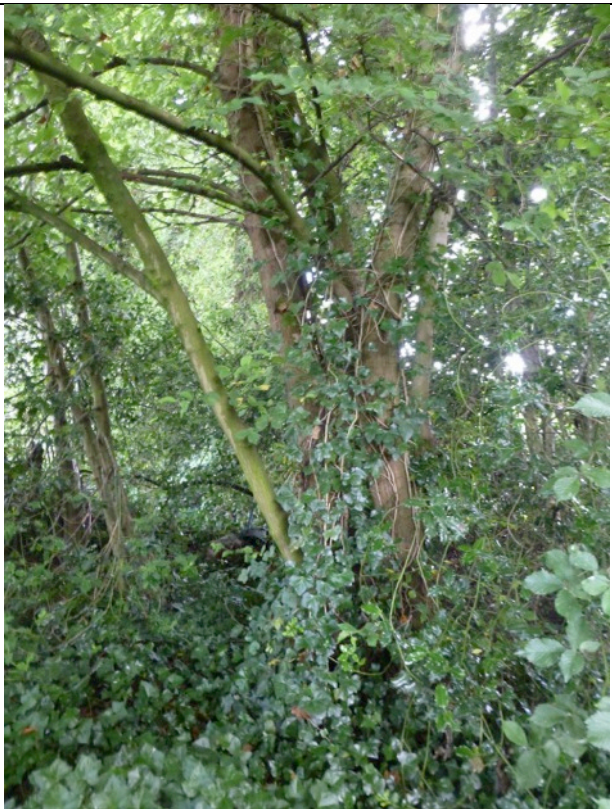
| T15 | <i>Ulmus sp.</i> | Coppiced elm tree. No bat potential. | 3 | |

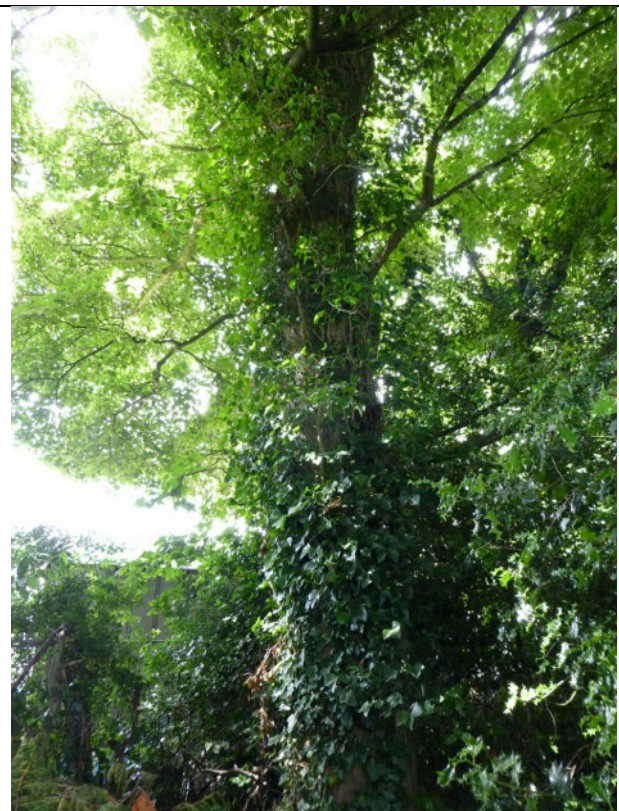
| T16 | <i>Acer pseudoplatanus</i> | A healthy sycamore tree with some ivy cover. | 2 | |

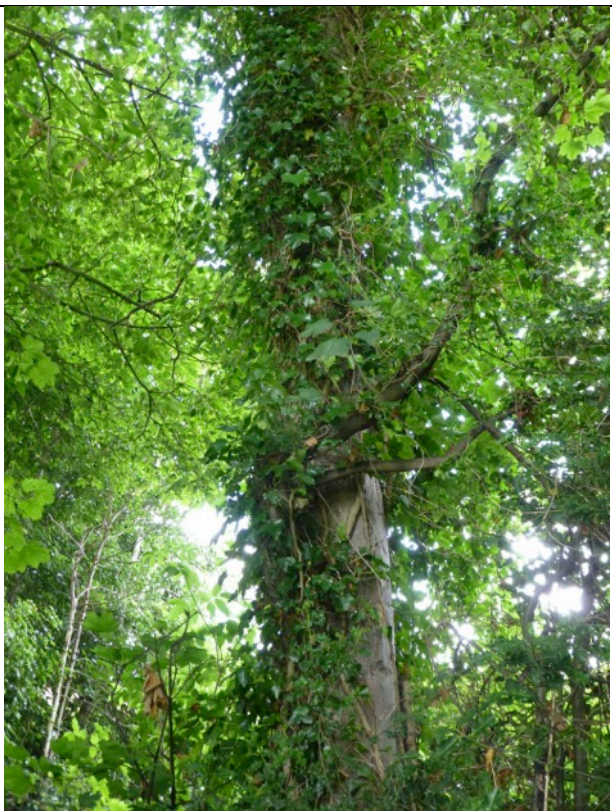
| T17 | <i>Acer pseudoplatanus</i> | Standard sycamore with heavy ivy cover. No obvious holes or broken branches. The arboricultural report states that there is dead wood in the crown. | 2 | |

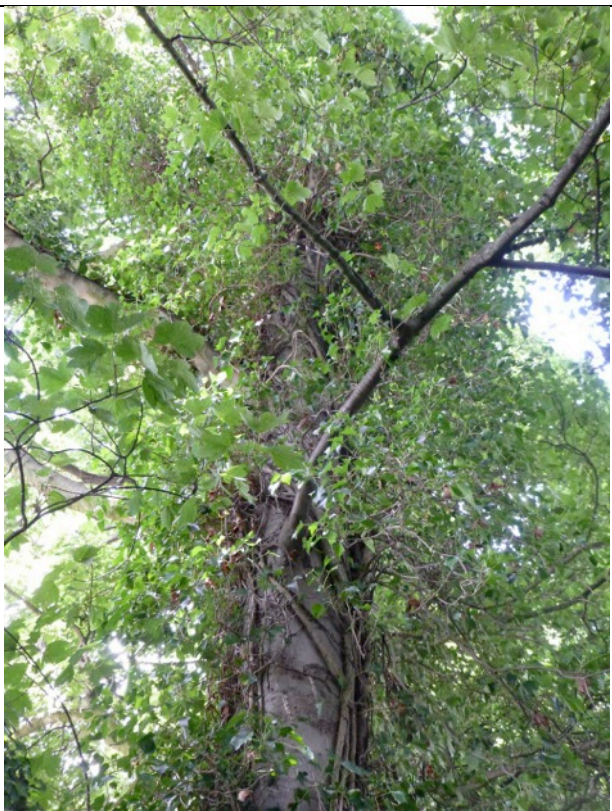
| T18 | <i>Acer pseudoplatanus</i> | Standard sycamore tree with some ivy cover.<br>There are no obvious holes. | 2 | |

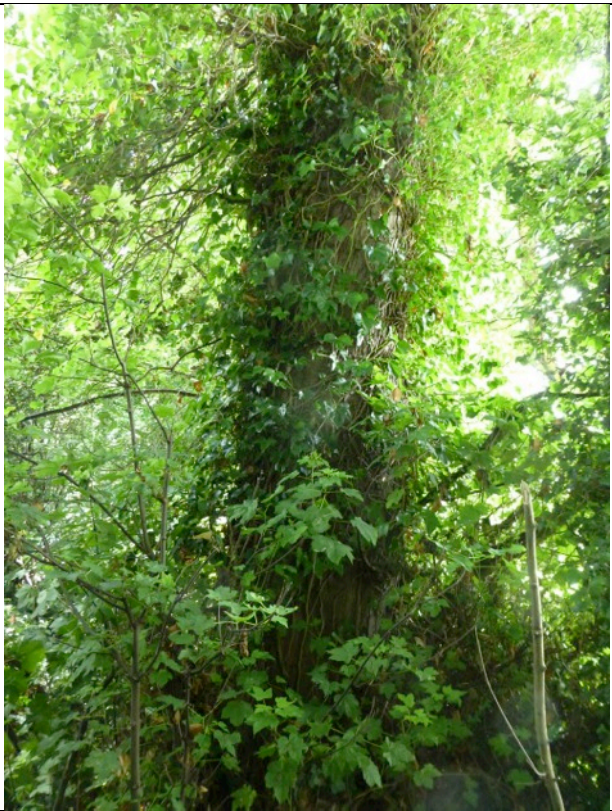
| T19 | <i>Acer pseudoplatanus</i> | Standard sycamore tree with ivy cover on the trunk. Difficult to tell whether there are any holes in the trunk due to the ivy cover. No broken branches apparent. | 2 | |

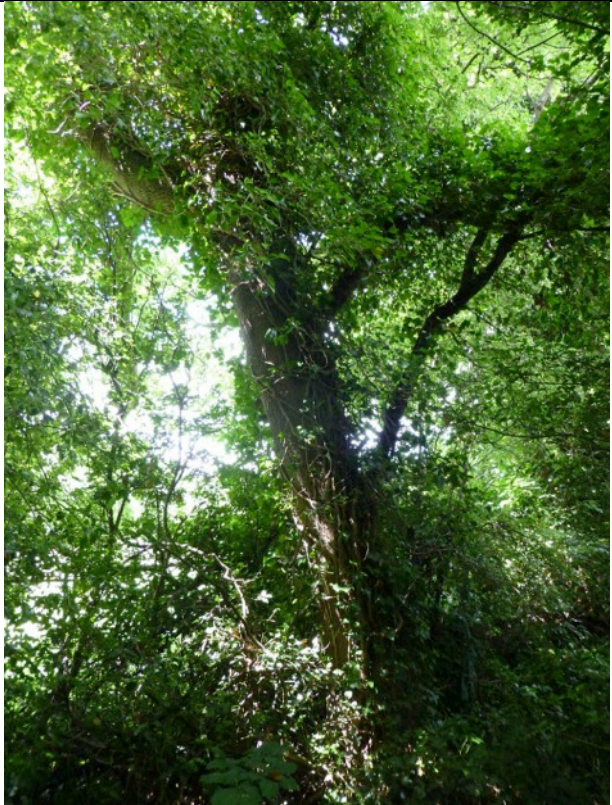
| T20 | <i>Fraxinus excelsior</i> | Poorly grown ash tree with a badly bent trunk. The tree has a number of branches that extend into the site. Some of the smaller branches are broken and have decaying wood. Difficult to assess because of all the ivy cover and the fact that it was not possible to see the tree from the western side. Cautionary Category 1. | 1 | |

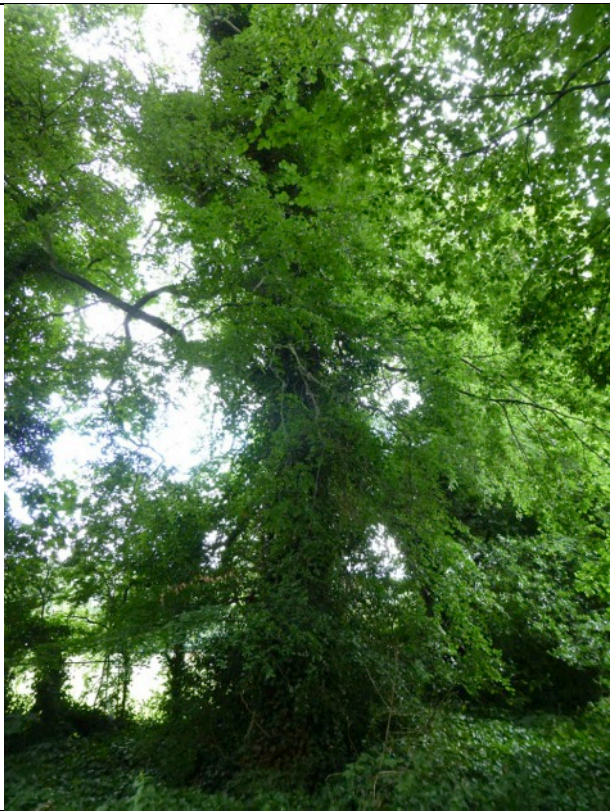
| T21 | <i>Fagus sylvatica</i> | Large standard beech tree with plenty of ivy cover on the trunk. The ivy appears to extend to the canopy. No obvious holes or broken branches, but these would be hidden by the ivy cover. | 1 | |

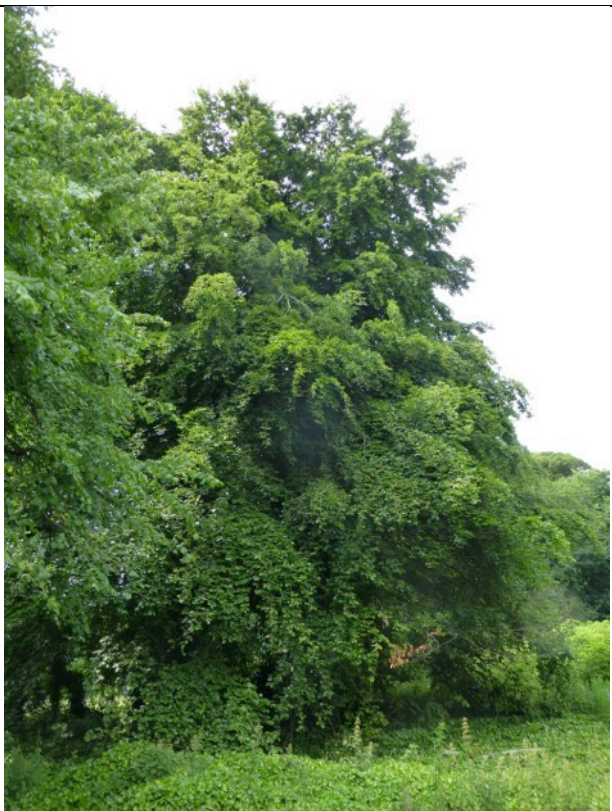
| T22 | <i>Fagus sylvatica</i> | A large, standard, ivy-clad beech tree. The dense foliage and ivy cover makes it difficult to see the top of the tree trunk. No obvious holes, but classed as Category 1 due to the ivy cover. | 1 | |

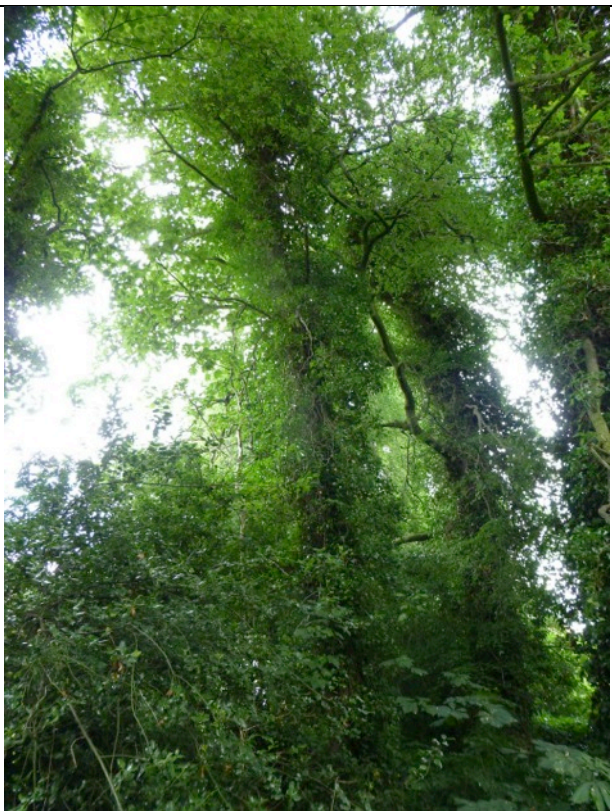
| T23 | <i>Acer pseudoplatanus</i> | A standard sycamore tree, which is leaning toward the adjacent field. The tree is heavily covered with ivy. No obvious broken branches, nor any holes. | 2 | |

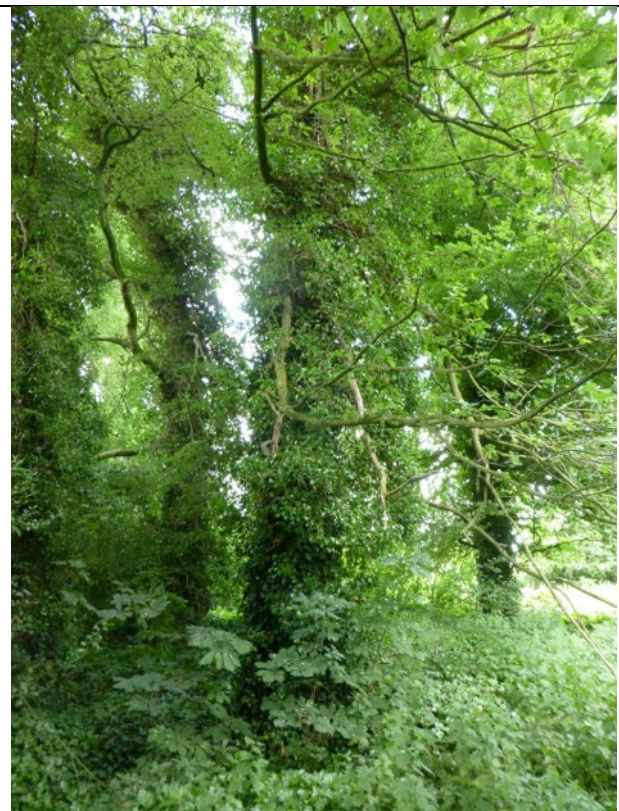
| T24 | <i>Quercus x rosacea</i> | A large, standard oak tree with some broken lower branches. The entire stem is clad by ivy. One upper branch is missing and jagged wood remains. No obvious holes, but the tree is partially senescent and holes could be hidden by ivy. | 1 | |

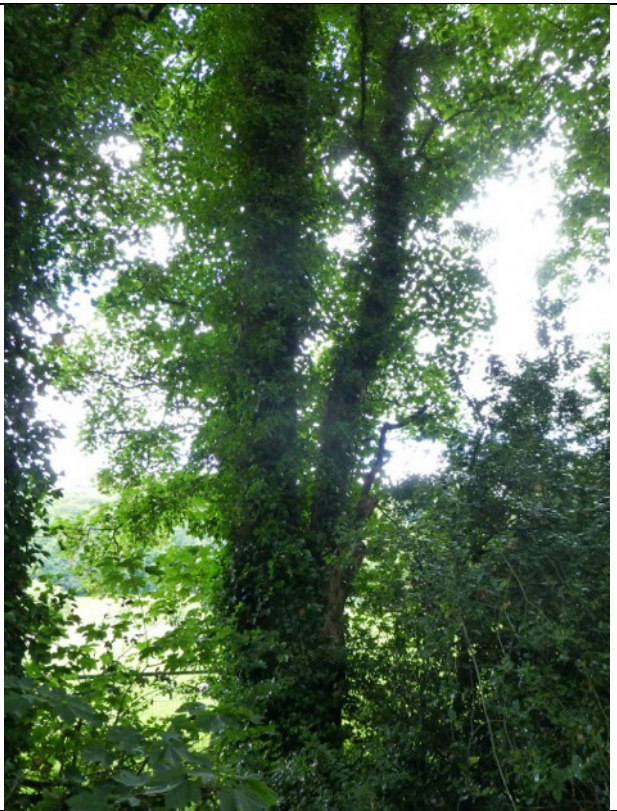
| T25 | <i>Acer pseudoplatanus</i> | A sycamore tree with a y-shaped trunk. Most of the trunk is covered with ivy, which extends to the top of the tree. No obvious holes. | 2 | |

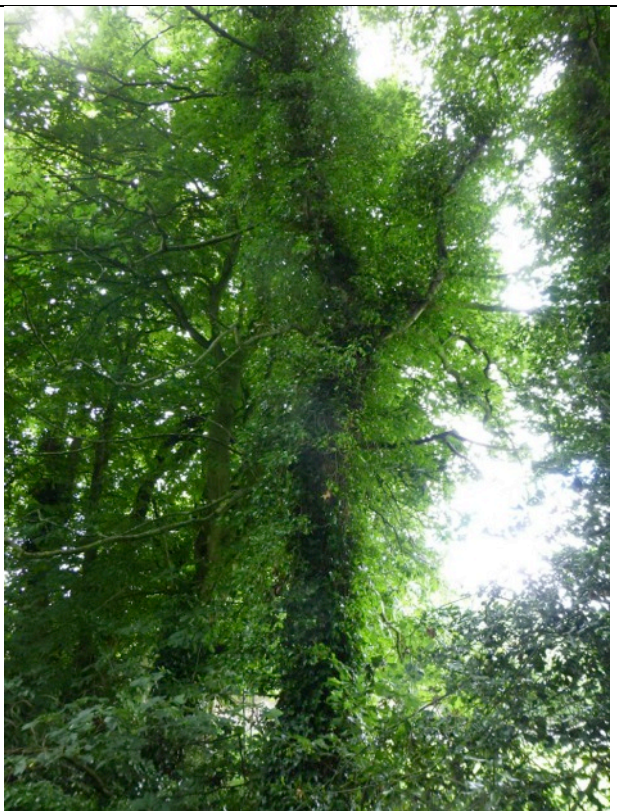
| T26 | <i>Acer pseudoplatanus</i> | Standard sycamore with ivy growth on the trunk. More extensive than T27 and appears to extend to the top of the canopy. | 2 | |

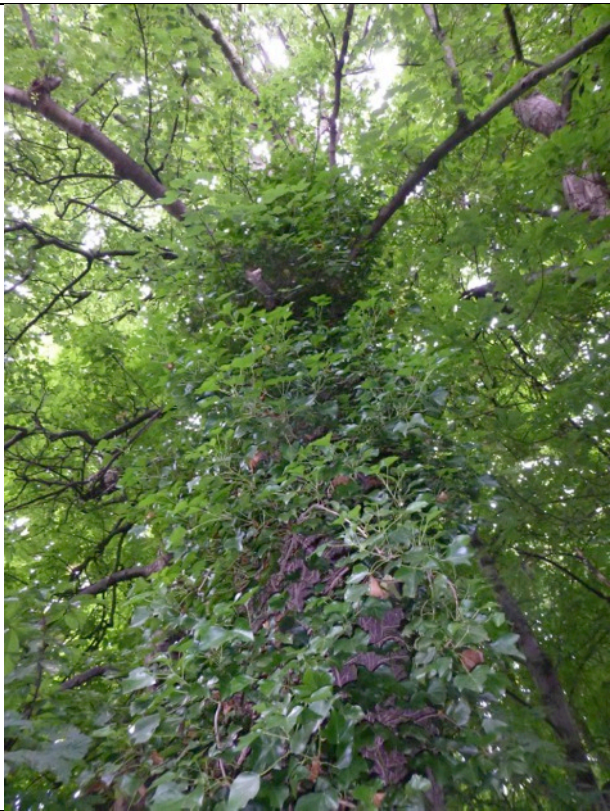
| T27 | <i>Acer pseudoplatanus</i> | Standard sycamore with some ivy cover on the main trunk. The trunk diverges at approximately 6m above the ground. Some smaller branches are missing, but holes are blind. No obvious sign so bat potential. | 2 | |

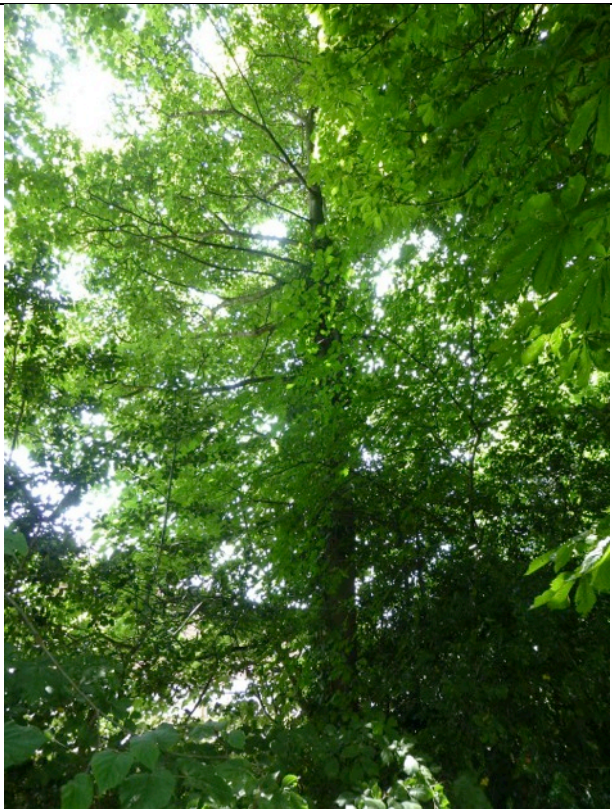
| T29 | <i>Acer pseudoplatanus</i> | A young standard sycamore tree, with a small amount of ivy cover. | 3 | |

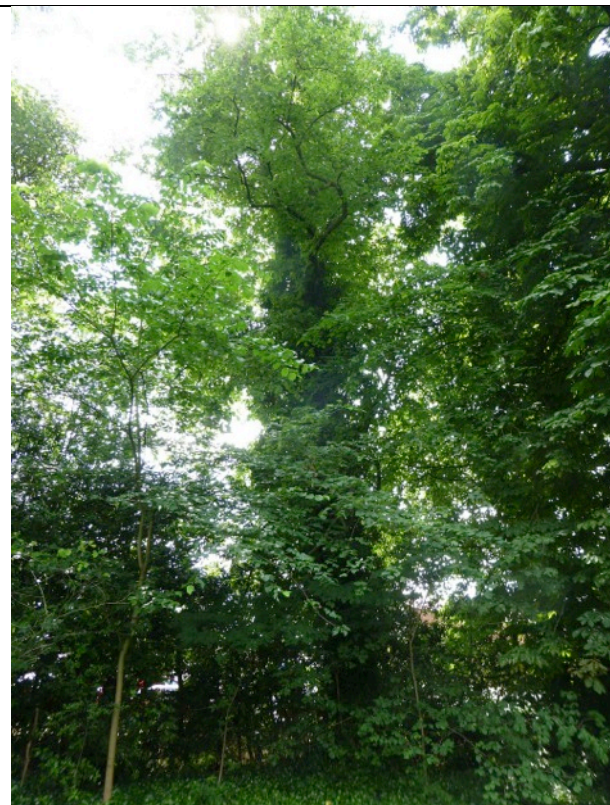
| T30 | <i>Tilia x europaea</i> | A standard lime tree, without any epicormic growth on the trunk. Some ivy cover. | 2 | |

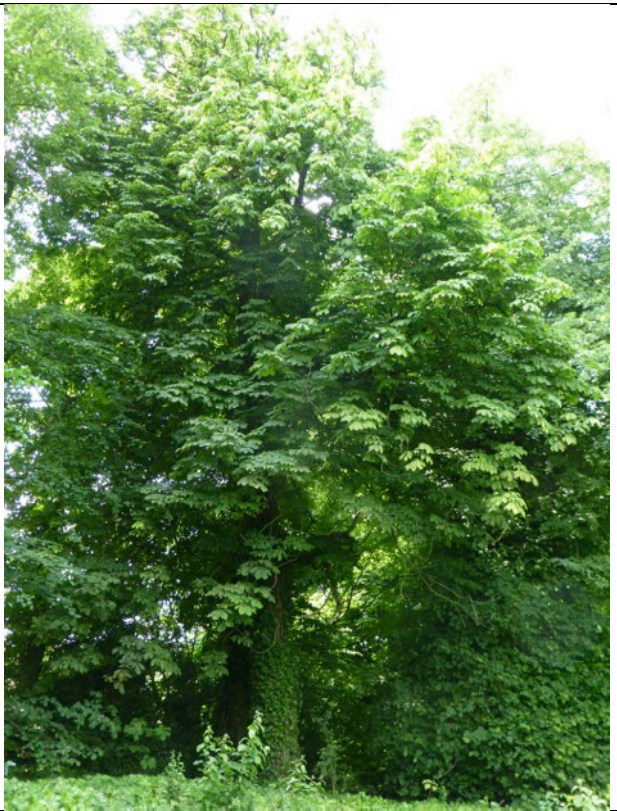
| T31 | <i>Aesculus hippocastanum</i> | Standard horse chestnut tree with rotting wood at the base of the trunk. The tree has some ivy cover, but not enough to make it suitable for bats. No obvious holes or broken branches above ground level. Some smaller lower branches are rotting. | 3 | |

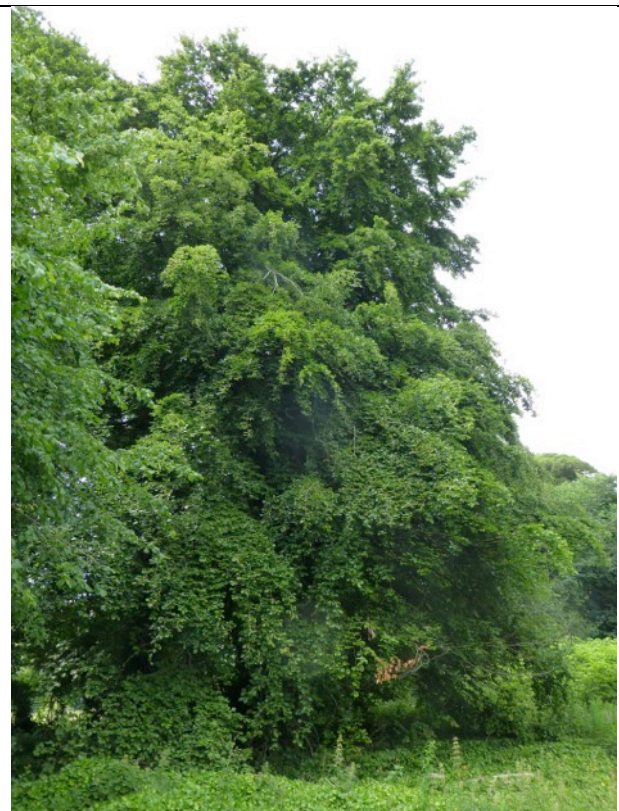
- 3.1.3 The lime trees in particular have a lot of epicormic growth and were rated at Category 1. These trees should have dusk and a dawn surveys carried out if they will be directly affected by the development.

| T32 | <i>Tilia x europaea</i> | A large lime tree with extensive epicormic growth around the base of the trunk. The profuse foliage makes it difficult to see whether there are any holes. | 1 | |

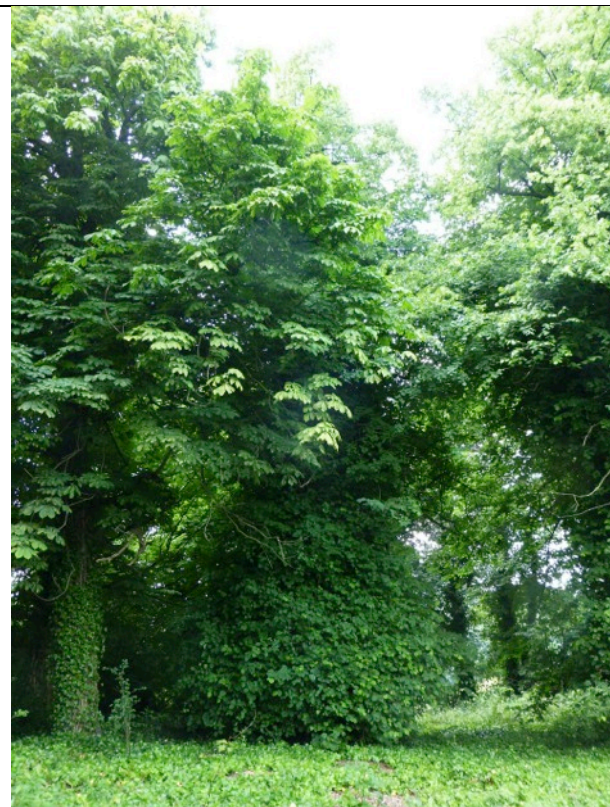
| T33 | <i>Tilia x europaea</i> | A large, well-grown lime tree with dense epicormic growth on the lower part of the trunk. The dense epicormic growth and other foliage hide the trunk. It was not possible to see any holes, even if they were present. | 1 | |

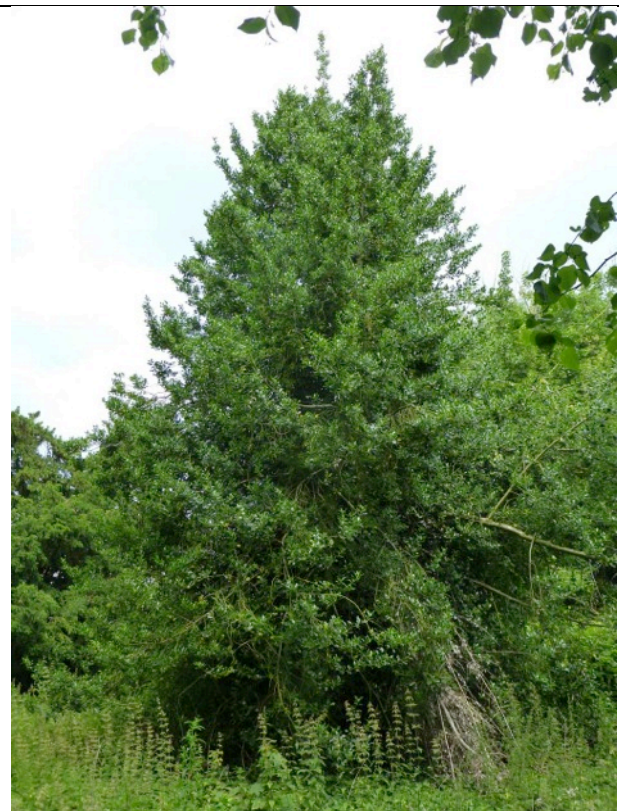
| T34 | <i>Ilex aquifolium</i> | Coppiced holly tree with rather tangled, strongly growing secondary growth. It is difficult to see within the tree due to the prickly foliage. No obvious holes, but Category 2 as it may offer cover for bats. | 2 | |

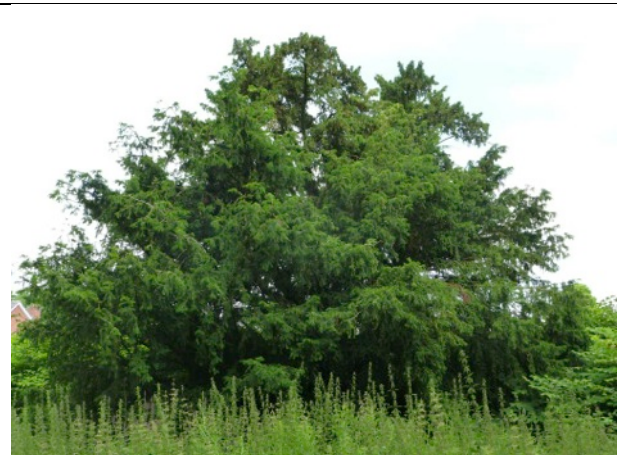
| T35 | <i>Taxus baccata</i> | A coppiced, or multi-stemmed yew tree. There are no obvious holes, but the tree has some epicormic growth on the branches and at least one branch has decay where a side branch has been removed. Part of another branch is rotting. | 3 | |

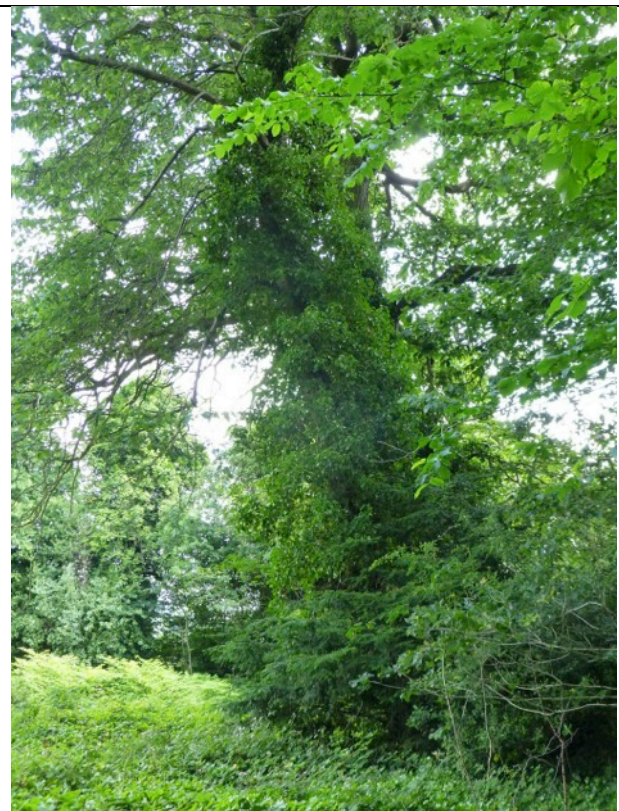
| T36 | <i>Prunus avium</i> | Standard wild cherry, with medium amount of ivy cover. One of the lower branches near the ground has been removed. No obvious holes. | 3 | |

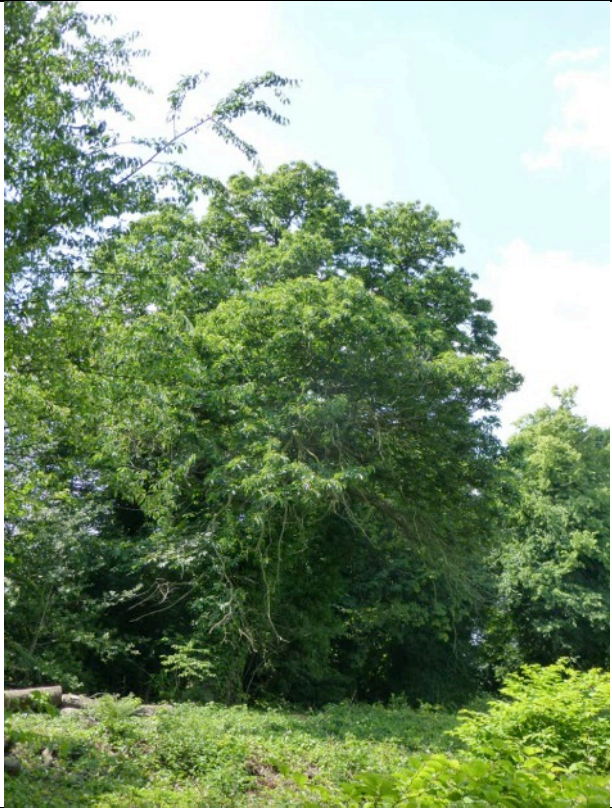
| T37 | <i>Castanea sativa</i> | Very large sweet horse chestnut. The tree is in good condition, although some of the smaller branches are decaying at the tips. Some woodpecker holes higher up. There are couple of locations where branches have fallen off or have been removed. These seem to be blind and there was no evidence of staining or claw marks around the holes. The lower part of the trunk has ivy cover. | 2 | |

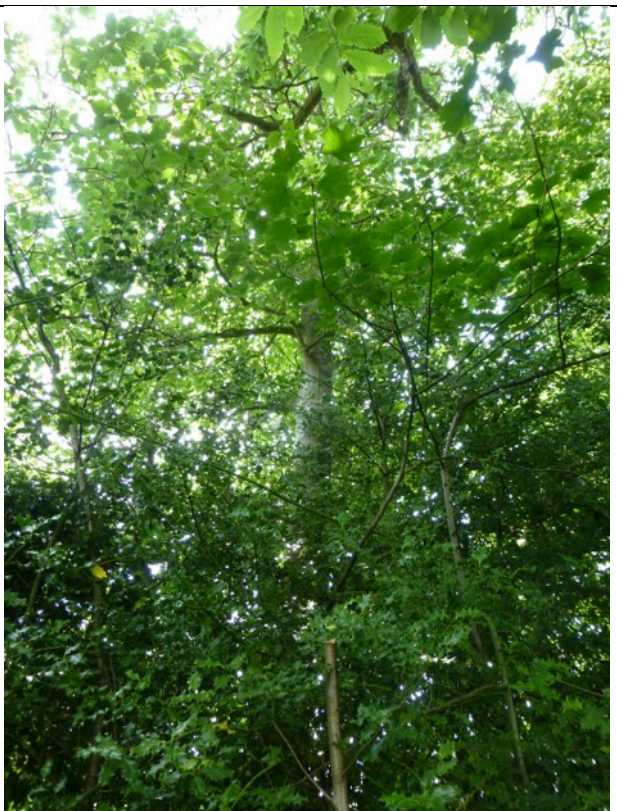
| T39 | <i>Acer pseudoplatanus</i> | A small sycamore. No ivy cover and no obvious holes. One of the lower branches is decaying. | 3 | |

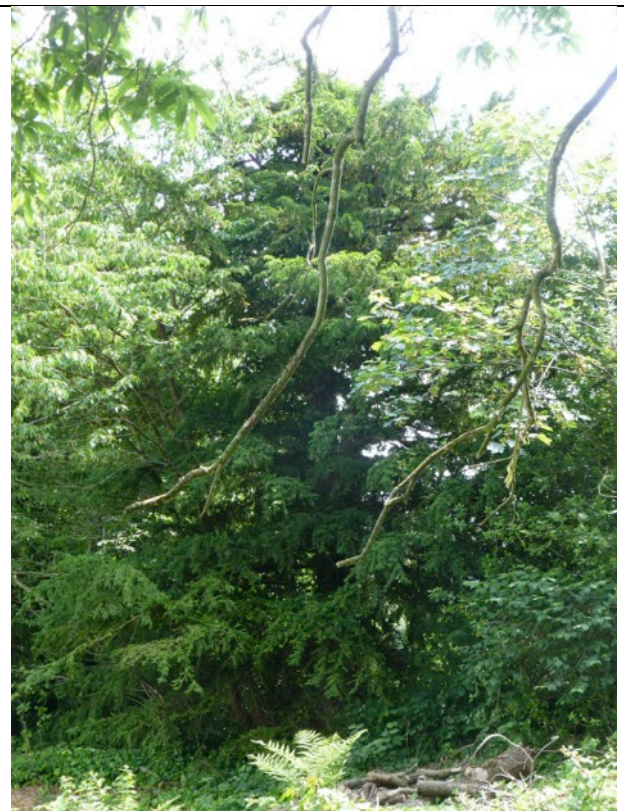
| T40 | <i>Taxus baccata</i> | Young yew tree, with single, well-grown vertical trunk. Very small amount of ivy cover. One small hole at approximately 4m above the ground. No staining and some cobwebs block the hole. | 3 | |

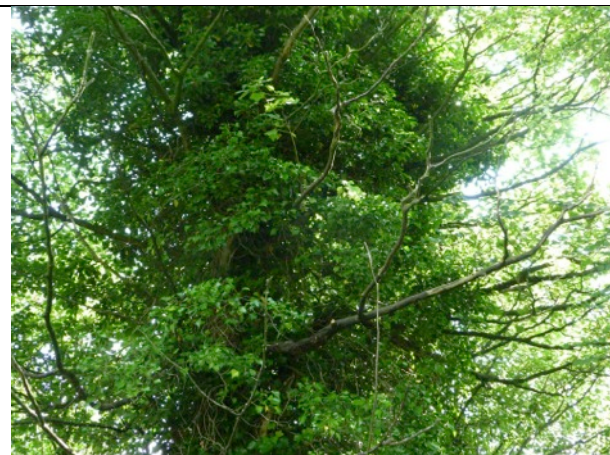
| T41 | <i>Acer pseudoplatanus</i> | Large sycamore with heavy ivy cover. No obvious holes or broken branches. Crevices behind branches could be used by pipistrelles. | 2 | |

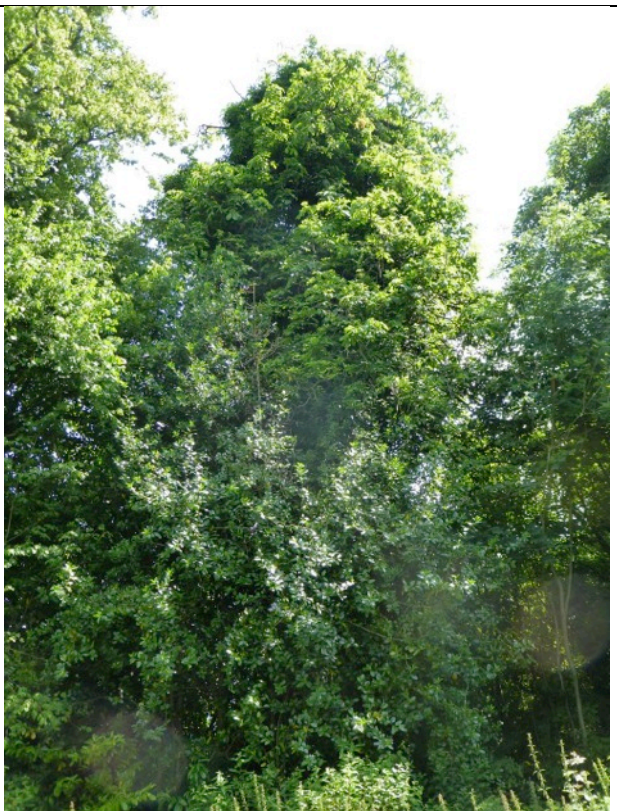
| T42 | <i>Aesculus hippocastanum</i> | Standard horse chestnut tree with dense ivy cover. No obvious holes, but plenty of crevices for bats to shelter. | 2 | |

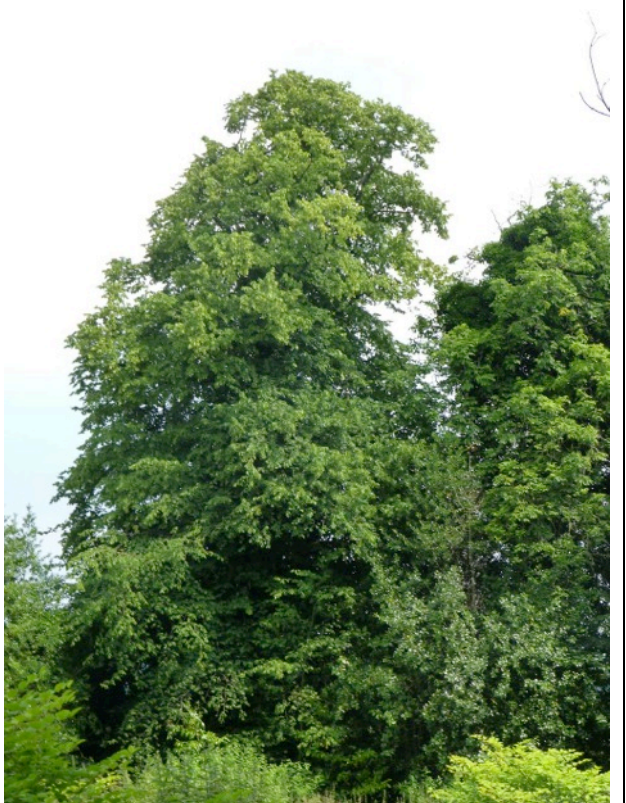
| T43 | <i>Tilia x europaea</i> | A mature lime tree with dense epicormic growth on the lower 5m of the trunk. The tree is branched at the base and at least one branch is broken. There are no obvious holes on the trunk. The tree has a dense clump of shoots at the base, which suggests that it may have been coppiced in the past. The tree could offer cover to bats, but there are better alternatives a short distance away. Predators such as domestic cats can probably reach the lower branches and the epicormic growth may offer little protection in the winter. | 2 | |

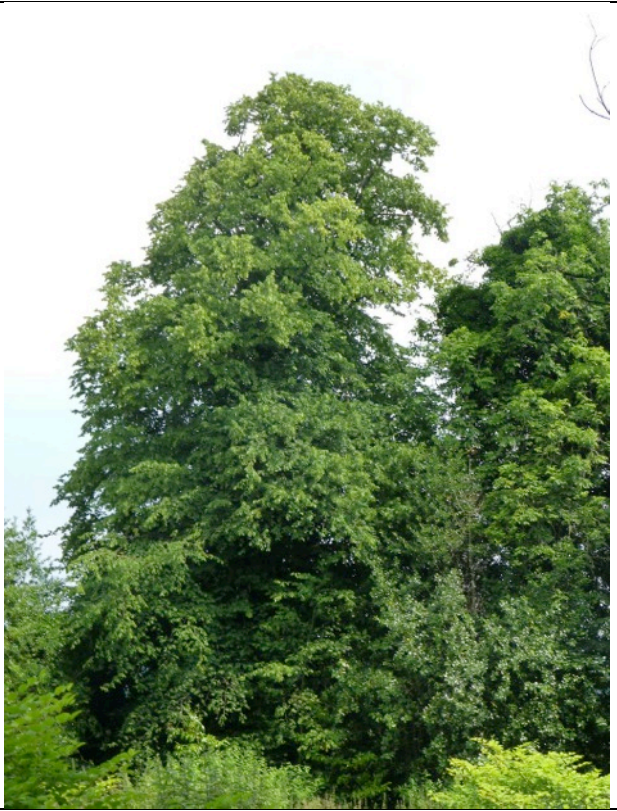
| T44 | <i>Acer pseudoplatanus</i> | A mature standard sycamore tree with dense ivy cover on the trunk. The ivy covers the entire trunk and it is therefore impossible to tell whether there are any holes or broken branches that may have bat potential. Hence cautionary Category 1. | 1 | |
