**Cheshire Ecology Ltd.**

**LAND OFF SUMMERHILL ROAD  
GWERSYLLT, WREXHAM**

**PRELIMINARY BAT SURVEY REPORT**

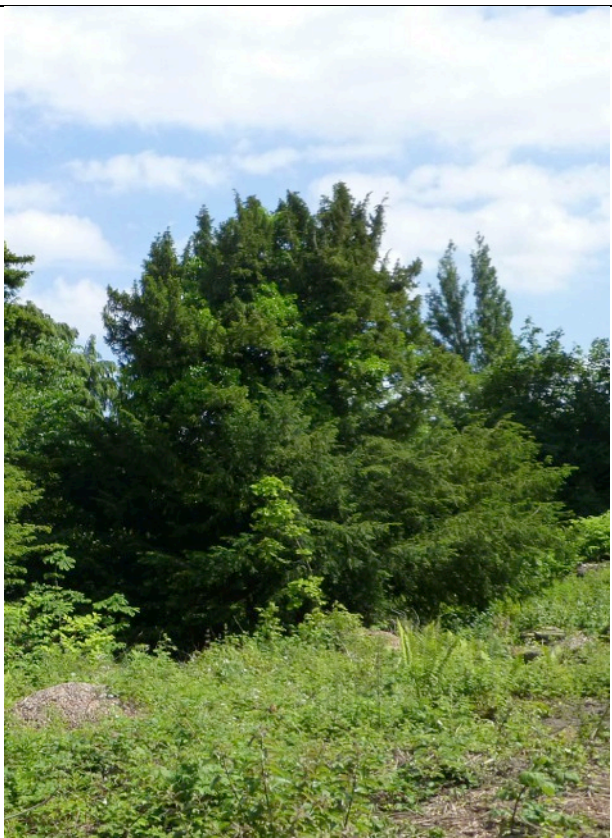
| T45 | <i>Taxus baccata</i> | Yew tree. No bat potential. | 3 | |

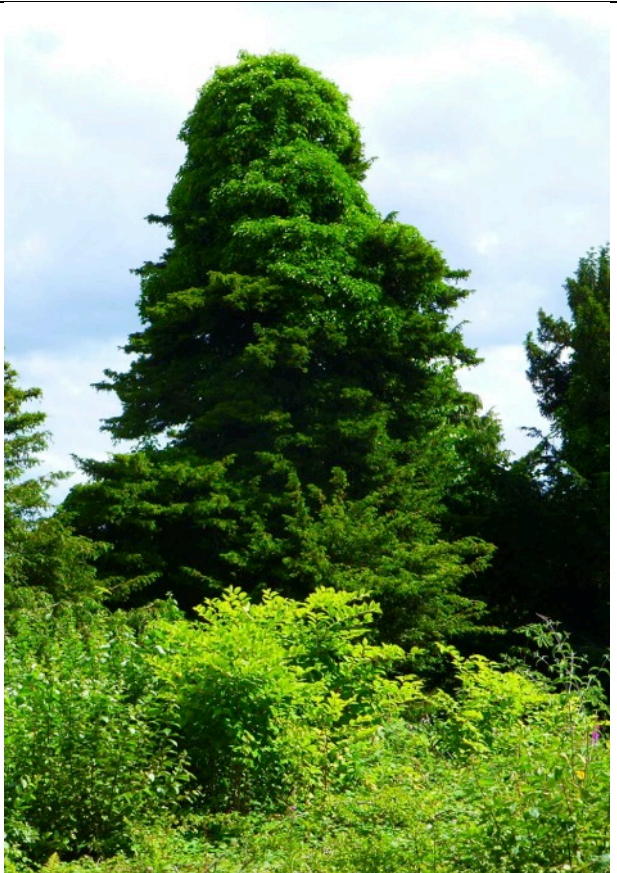
| T47 | <i>Taxus baccata</i> | Yew tree. No bat potential. | 3 | |

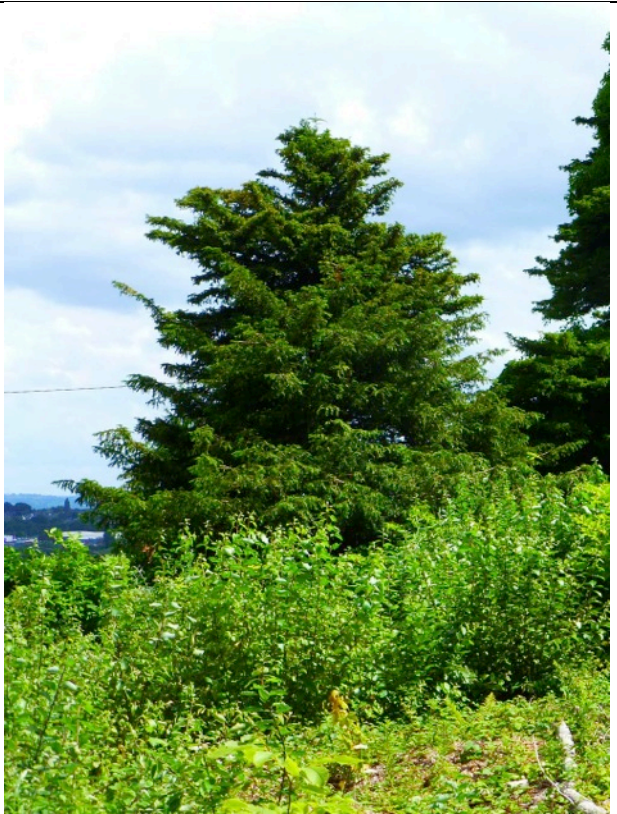
| T48 | <i>Taxus baccata</i> | Yew tree. No bat potential. | 3 | |

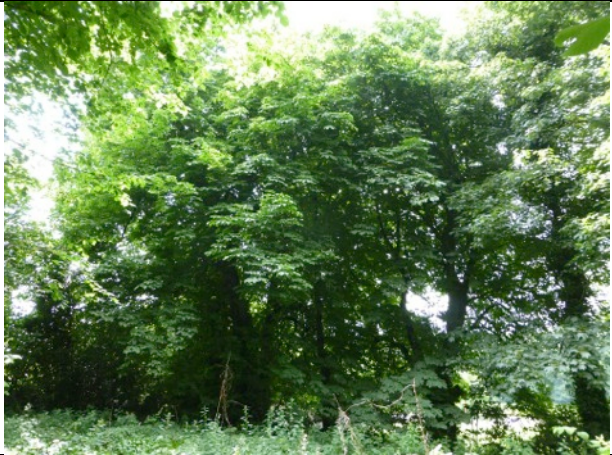
| G1 | <i>Aesculus hippocastanum</i> | A small group of five horse chestnut trees. All of the trees are of a similar age and have presumably been planted. Most have occasional branches missing. One has some ivy cover and others have flaking bark. No obvious holes though. | 3 | |

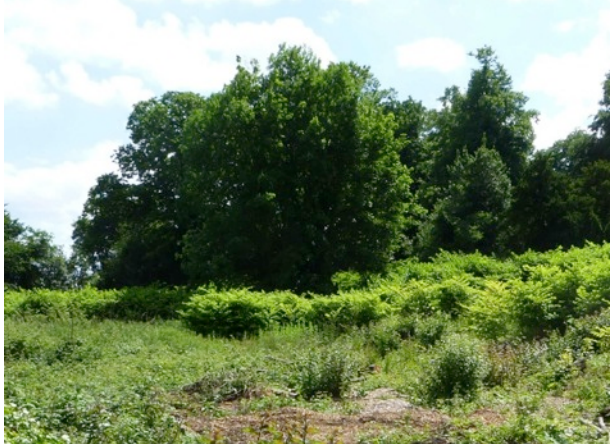
| G2 | <i>Acer pseudoplatanus</i> | Coppiced sycamore tree. No bat potential. | 3 | |
