## **PLANNING APPLICATION ASSESSMENT SURVEY – PENUEL CHAPEL, PANDY.**

**Site:** Penuel Chapel  
Pandy hafod Y garreg  
Glyn Ceiriog  
Wrexham  
LL20 7NT

**Job No:** 0746 – Penuel Chapel Report – v1

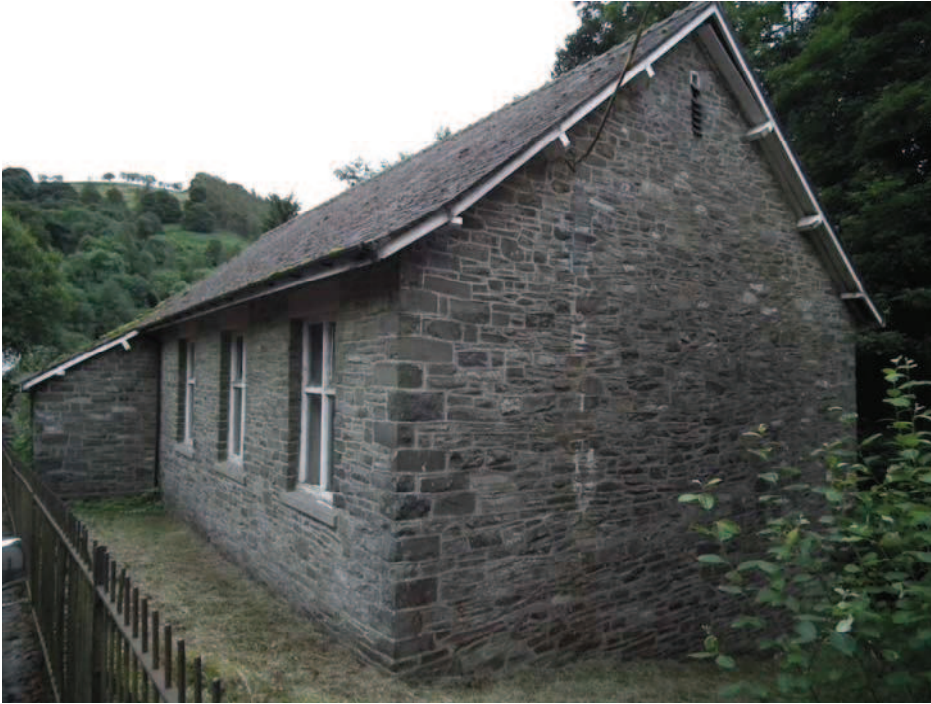
Photo 1 - Photograph of the site looking south east.

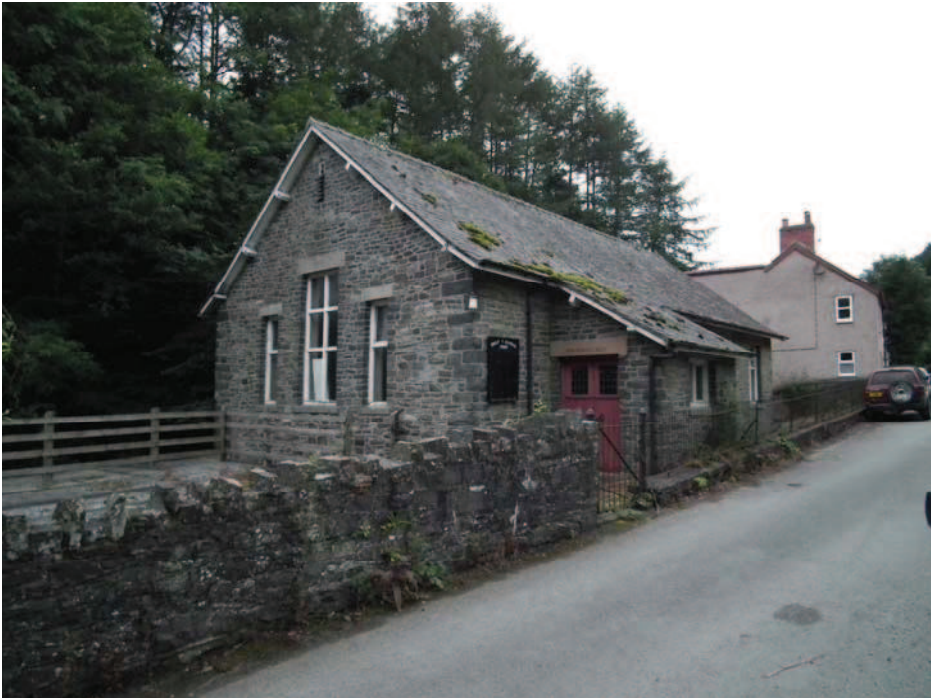
Photo 2 - Photograph of the site looking south west.
