Mr and Mrs Piggott

Hugmore House  
Hugmore Lane, Llan-y-pwll LL13 9YE

Bat and Bird Survey Report

August 2024

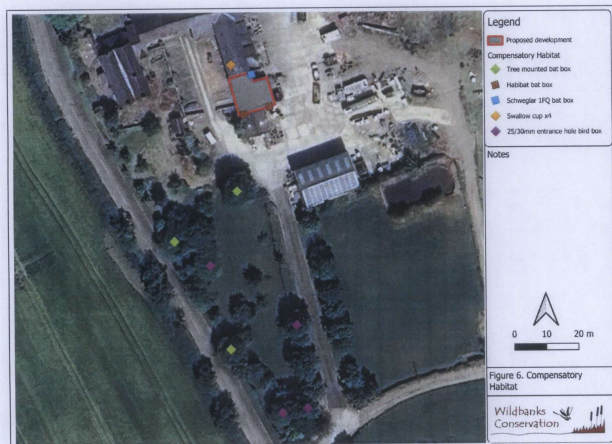
Figure 6: Location of compensatory habitat.

- 4.8.4 Internal features within the barn, that are used or have potential to be used, by small birds and swallows will be destroyed through the development. Supplementary nesting boxes will be installed within the copse to the southwest of the barn. In the form of:

- 2 x 25mm entrance hole boxes (such as Vivaro Pro nest box)
- 2 x 30mm entrance hole boxes

- 4.8.5 Nesting features for swallows will also be created through the development and these will be left available post construction. Four supplementary swallow cups will be added to the beams within the barn adjacent to Building B1 before 01/03/25 to encourage individuals to nest within this area and not within Building B1.
