# Environmental Statement

## Appendix 10.1: Phase I Geoenvironmental Site Assessment

### Land at Ruthin Road, Wrexham

# PHASE I GEOENVIRONMENTAL SITE ASSESSMENT

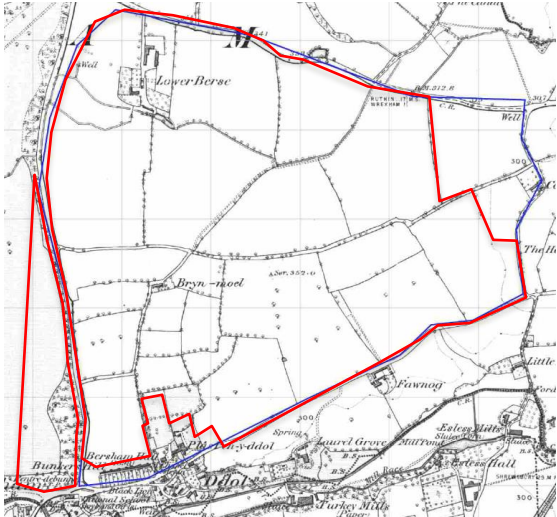
| MAP EDITION | HISTORICAL LAND USE | HISTORICAL MAP EXCERPT |
|---|---|---|
| 1872<br>1:10,560 | <p>Lower Berse Farm and Bryn-Moel are both already constructed in the north and centre of the site.</p> <p>The area is split up into agricultural land with numerous field boundaries. A wooded area is shown in the western sector.</p> <p>There is a road running through the centre of the site and a branch leading south that feeds Bryn-Moel. A footpath is marked through the centre of the site.</p> <p>A well is recorded on-site in the northwest. A pond is present to the south of Lower Berse Farm leading to a drain and two further ponds are present in the south of the site.</p> | |

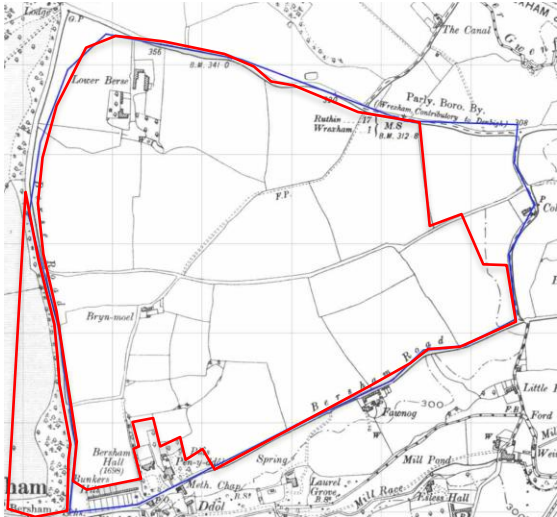
| MAP EDITION | HISTORICAL LAND USE | HISTORICAL MAP EXCERPT |
|---|---|---|
| 1898-1900<br>1:10,560 | <p>The well in the northwest is no longer marked and a well is now recorded to the south of Lower Berse Farm.</p> <p>A field boundary in the southwest is no longer present and the small ponds in the south are no longer shown.</p> | |

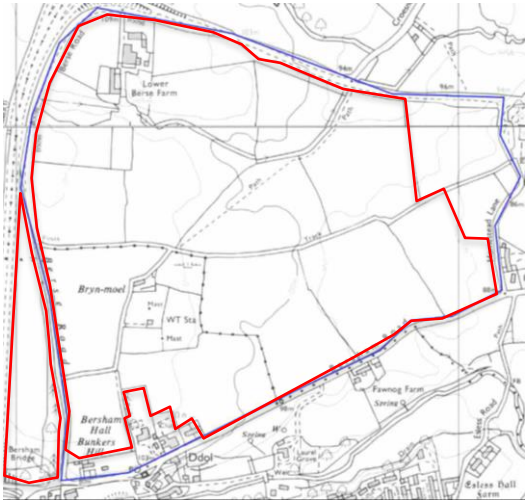
| MAP EDITION | HISTORICAL LAND USE | HISTORICAL MAP EXCERPT |
|---|---|---|
| <p><b>1992</b><br/><b>1:10,000</b></p> | <p>A track leading from the south of Lower Berse farm has been added.</p> <p>The large pond in the north is no longer recorded.</p> | |

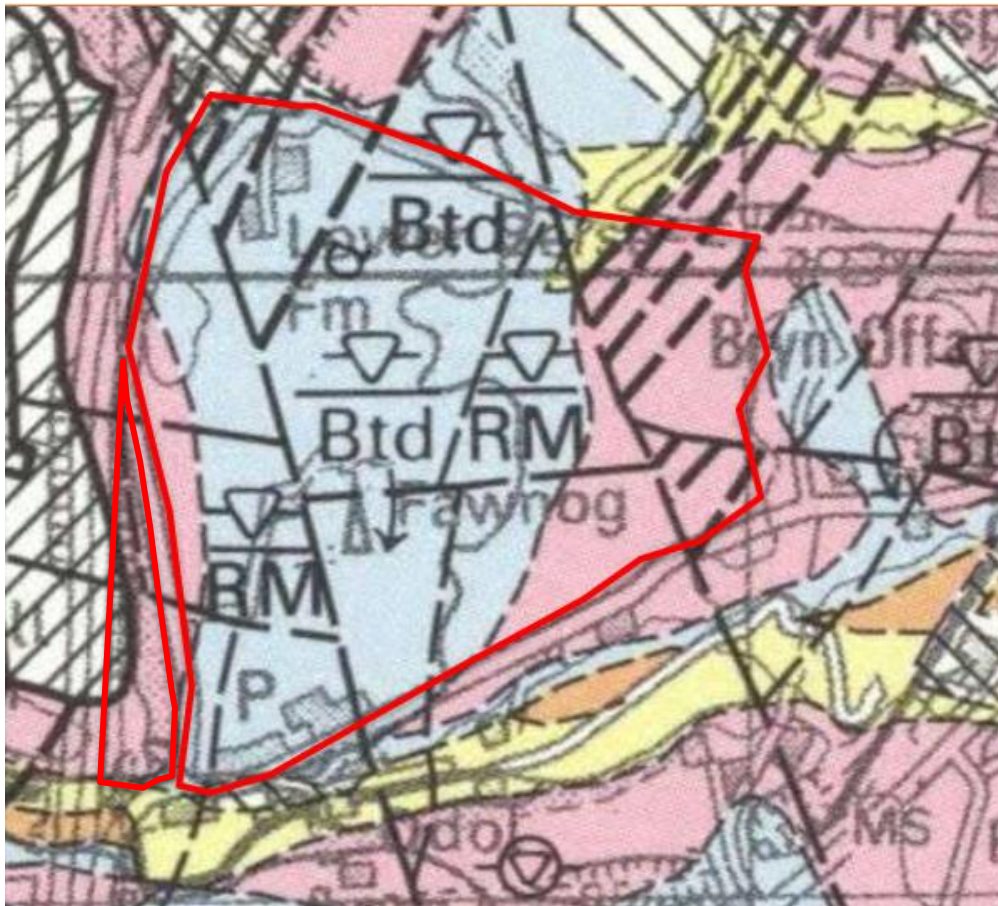
FIGURE 4.2 PHOTOGRAPH OF THE 1:50,000 PLAN FOR THE SITE

Figure 4.2 is a photograph of the 1:50,000 plan for the site which shows coal outcrops inferred in the north, northeast and southeast of the site. The site is heavily faulted.

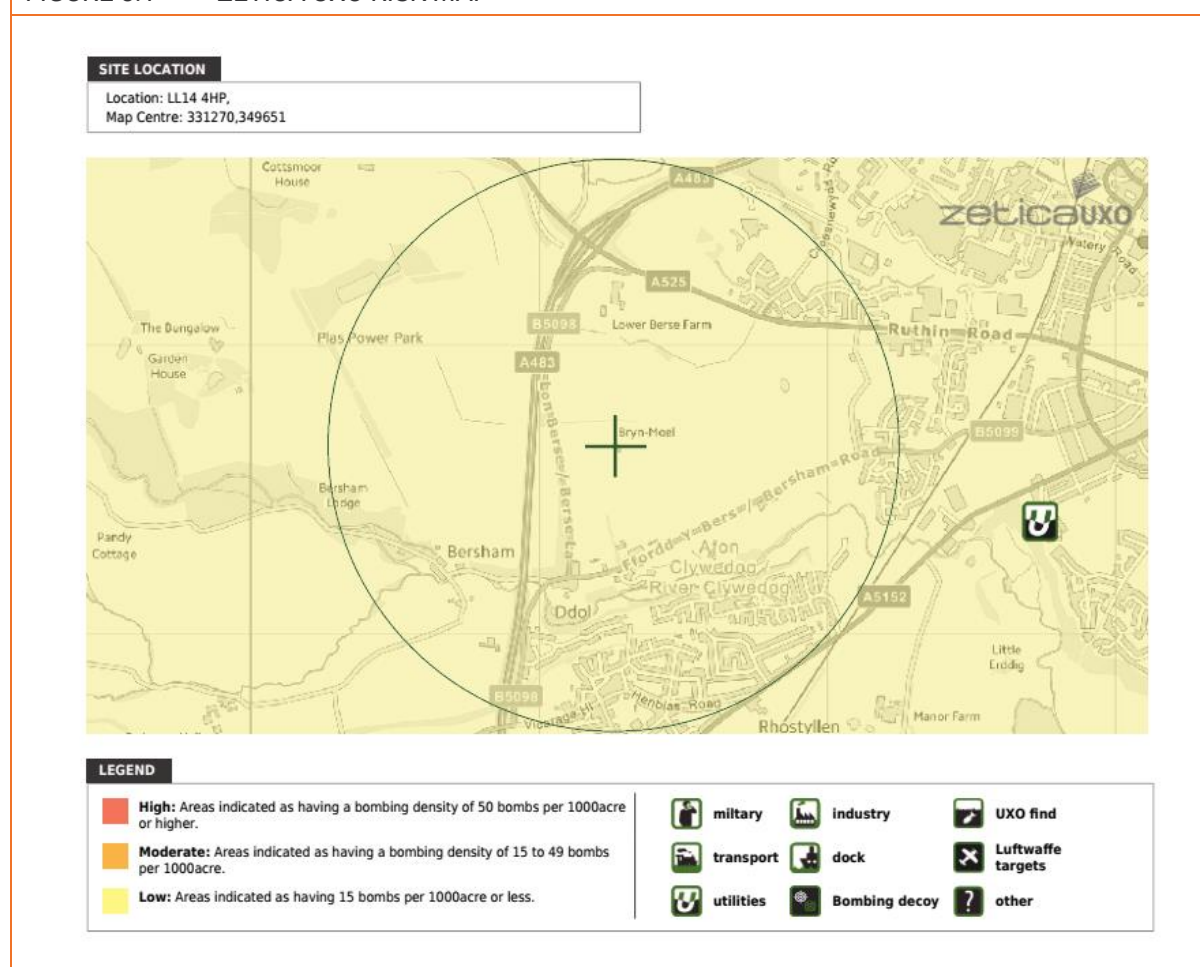
FIGURE 5.1 ZETICA UXO RISK MAP

The regional unexploded bomb risk map from Zetica (2014) indicates that the site is in an area at low risk from possible unexploded ordnance (UXO) resulting from the Second World War. The Zetica UXO Risk Map is presented as Figure 5.1. No further assessment is required.

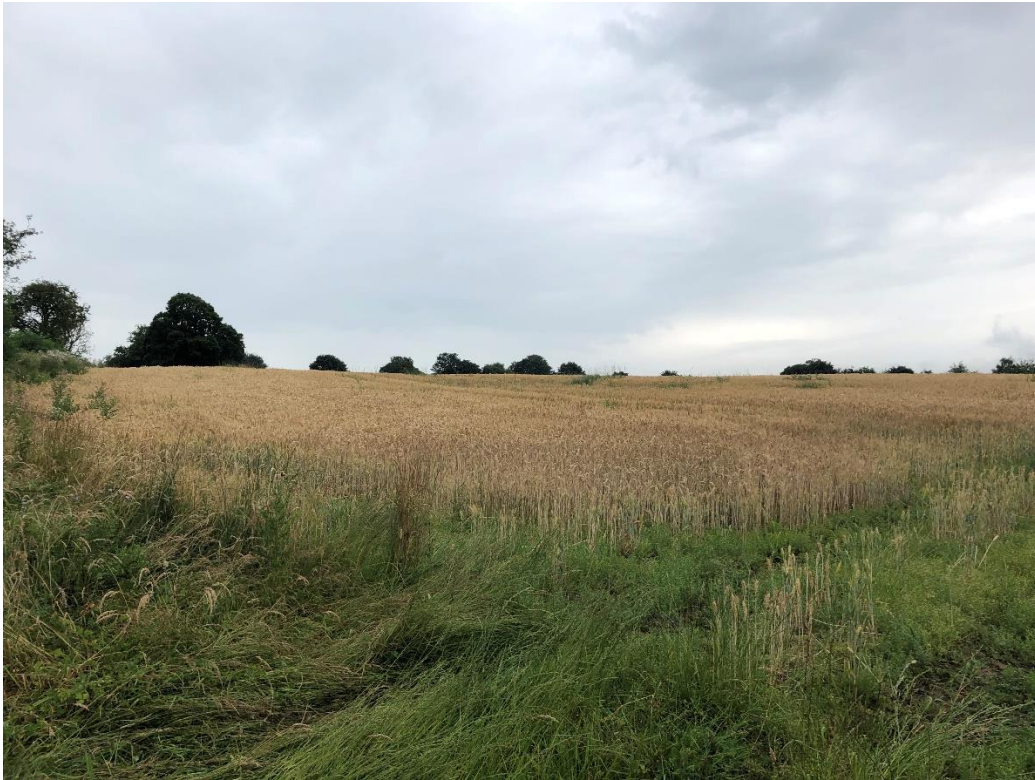
PLATE 1 – GENERAL SURFACE CONDITIONS THROUGH NORTHERN FIELDS
