## Appendix 10.1: Phase I Geoenvironmental Site Assessment

### Land at Lower Berse Farm, Wrexham

Phase I Geoenvironmental Site Assessment  
Ruthin Road, Wrexham

Reference: 14-854-R3-Rev E  
Date: June 2024

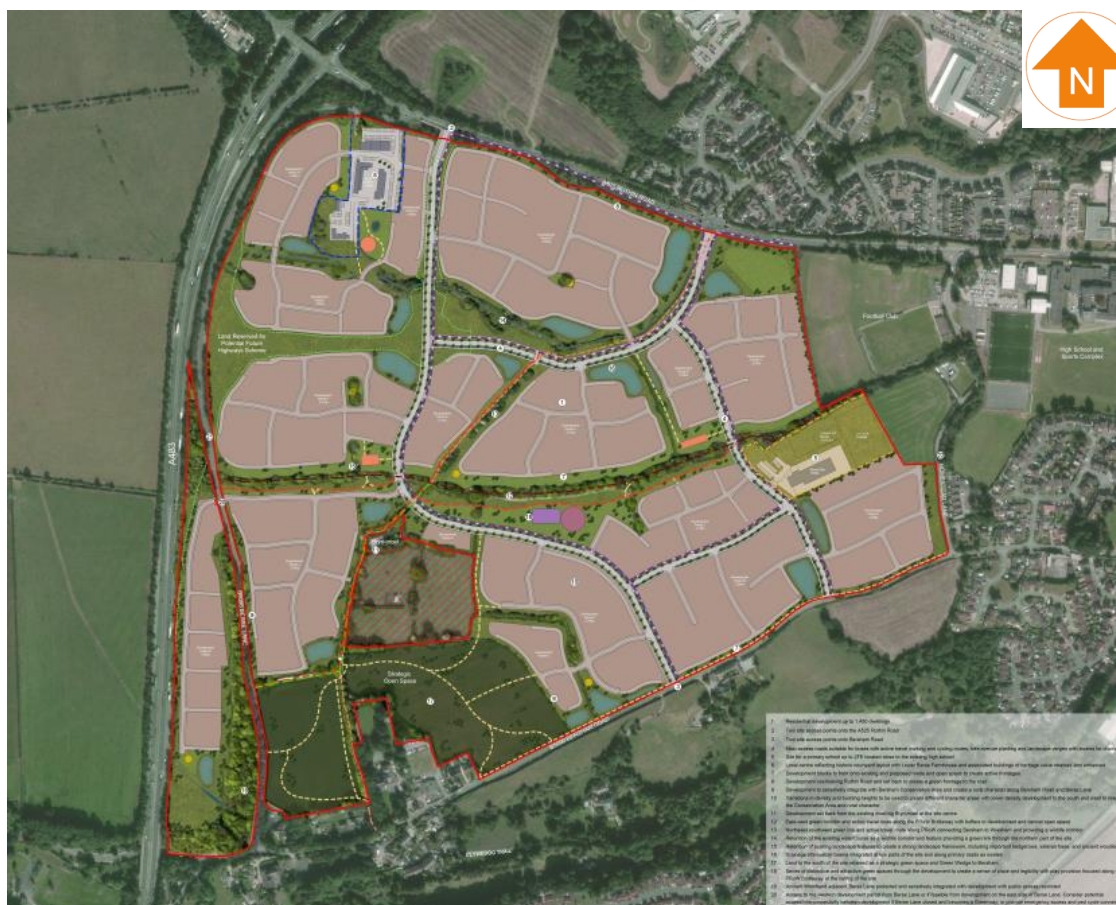
FIGURE 1.1 SNAPSHOT OF PROPOSED DEVELOPMENT

A snapshot of the proposed development layout is indicated in Figure 1.1.

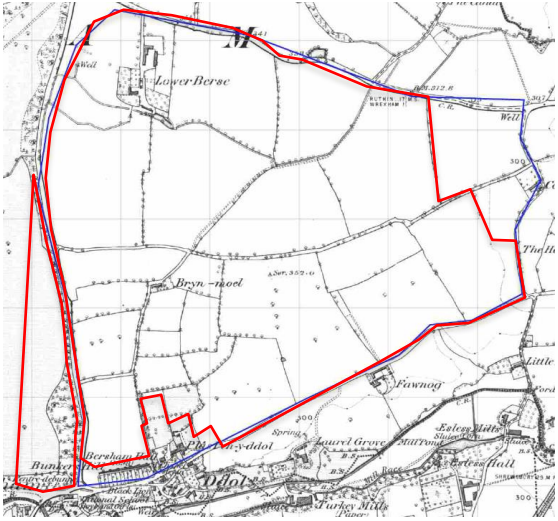
| MAP EDITION | HISTORICAL LAND USE | HISTORICAL MAP EXCERPT |
|---|---|---|
| 1872<br>1:10,560 | <p>Lower Berse Farm and Bryn-Moel are both already constructed in the north and centre of the site.</p> <p>The area is split up into agricultural land with numerous field boundaries. A wooded area is shown in the western sector.</p> <p>There is a road running through the centre of the site and a branch leading south that feeds Bryn-Moel. A footpath is marked through the centre of the site.</p> <p>A well is recorded on-site in the northwest. A pond is present to the south of Lower Berse Farm leading to a drain and two further ponds are present in the south of the site.</p> | |

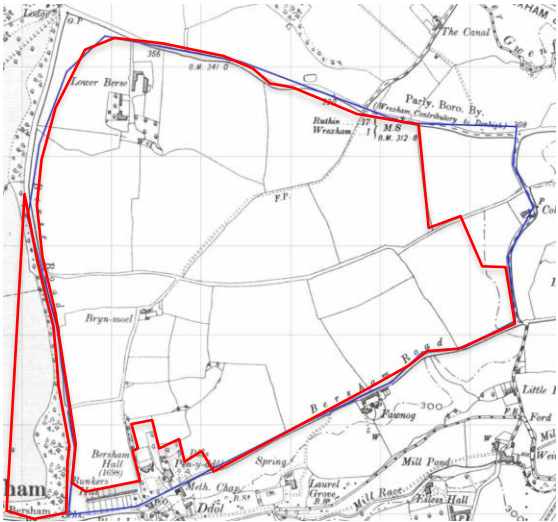
| MAP EDITION | HISTORICAL LAND USE | HISTORICAL MAP EXCERPT |
|---|---|---|
| 1898-1900<br>1:10,560 | <p>The well in the northwest is no longer marked and a well is now recorded to the south of Lower Berse Farm.</p> <p>A field boundary in the southwest is no longer present and the small ponds in the south are no longer shown.</p> | |

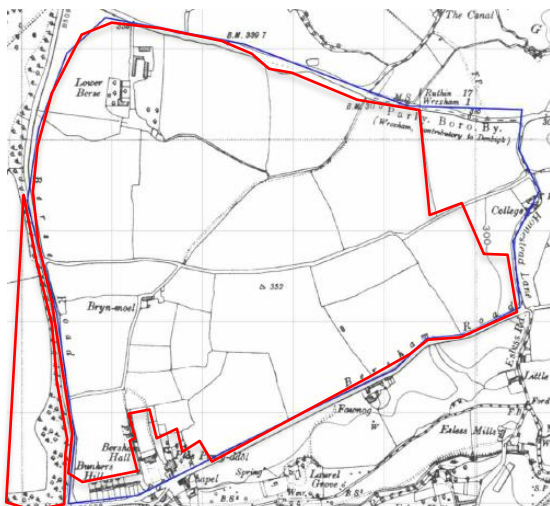
| MAP EDITION | HISTORICAL LAND USE | HISTORICAL MAP EXCERPT |
|---|---|---|
| <p><b>1938</b><br/><b>1:10,560</b></p> | <p>A small pond is shown in the central southern sector. The well is no longer marked.</p> <p>A footpath is present east of Bersham Hall.</p> <p>There are no further changes.</p> | |

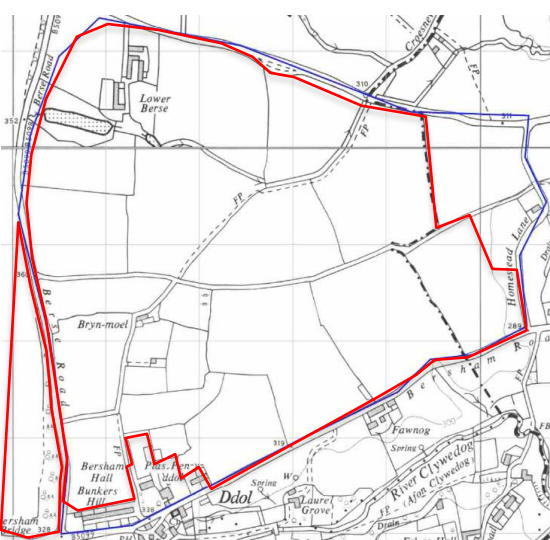
| MAP EDITION | HISTORICAL LAND USE | HISTORICAL MAP EXCERPT |
|---|---|---|
| <p><b>1964</b><br/><b>1:10,560</b></p> | <p>A large pond is shown to the southwest of Lower Berse Farm. The small pond in the central southern sector is no longer shown.</p> <p>A field boundary has been added in the northwest and a field boundary has been removed in the southeast.</p> | |

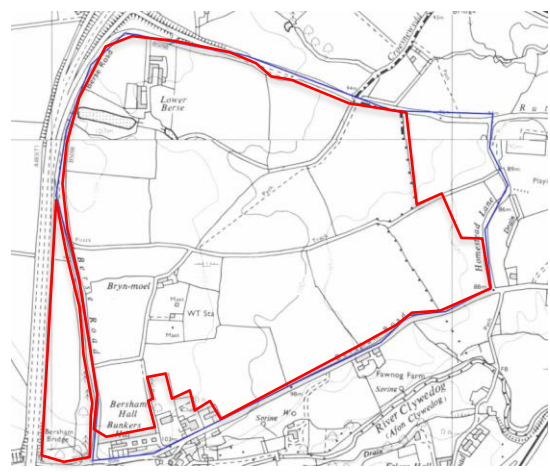
| MAP EDITION | HISTORICAL LAND USE | HISTORICAL MAP EXCERPT |
|---|---|---|
| <p><b>1974-1979</b><br/><b>1:10,560</b></p> | <p>A wireless electricity station has been constructed next to Bryn-Moel. Two masts are shown.</p> <p>A field boundary in the southwest has been removed.</p> | |

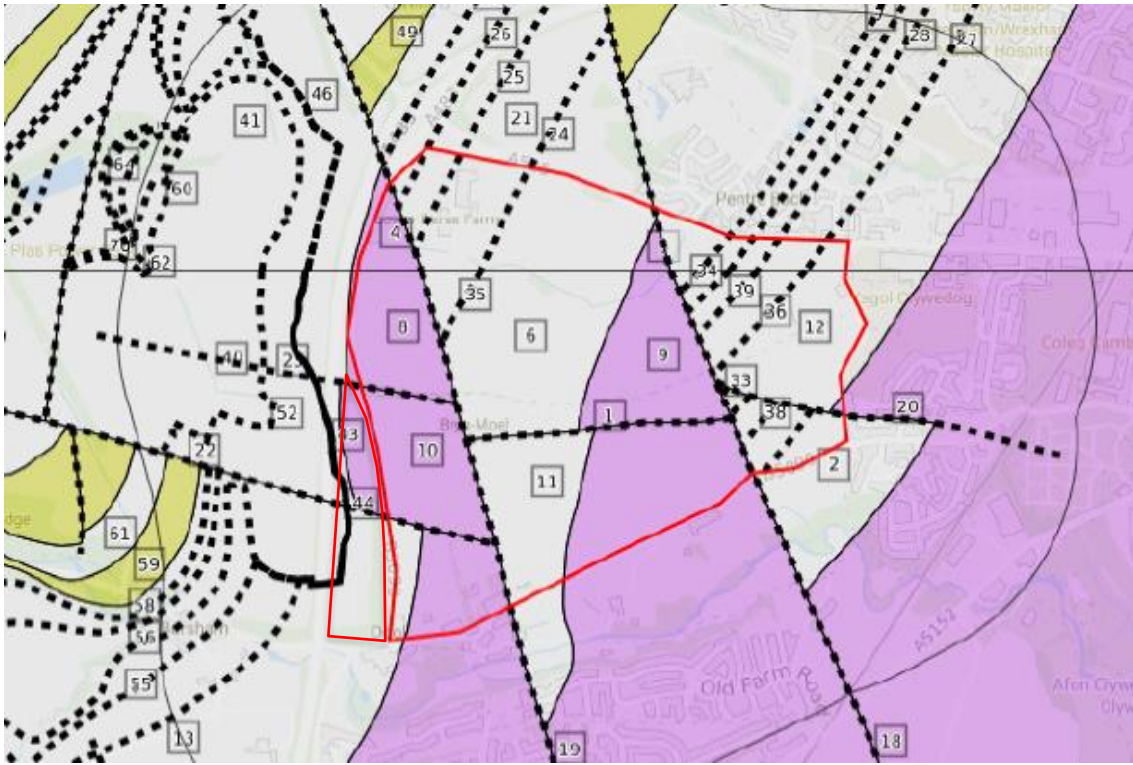
TABLE 4.3 FAULTING

| | |
|---|---|
| <b>Fault 1 – On site</b> | Normal fault, inferred (from Geological sequence) |

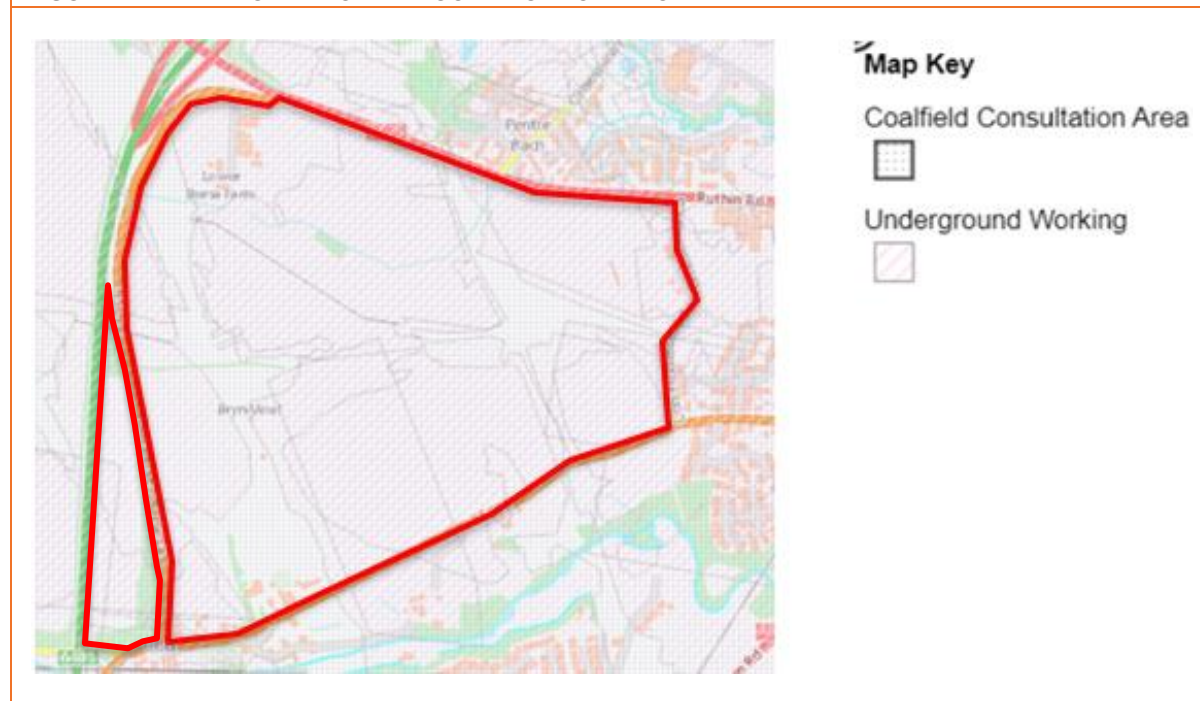
FIGURE 4.1 EXCERPT OF THE COAL AUTHORITY ONLINE VIEWER

In the first instance, E3P has reviewed the Coal Authority Online Viewer and an excerpt of this is presented as Figure 4.1. This map shows recorded underground workings across much of the site, however there are no past shallow mine workings or probable shallow workings. The rate of dip is recorded as between 0.4 – 7.0 degrees. No outcrops are shown, however, BGS mapping shows inferred coal seams on site. No mine entries are recorded in the vicinity of the site.

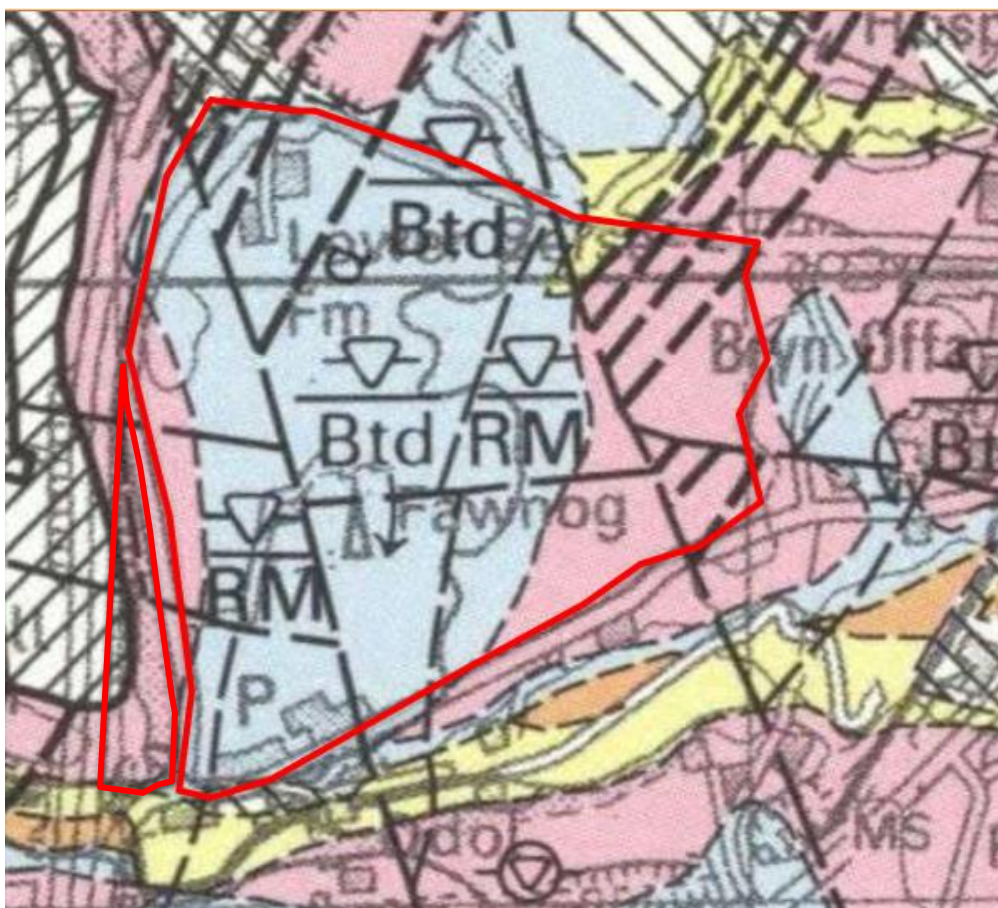
FIGURE 4.2 PHOTOGRAPH OF THE 1:50,000 PLAN FOR THE SITE

Figure 4.2 is a photograph of the 1:50,000 plan for the site which shows coal outcrops inferred in the north, northeast and southeast of the site. The site is heavily faulted.

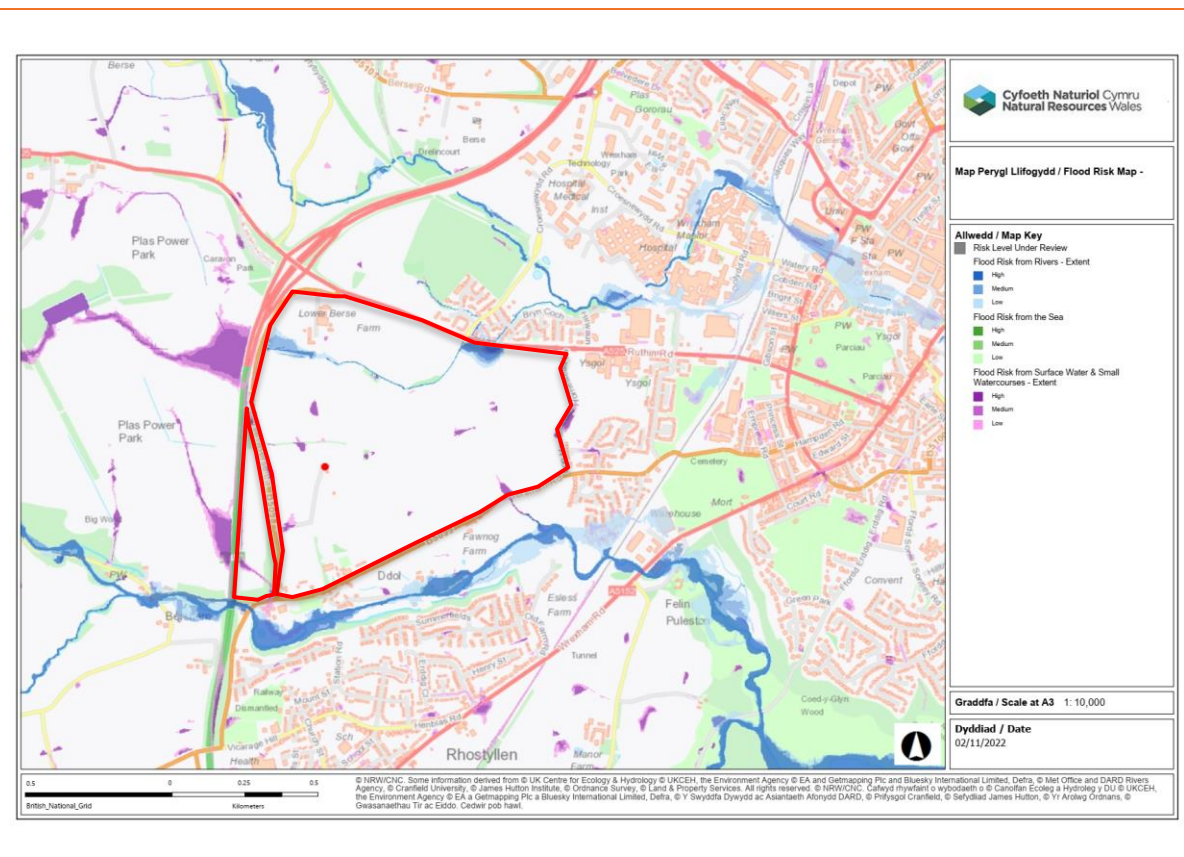
FIGURE 4.3 NRW FLOOD RISK MAP

Based on the local topography, the location of surface watercourses and the presence of several drainage ditches and streams within the site boundary, it is considered likely that shallow groundwater, if present, will flow in a south-easterly direction, following the topographical gradient towards the River Clywedog in the south.

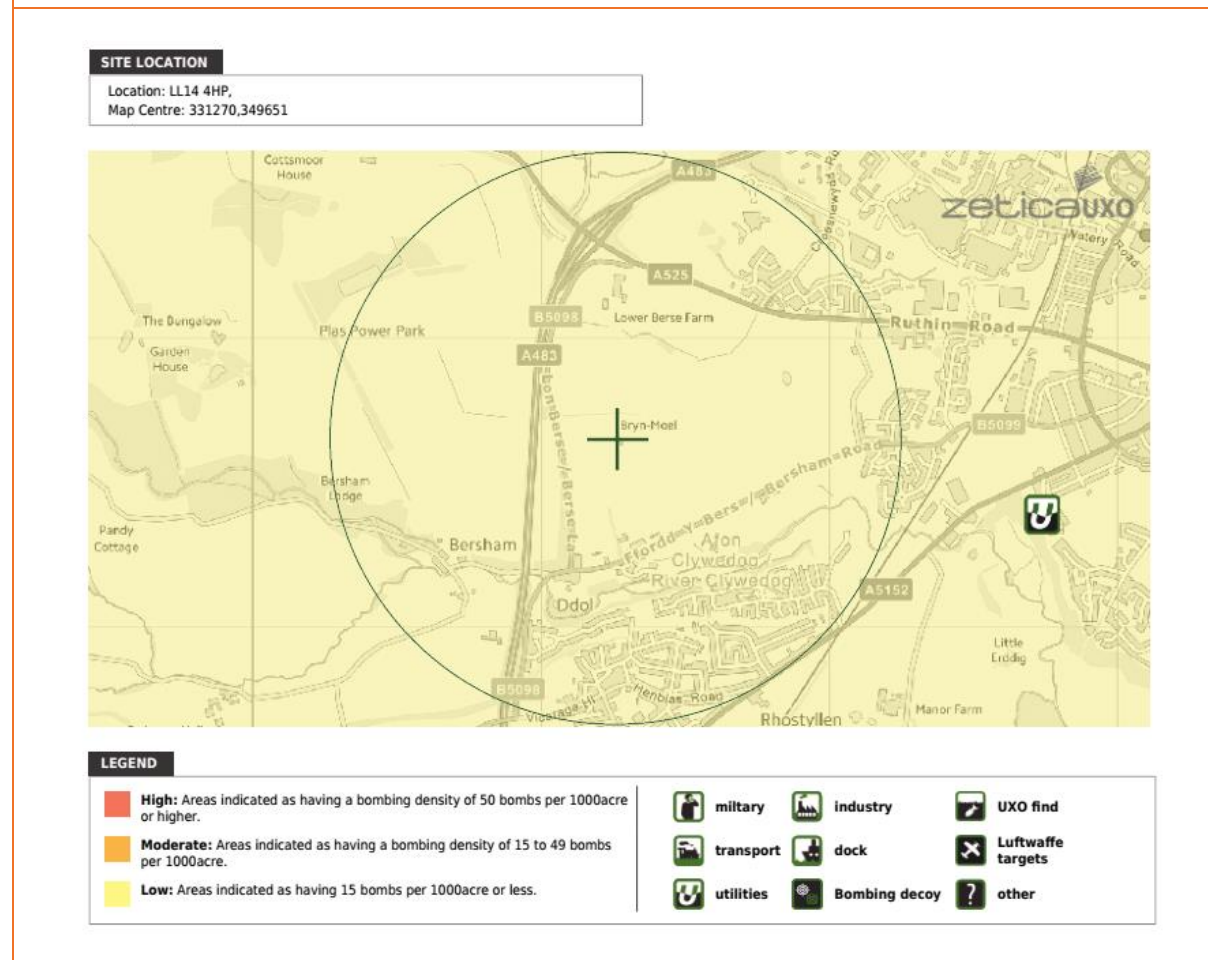
FIGURE 5.1 ZETICA UXO RISK MAP

The regional unexploded bomb risk map from Zetica (2014) indicates that the site is in an area at low risk from possible unexploded ordnance (UXO) resulting from the Second World War. The Zetica UXO Risk Map is presented as Figure 5.1. No further assessment is required.

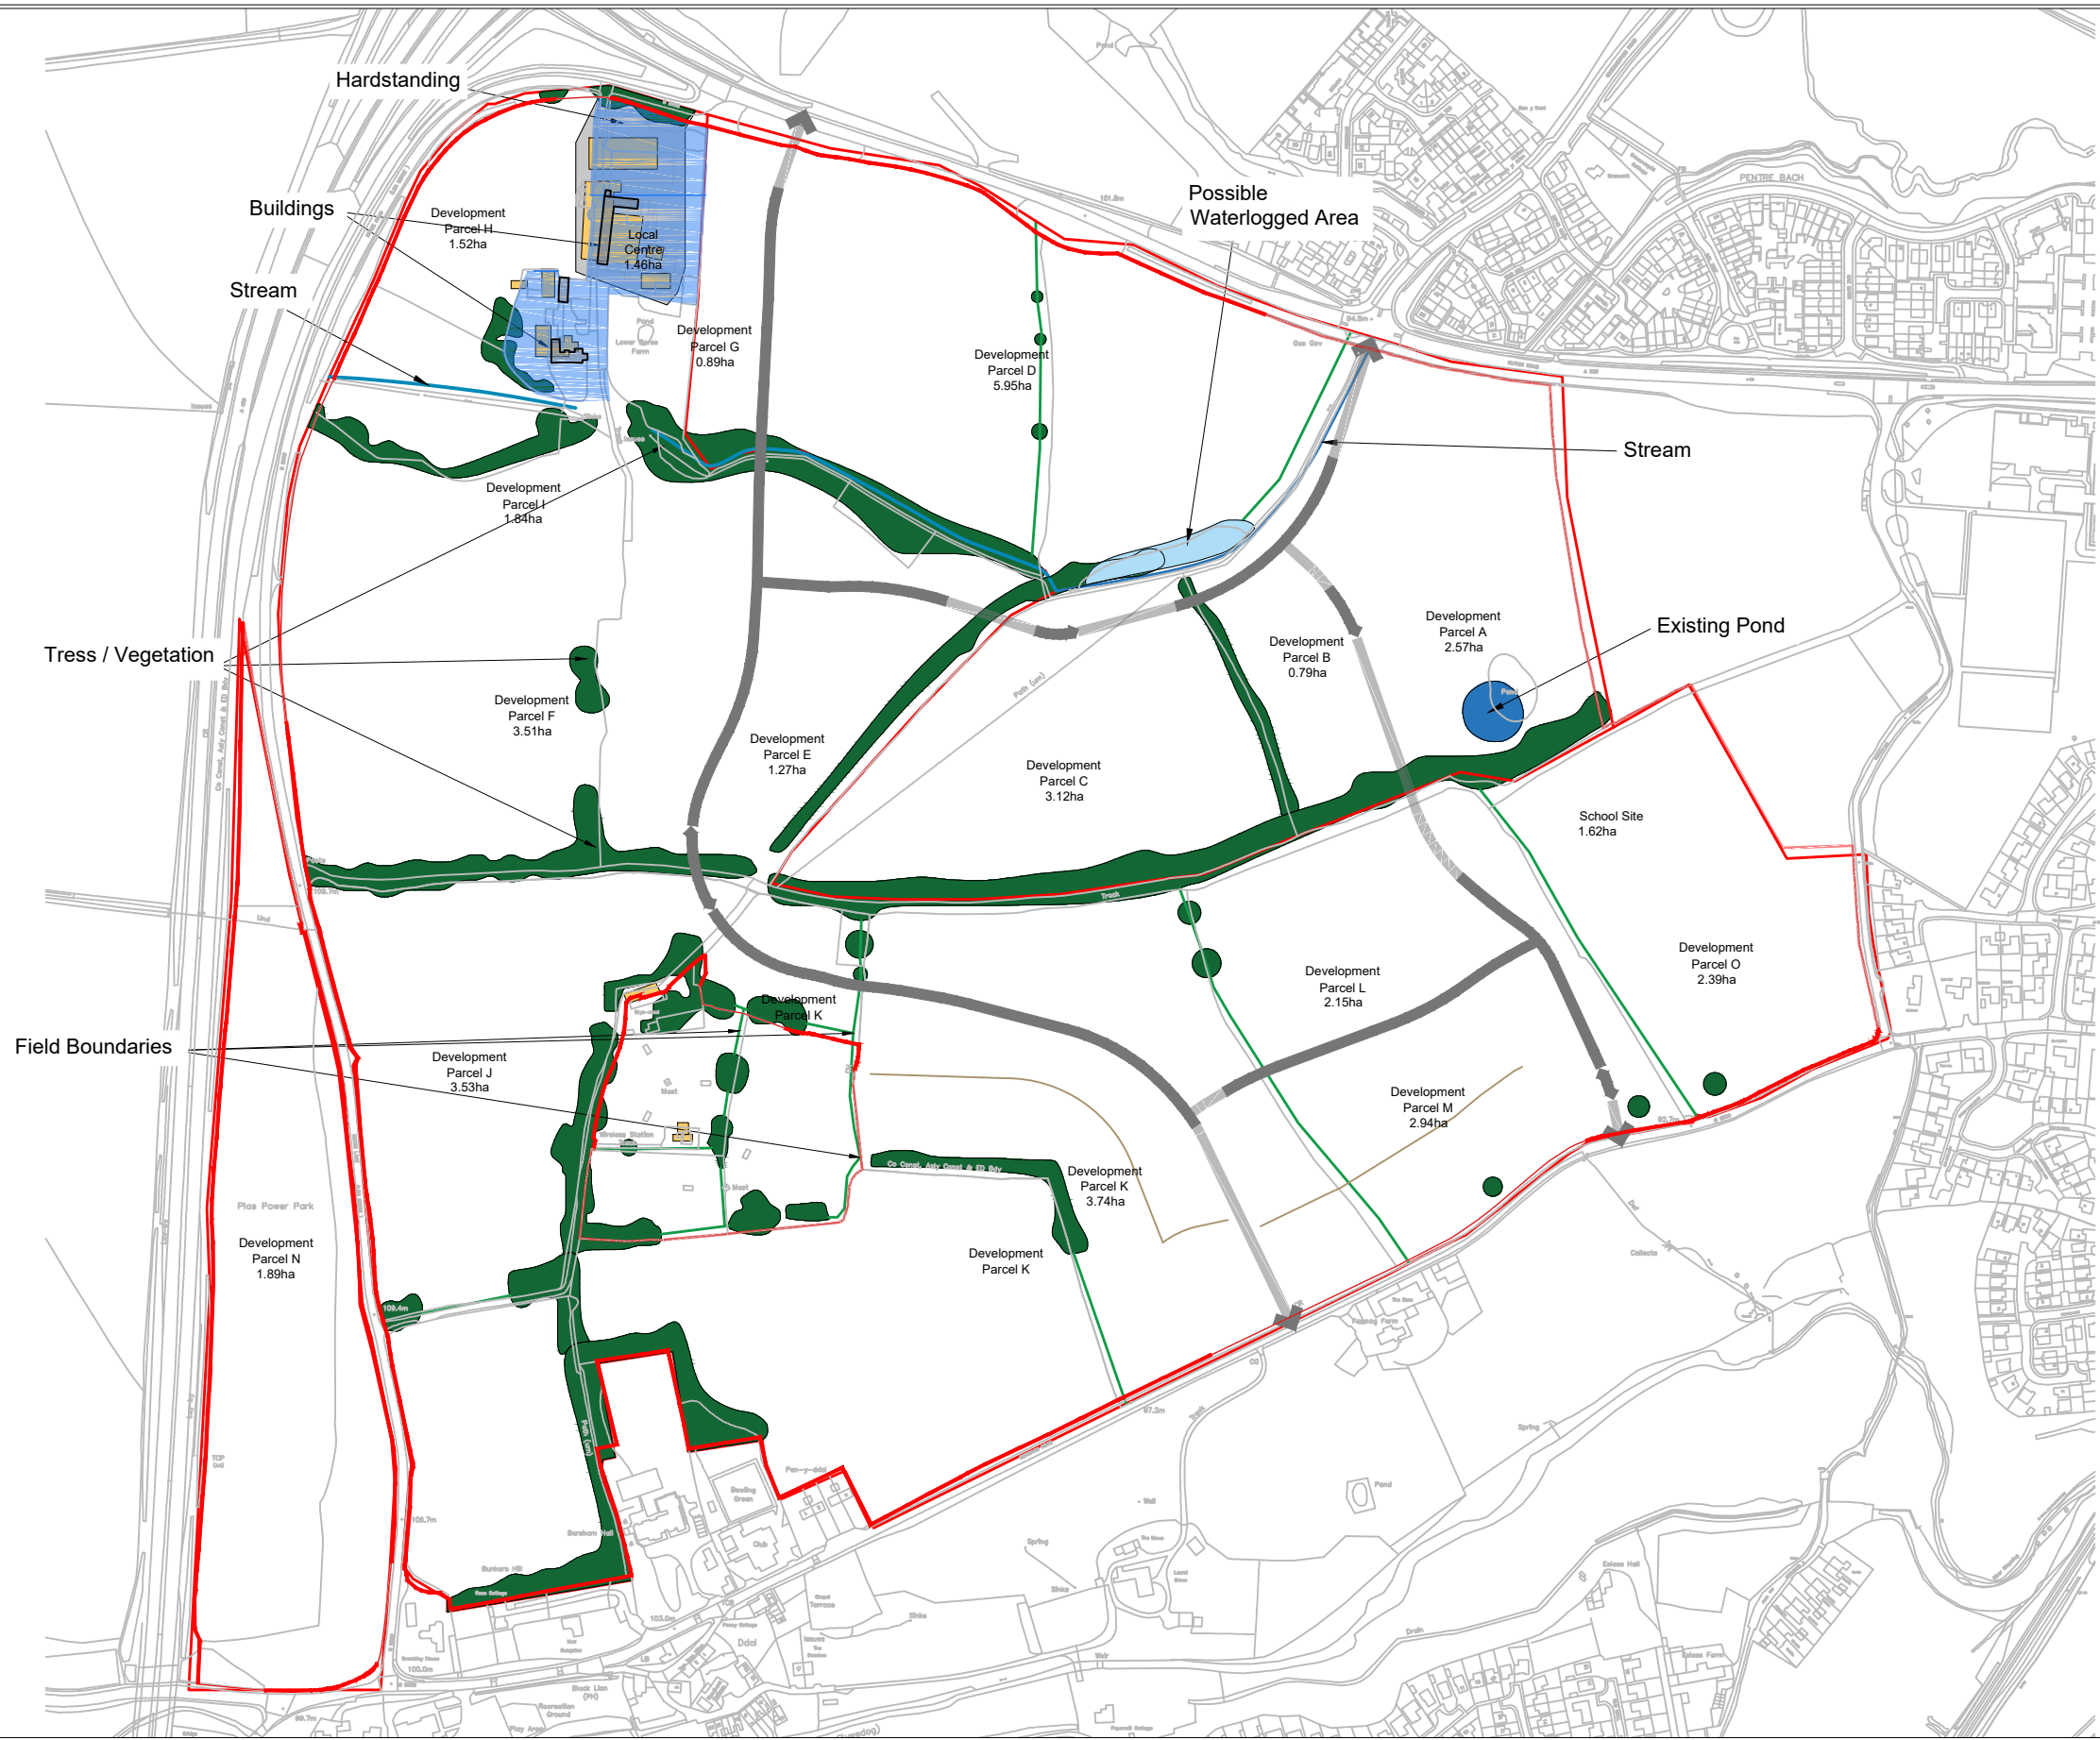
| <div>Site Features</div> <div><div><div></div><div>Buildings</div></div><div><div></div><div>Hardstanding</div></div><div><div></div><div>Field Boundaries</div></div><div><div></div><div>Trees / Vegetation</div></div><div><div></div><div>Pond</div></div><div><div></div><div>Possible Waterlogged Area</div></div><div><div></div><div>Stream</div></div></div> | <div>Notes:</div> | | | | | <div>Client:</div> <div>Redrow</div> | | <div>Job No:</div> <div>14-854</div> | | <div>Date:</div> <div>26.06.2024</div> | | <div><div><div></div><div>e3p</div></div><div>Environmental Engineering Partnership Ltd<br/>Taylor Road, Trafford Park<br/>Urmston, Manchester, M41 7JQ<br/>Tel: 0161 707 9612<br/>E-mail: info@e3p.co.uk<br/>Website: www.e3p.co.uk</div></div> | | |

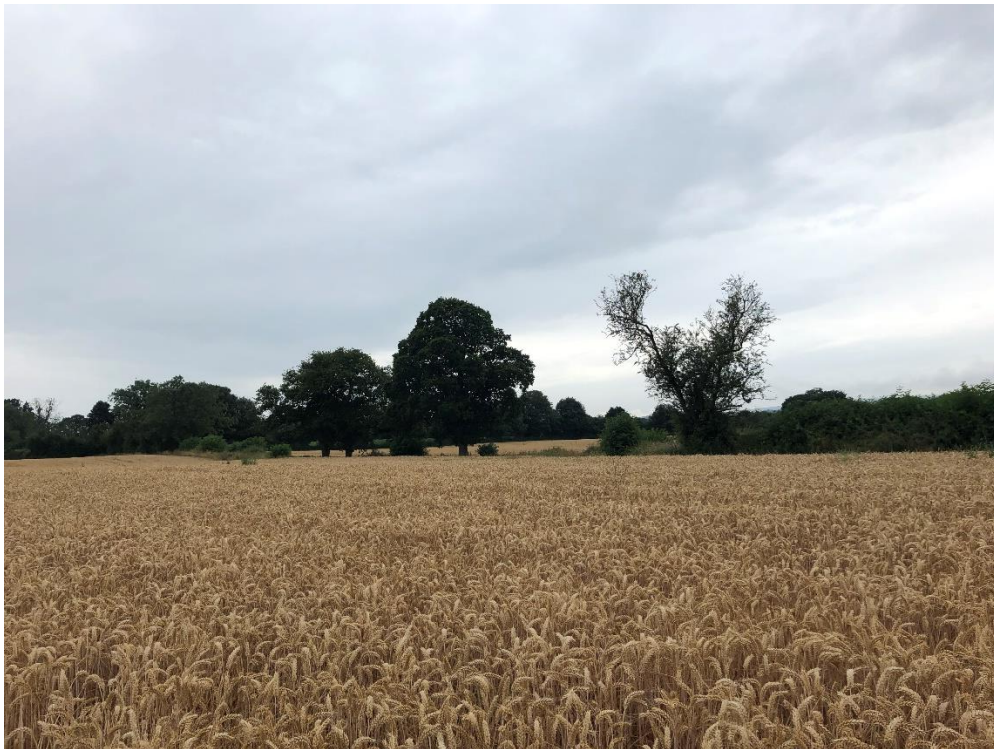
PLATE 2 – GENERAL SITE COVERAGE

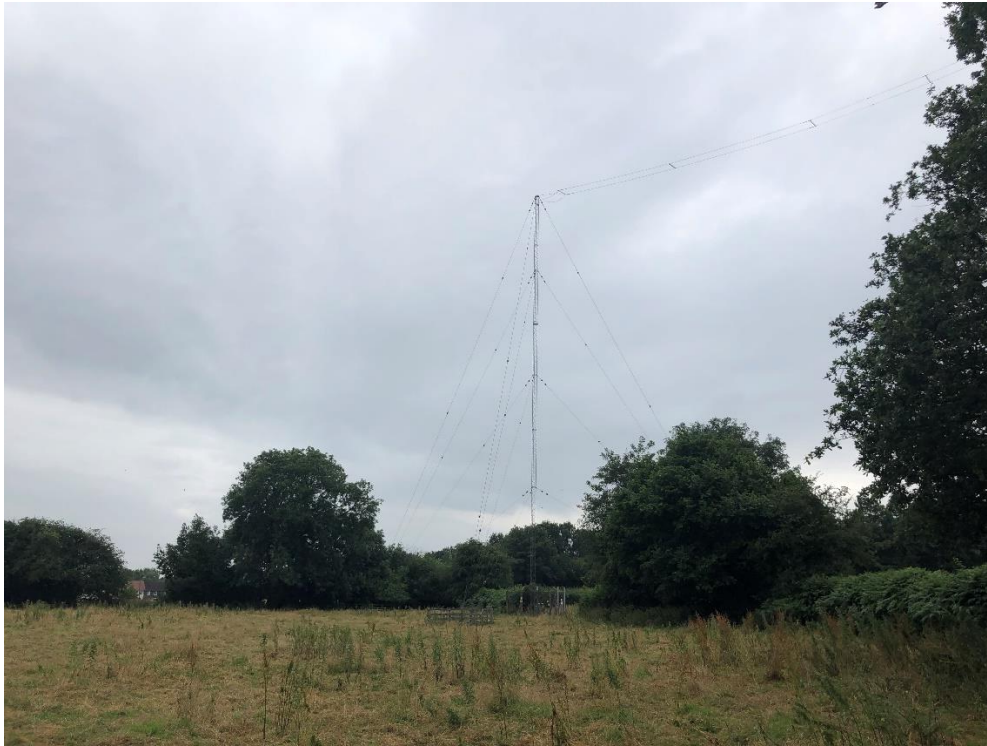
PLATE 3 – GENERAL SURFACE CONDITIONS IN THE SOUTH OF THE SITE AND MAST IN BACKGROUND

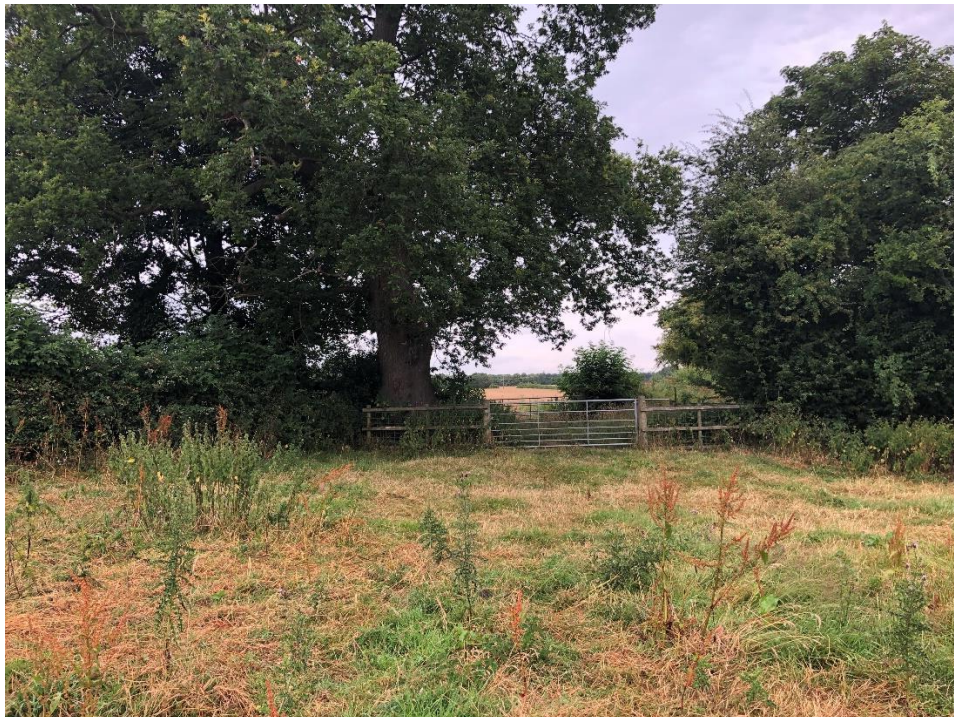
PLATE 4 – GENERAL SURFACE CONDITIONS THROUGH SOUTH OF THE SITE.

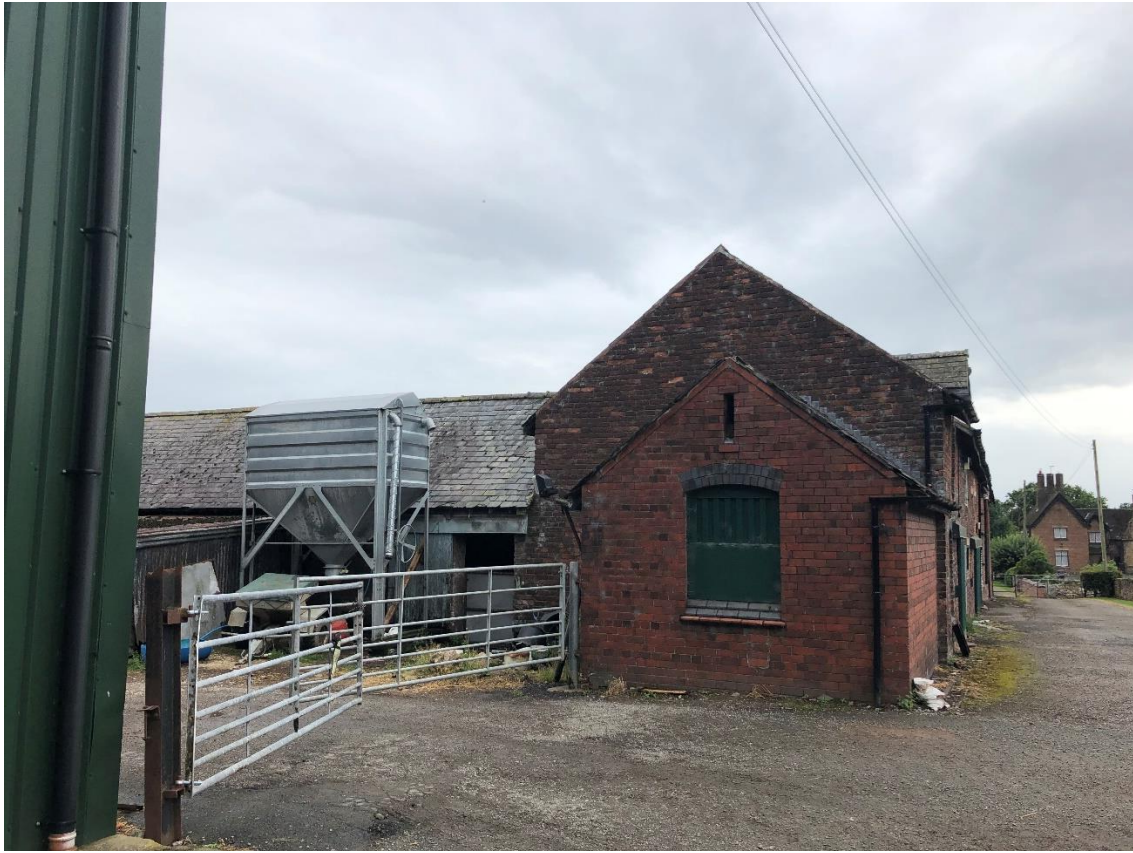
PLATE 5 YARD AREAS AND FARMHOUSE IN BACKGROUND
