Report : Internal inspections for bat:  
Erddig roof-spaces,  
Wrexham LL13 0YT

Reference : NT/2748/22.1

Date : 21 August 2023

Purpose : To inform the installation of (a) new fire alarm system(s) and fire stopping and compartmentation remedial works.

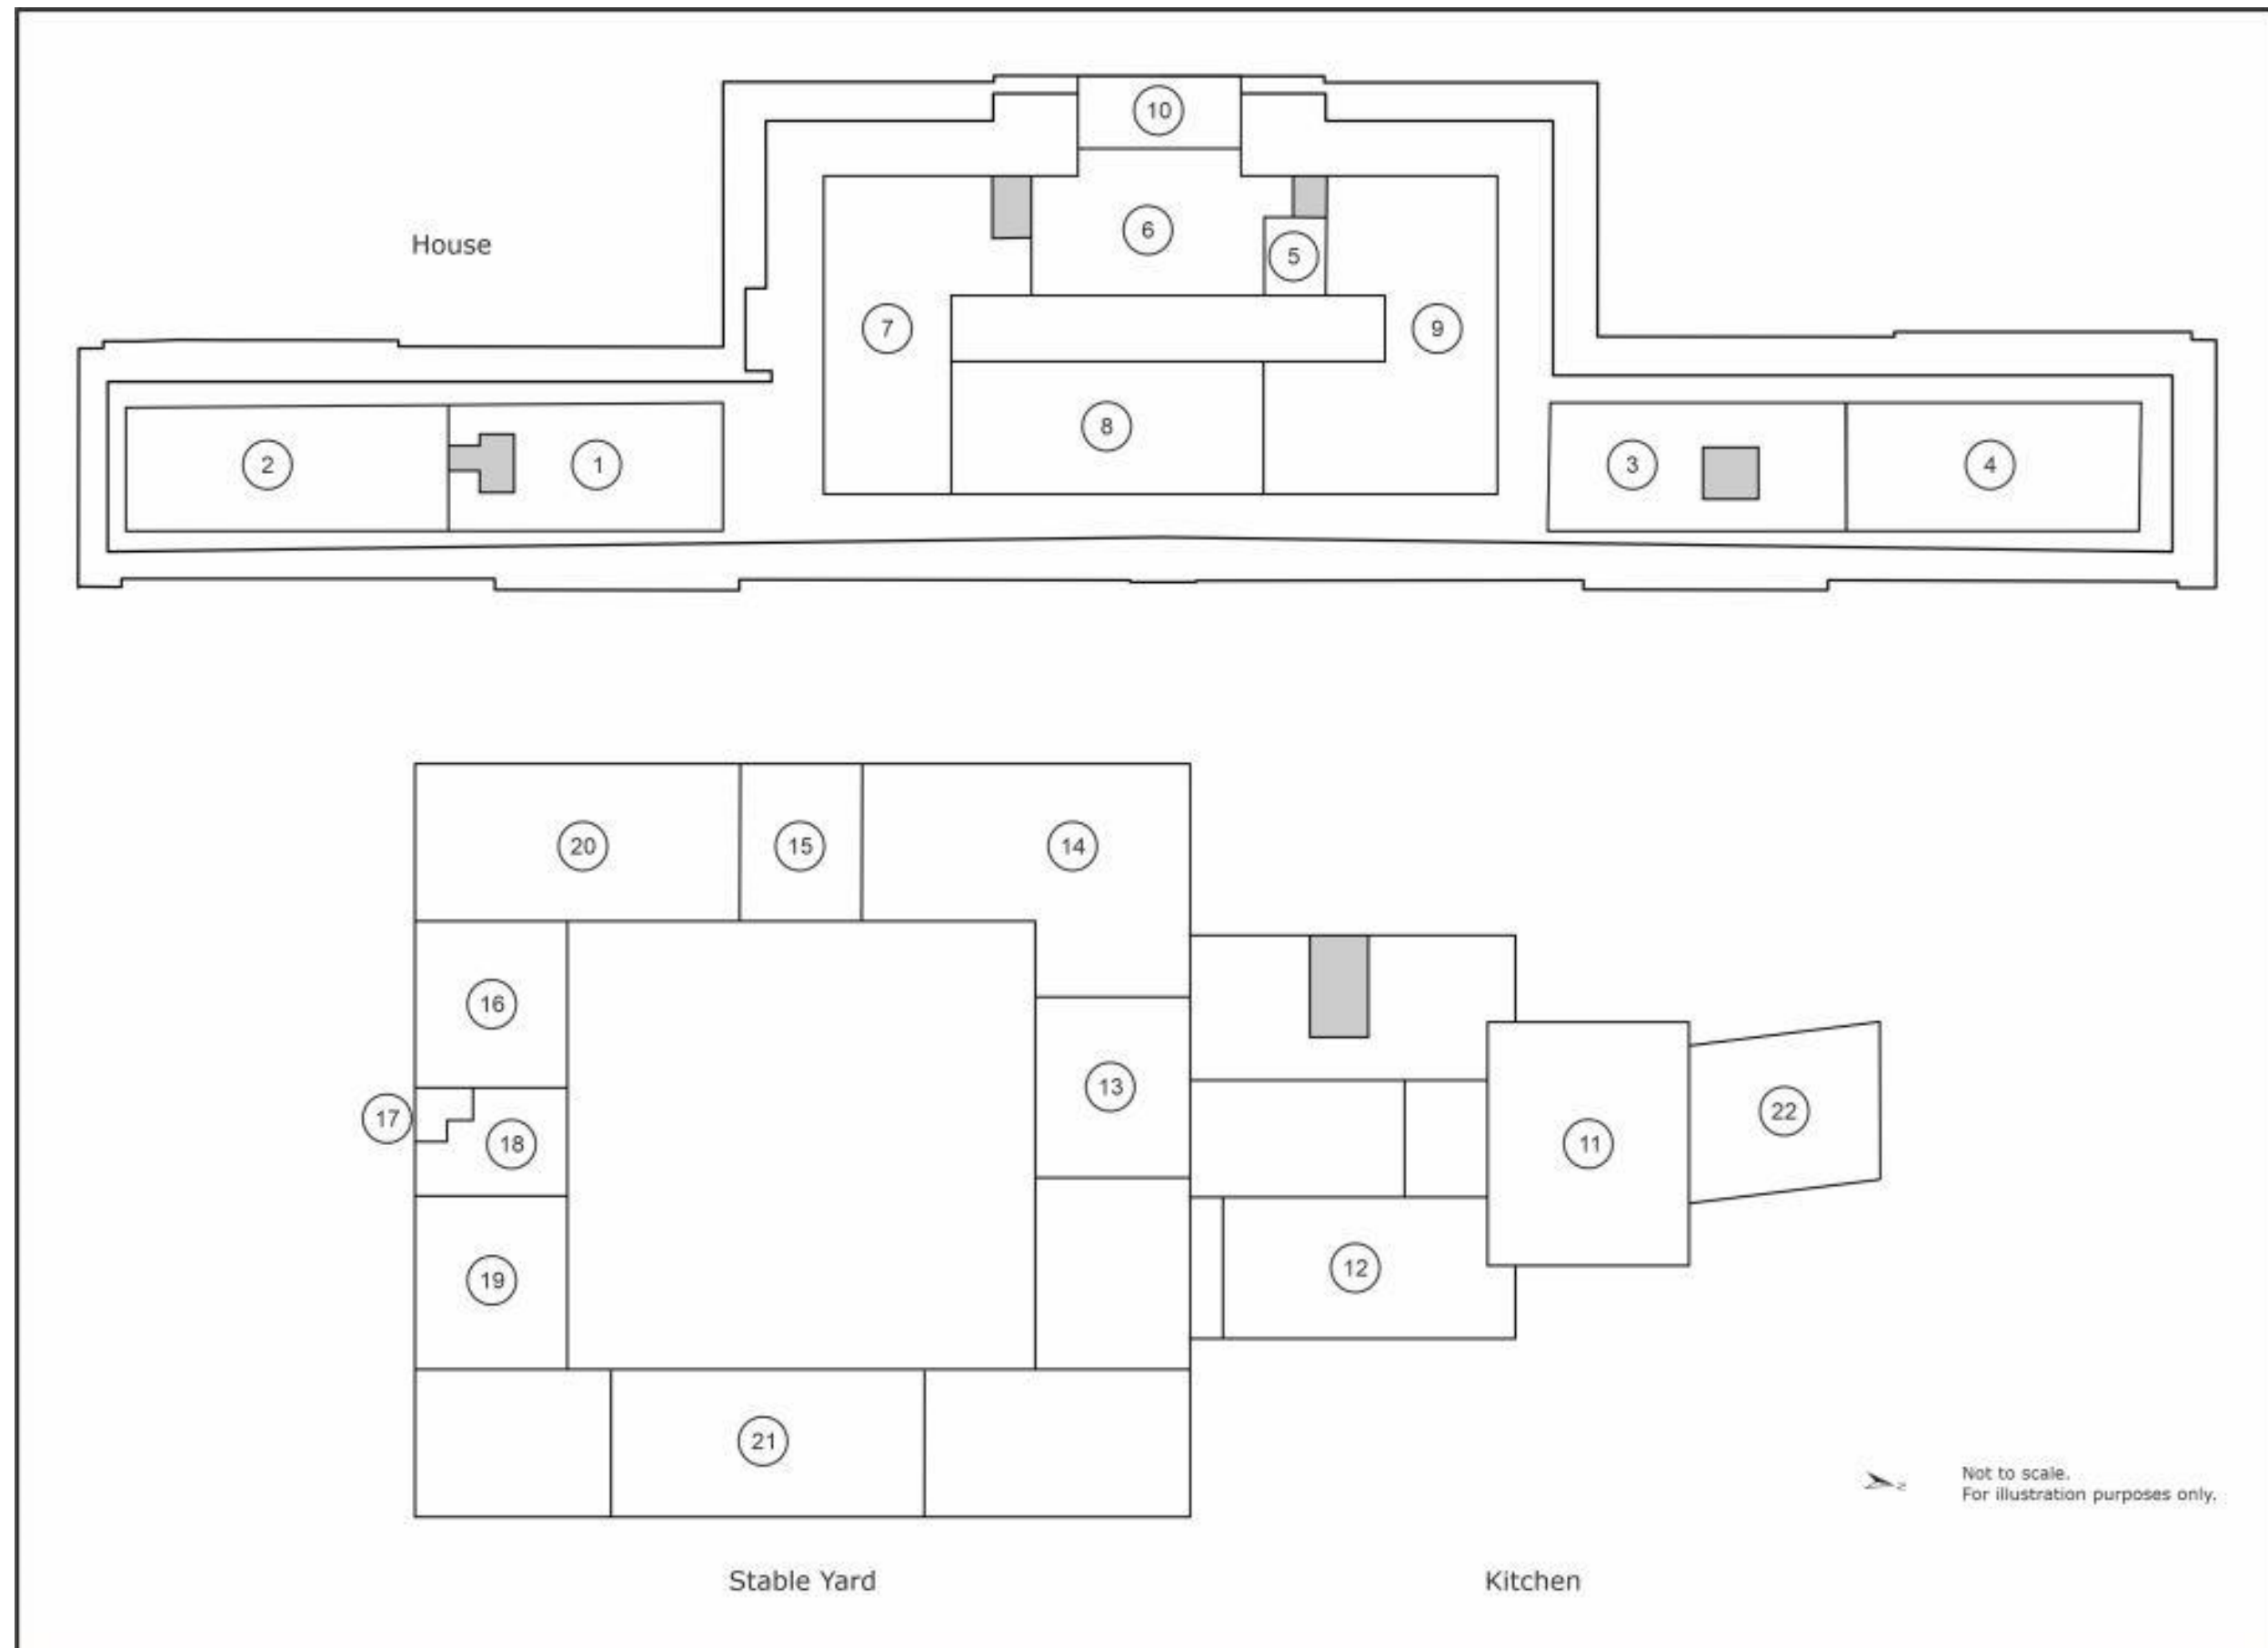
Appendix 1. Roof-space plans.

Plans showing the approximate locations of the Roof-spaces 1 – 22 are contained in Appendix 1. Roof-space 23 is within a standalone building known as the 'Saw Mill' and 'The Hub', and a plan showing the location of this roof-space is not provided.
