## Coal Mining Risk Assessment

Former Air Products Site

Acrefair

**Report No. A3341/G/1**

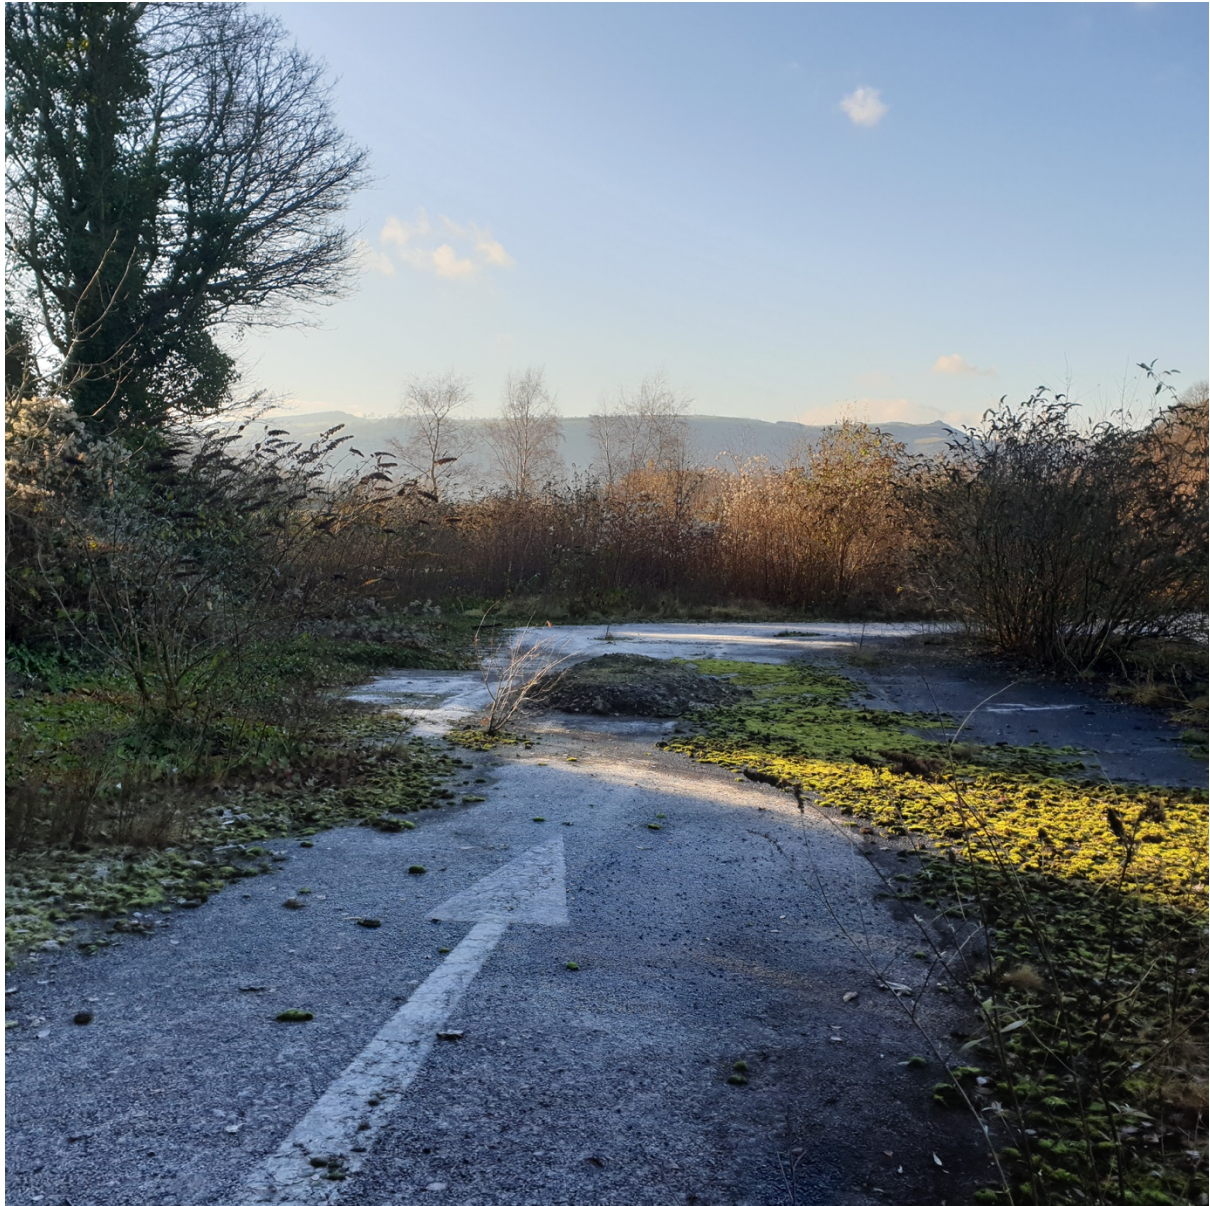
**Figure 2 Site Photograph**

- 2.3 Residential properties border the site to the west and east with a bowling green to the north. To the south there is a large area of vacant land that once formed part of the main Air Products Engineering facility. It is understood that that the site was cleared of all structures in 2015 with the crushed demolition rubble left spread across the site. Ground slabs and foundations were broken up and removed.

- 2.4 The site is separated from the bowling green by a large stone built retaining wall, that is structurally distressed.
- 2.5 Old kilns/furnaces are set into the eastern tree lined embankment.

- 2.6 Site levels fall by approximately from 140mAOD on the northern boundary to 135mAOD on the southern boundary.
- 2.7 A location plan is shown below as Figure 1, with Figure 2 showing a photograph of the site.

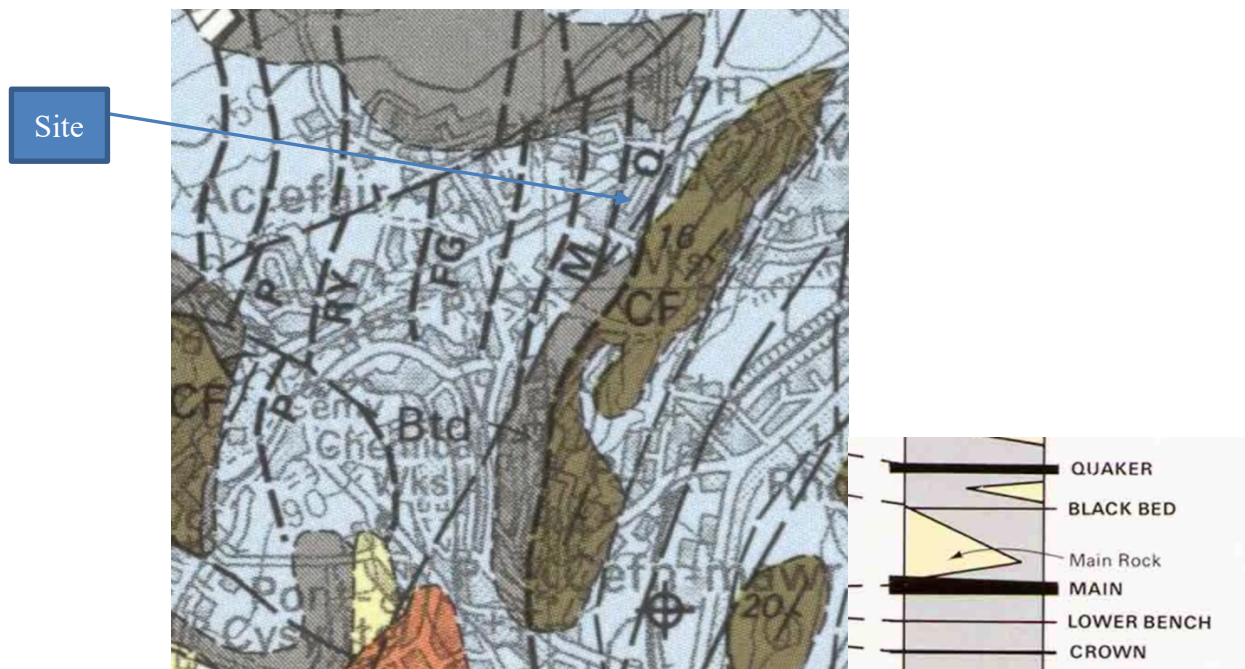
**Figure 3 Geological Map Extract**

- 3.1 The geology of the site has been determined from acquisition of geological maps for the area and examination of Coal Authority records.
- 3.2 The British Geological Survey (BGS) states that the site is underlain by superficial deposits consisting of Devensian Till, commonly known as Boulder Clay.
- 3.3 The solid geology beneath the site comprises the Pennine Lower Coal Measures Formation (PLCM) consisting of coal seams, mudstone and siltstone.
- 3.4 Figure 3, below, shows an extract from the geological map.

3.19 Voiding, soft drilling and collapsed mineworking's were observed in all the coal seams, with a dip of strata of 1 in 7 (eight degrees) to the east. This angle of dip is less than that shown on the geological map (sixteen degrees) but does accord with Wynnstay mineplans.
