**PROPOSED DEVELOPMENT AT HOLT ROAD, WREXHAM BY BLOOR HOMES NORTH  
WEST AND BARRATT HOMES**

**SUDS STRATEGY STATEMENT IN SUPPORT OF OUTLINE PLANNING APPLICATION  
REF. P/2019/0005**

**Ground Investigation Report**

**Holt Road, Wrexham**

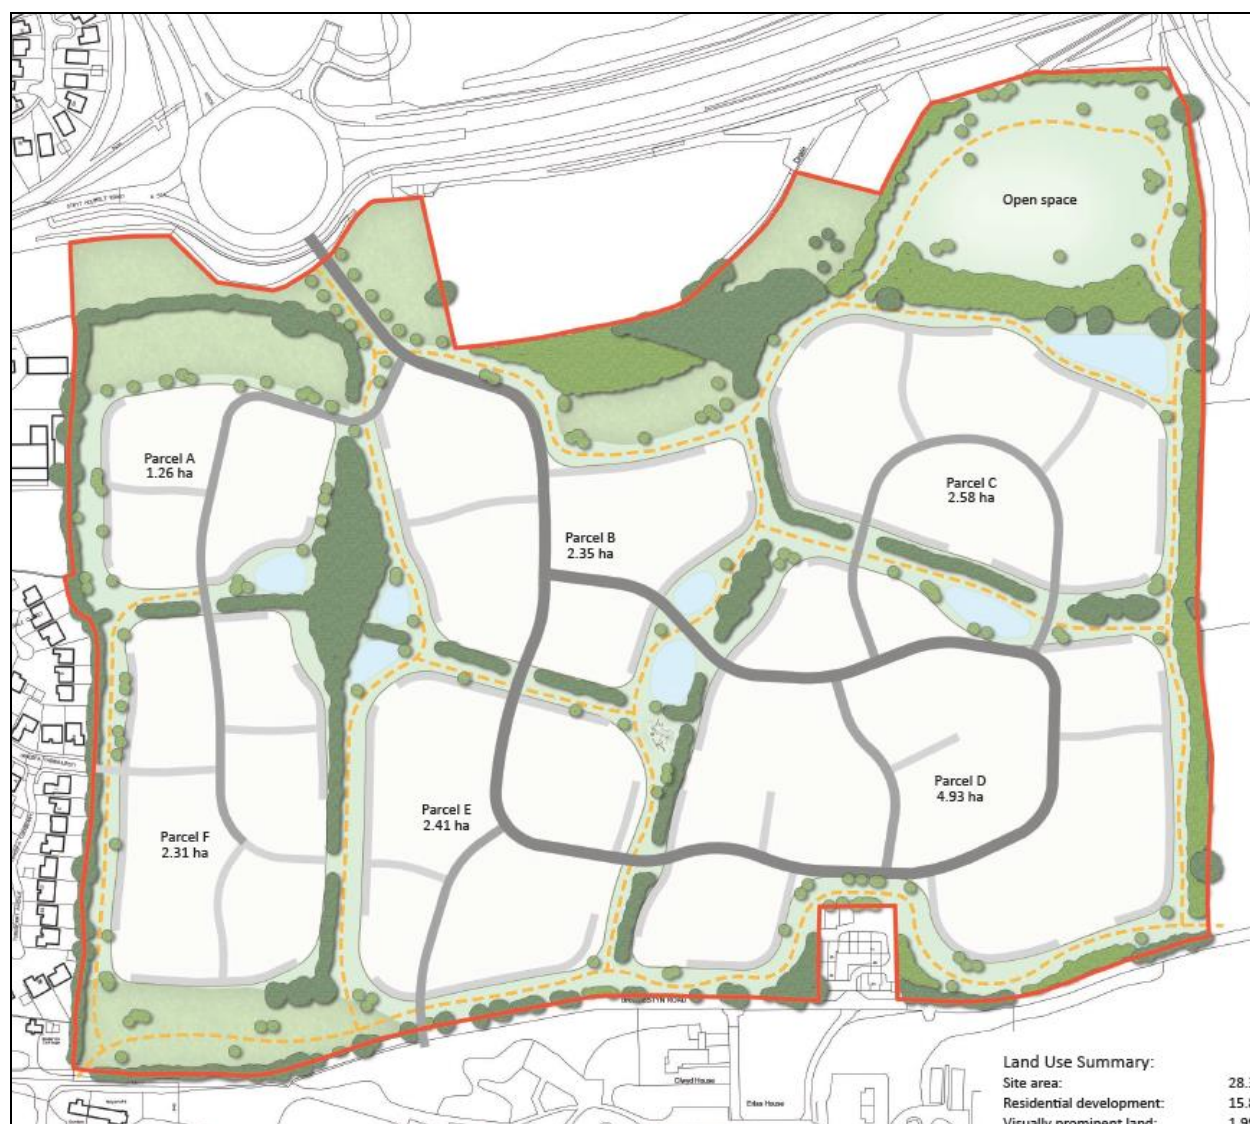
Concept Layout, drwg No. 661B-01, dated 18/08/17, by Randall Thorp.

This investigation was carried out on the instruction of Bloor Homes on behalf of Bloor Homes Northwest, Barratt Homes, John Raymond Jones and the Trustees of The Wrexham (Parochial) Education Foundation, who are looking at developing the site in a joint venture. The purpose of the work was to review a previous Desk Study and undertake Ground Investigation works to provide geotechnical and contamination risk information for the proposed construction of residential dwellings and associated gardens, public open spaces, new road and associated infrastructure. A proposed concept drawing can be seen below;

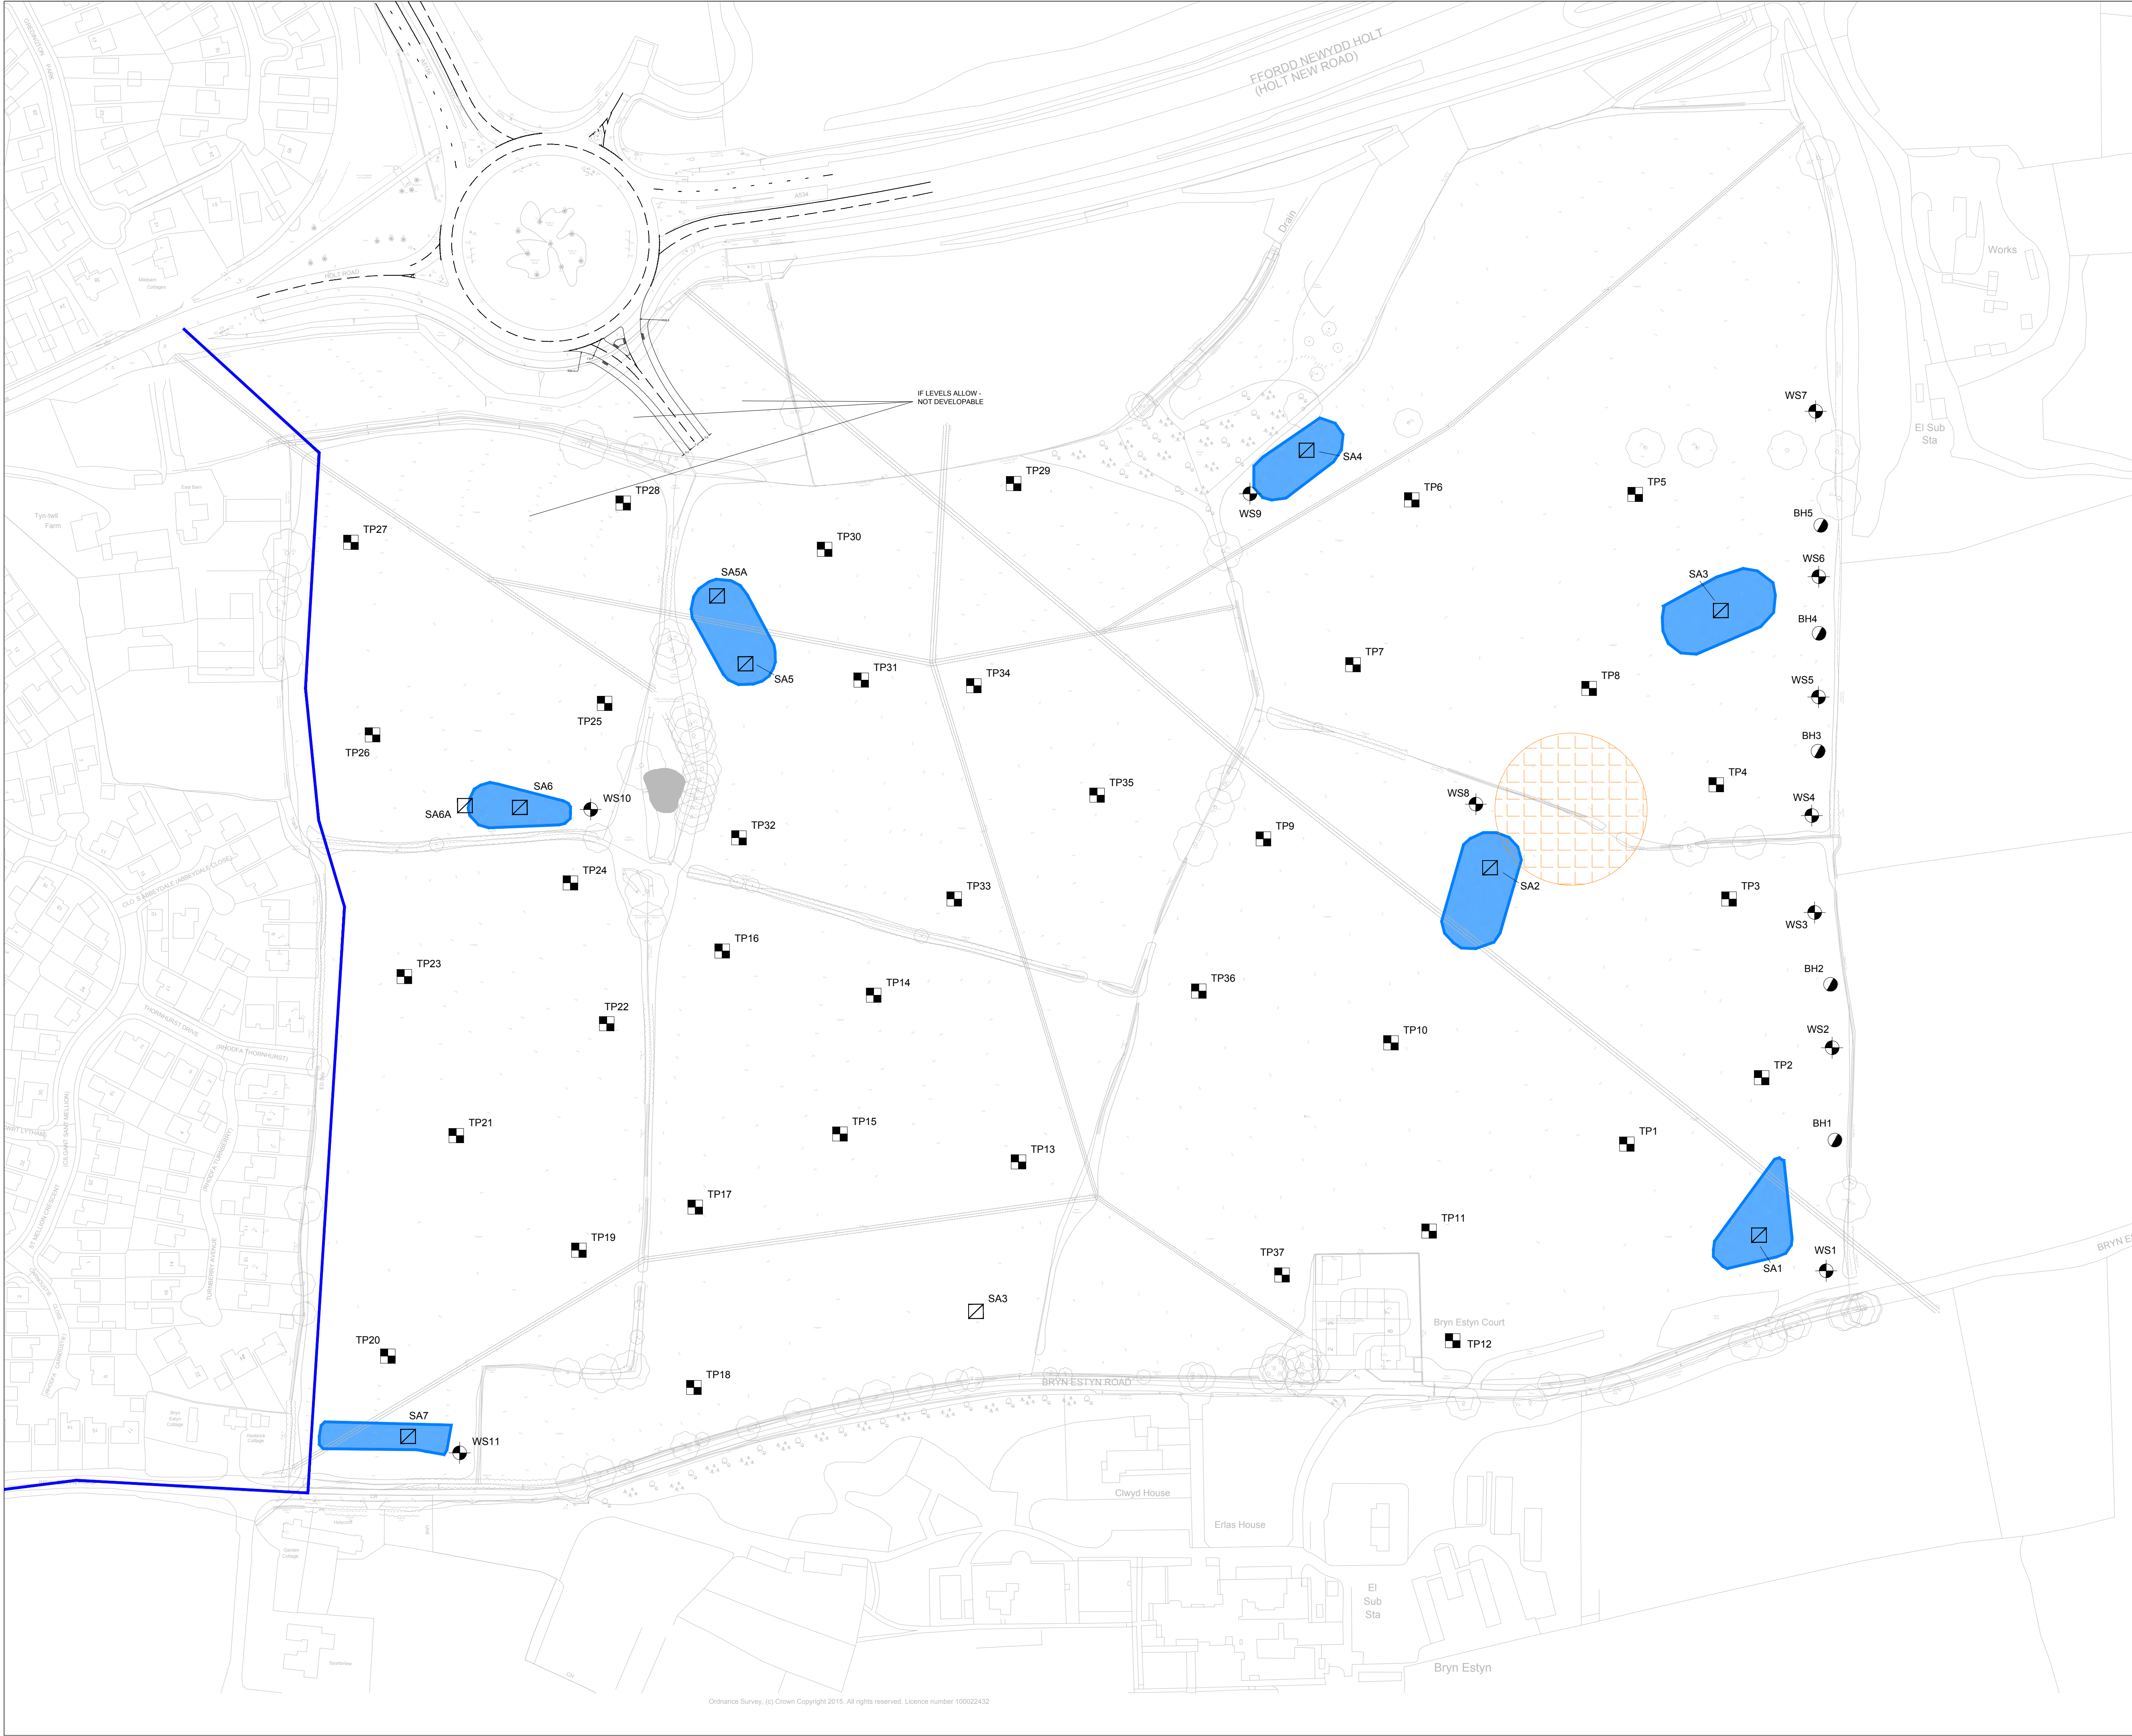
### (i) Betts Exploratory Hole Location Plan

THIS DRAWING SHOWS THE INDICATIVE LOCATION OF EXPLORATORY HOLES UNDERTAKEN BY BETTS GEO LTD IN 2018.
