**BAT ACTIVITY SURVEY FOR**

**PARK VIEW**

**GATEWEN**

**WREXHAM, NORTH WALES**

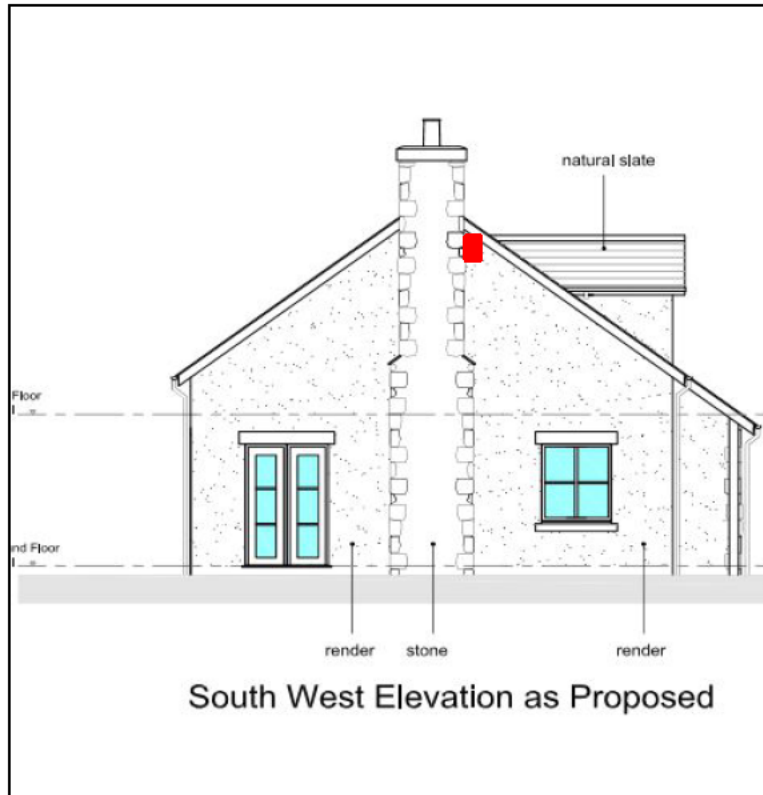
- A Vivara Pro bat box will be built into the wall on the south-west facing elevation wall as shown below.

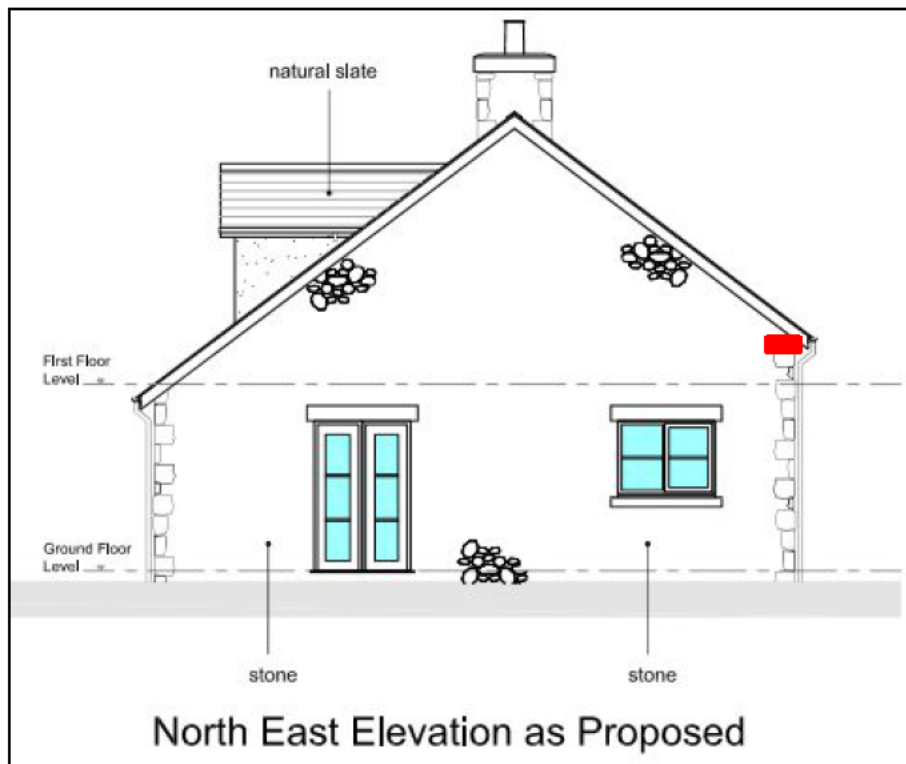
**A Vivara Pro Woodstone sparrow terrace nest box will be secured to the wall on the north-east facing elevation as shown below in red.**
