## **BAT SCOPING SURVEY**

### **Bridgeway Centre**

Bridge Road  
Wrexham  
LL13 9QS

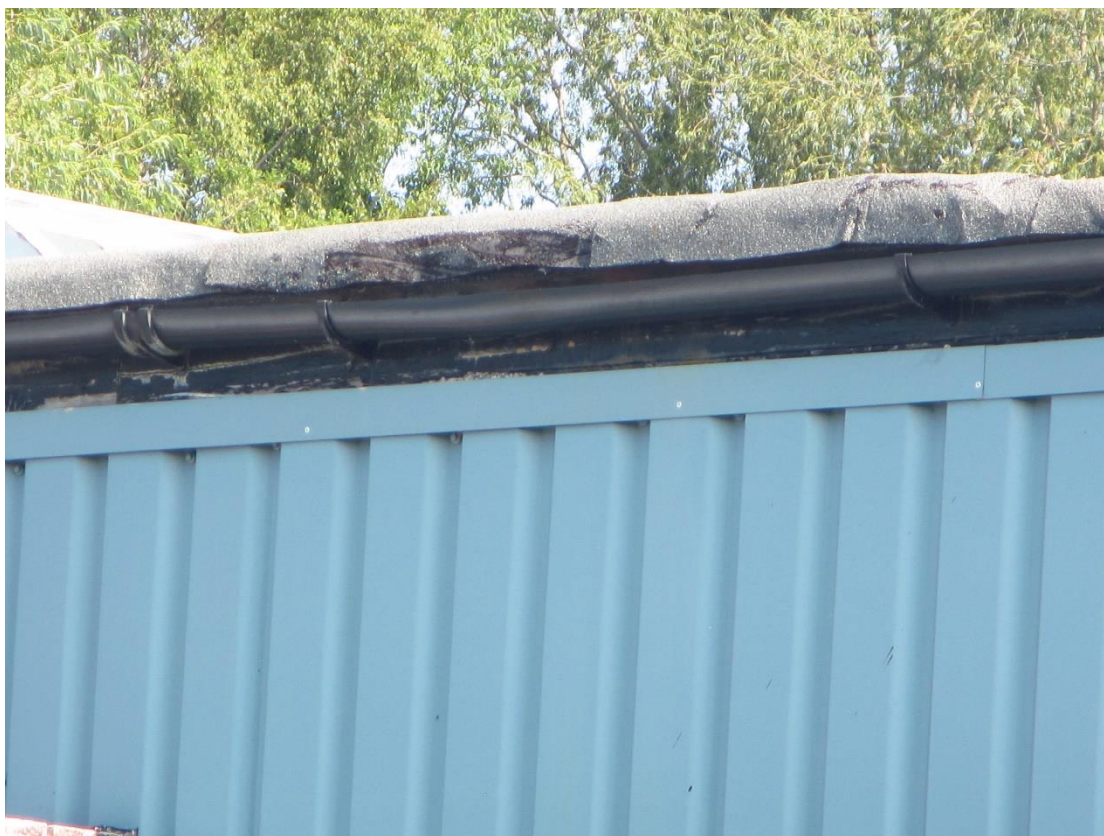
**Building 3** is a single storey rectangular building used for offices. It is constructed of corrugated metal with a flat roof lined with 1F bitumen roofing felt. Most of the roof is in good condition and tightly sealed. However, there is one small section which is lifted on the southern aspect (Photograph 13). However, this was fully inspected, and the gap is superficial and does not provide suitable roosting opportunities for bats. Furthermore, no

evidence of roosting bats was recorded within the feature. The windows are modern UPVC whilst the doors are metal. All windows and doors are in excellent condition.

Photograph 13 – Slightly lifted roofing felt on Building 3.

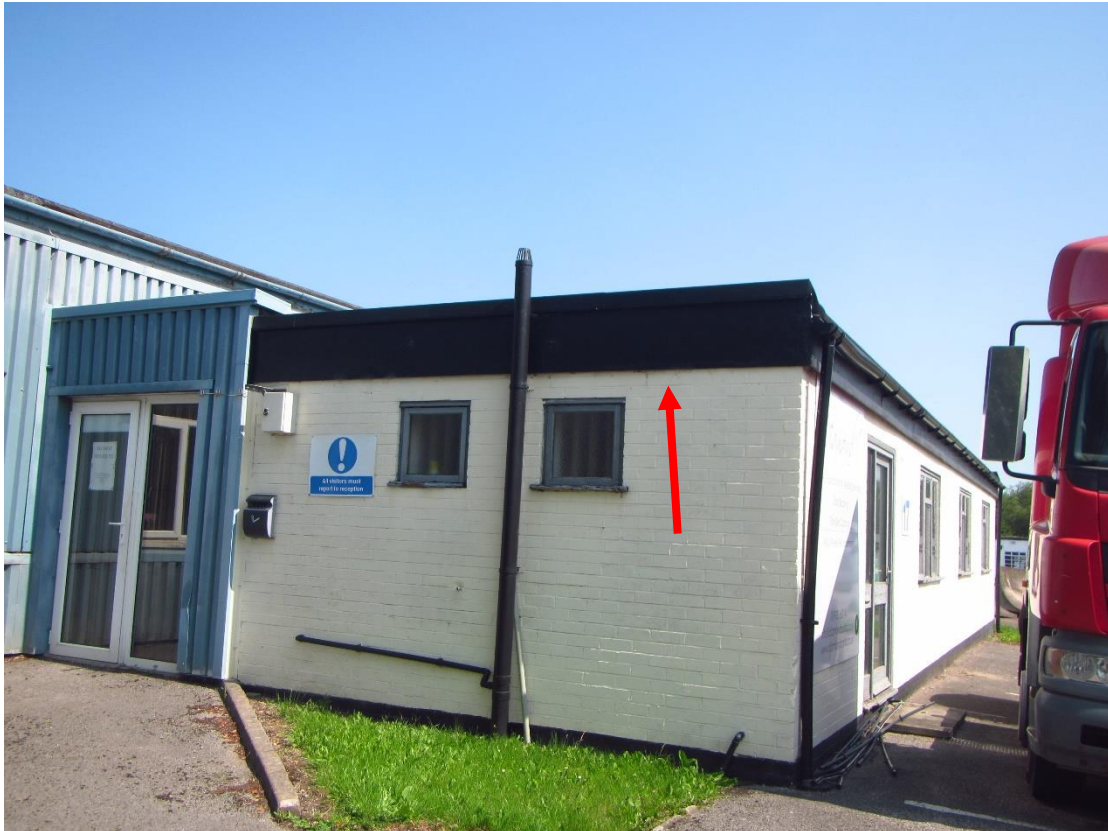
Photograph 16 – Southern aspect of Building 4, arrow pointing to gap in barge board.

Building 2, 4 and 7 will be demolished as part of the proposed development. Therefore, a single bat presence / absence survey of each building is required in order to determine whether or not bats are using the buildings to roost. The surveys should be undertaken by an appropriately licenced ecologist during the peak bat survey season, May to August inclusive. In addition, if the presence of bats is established during the survey, further roost characterisation surveys may be required to assess the type and importance of roosts in order to inform the planning process.
