## **BAT PRESENCE / ABSENCE SURVEY**

**Bridgeway Centre**

Bridge Road  
Wrexham  
LL13 9QS

| UES reference: | UES03012/03 |

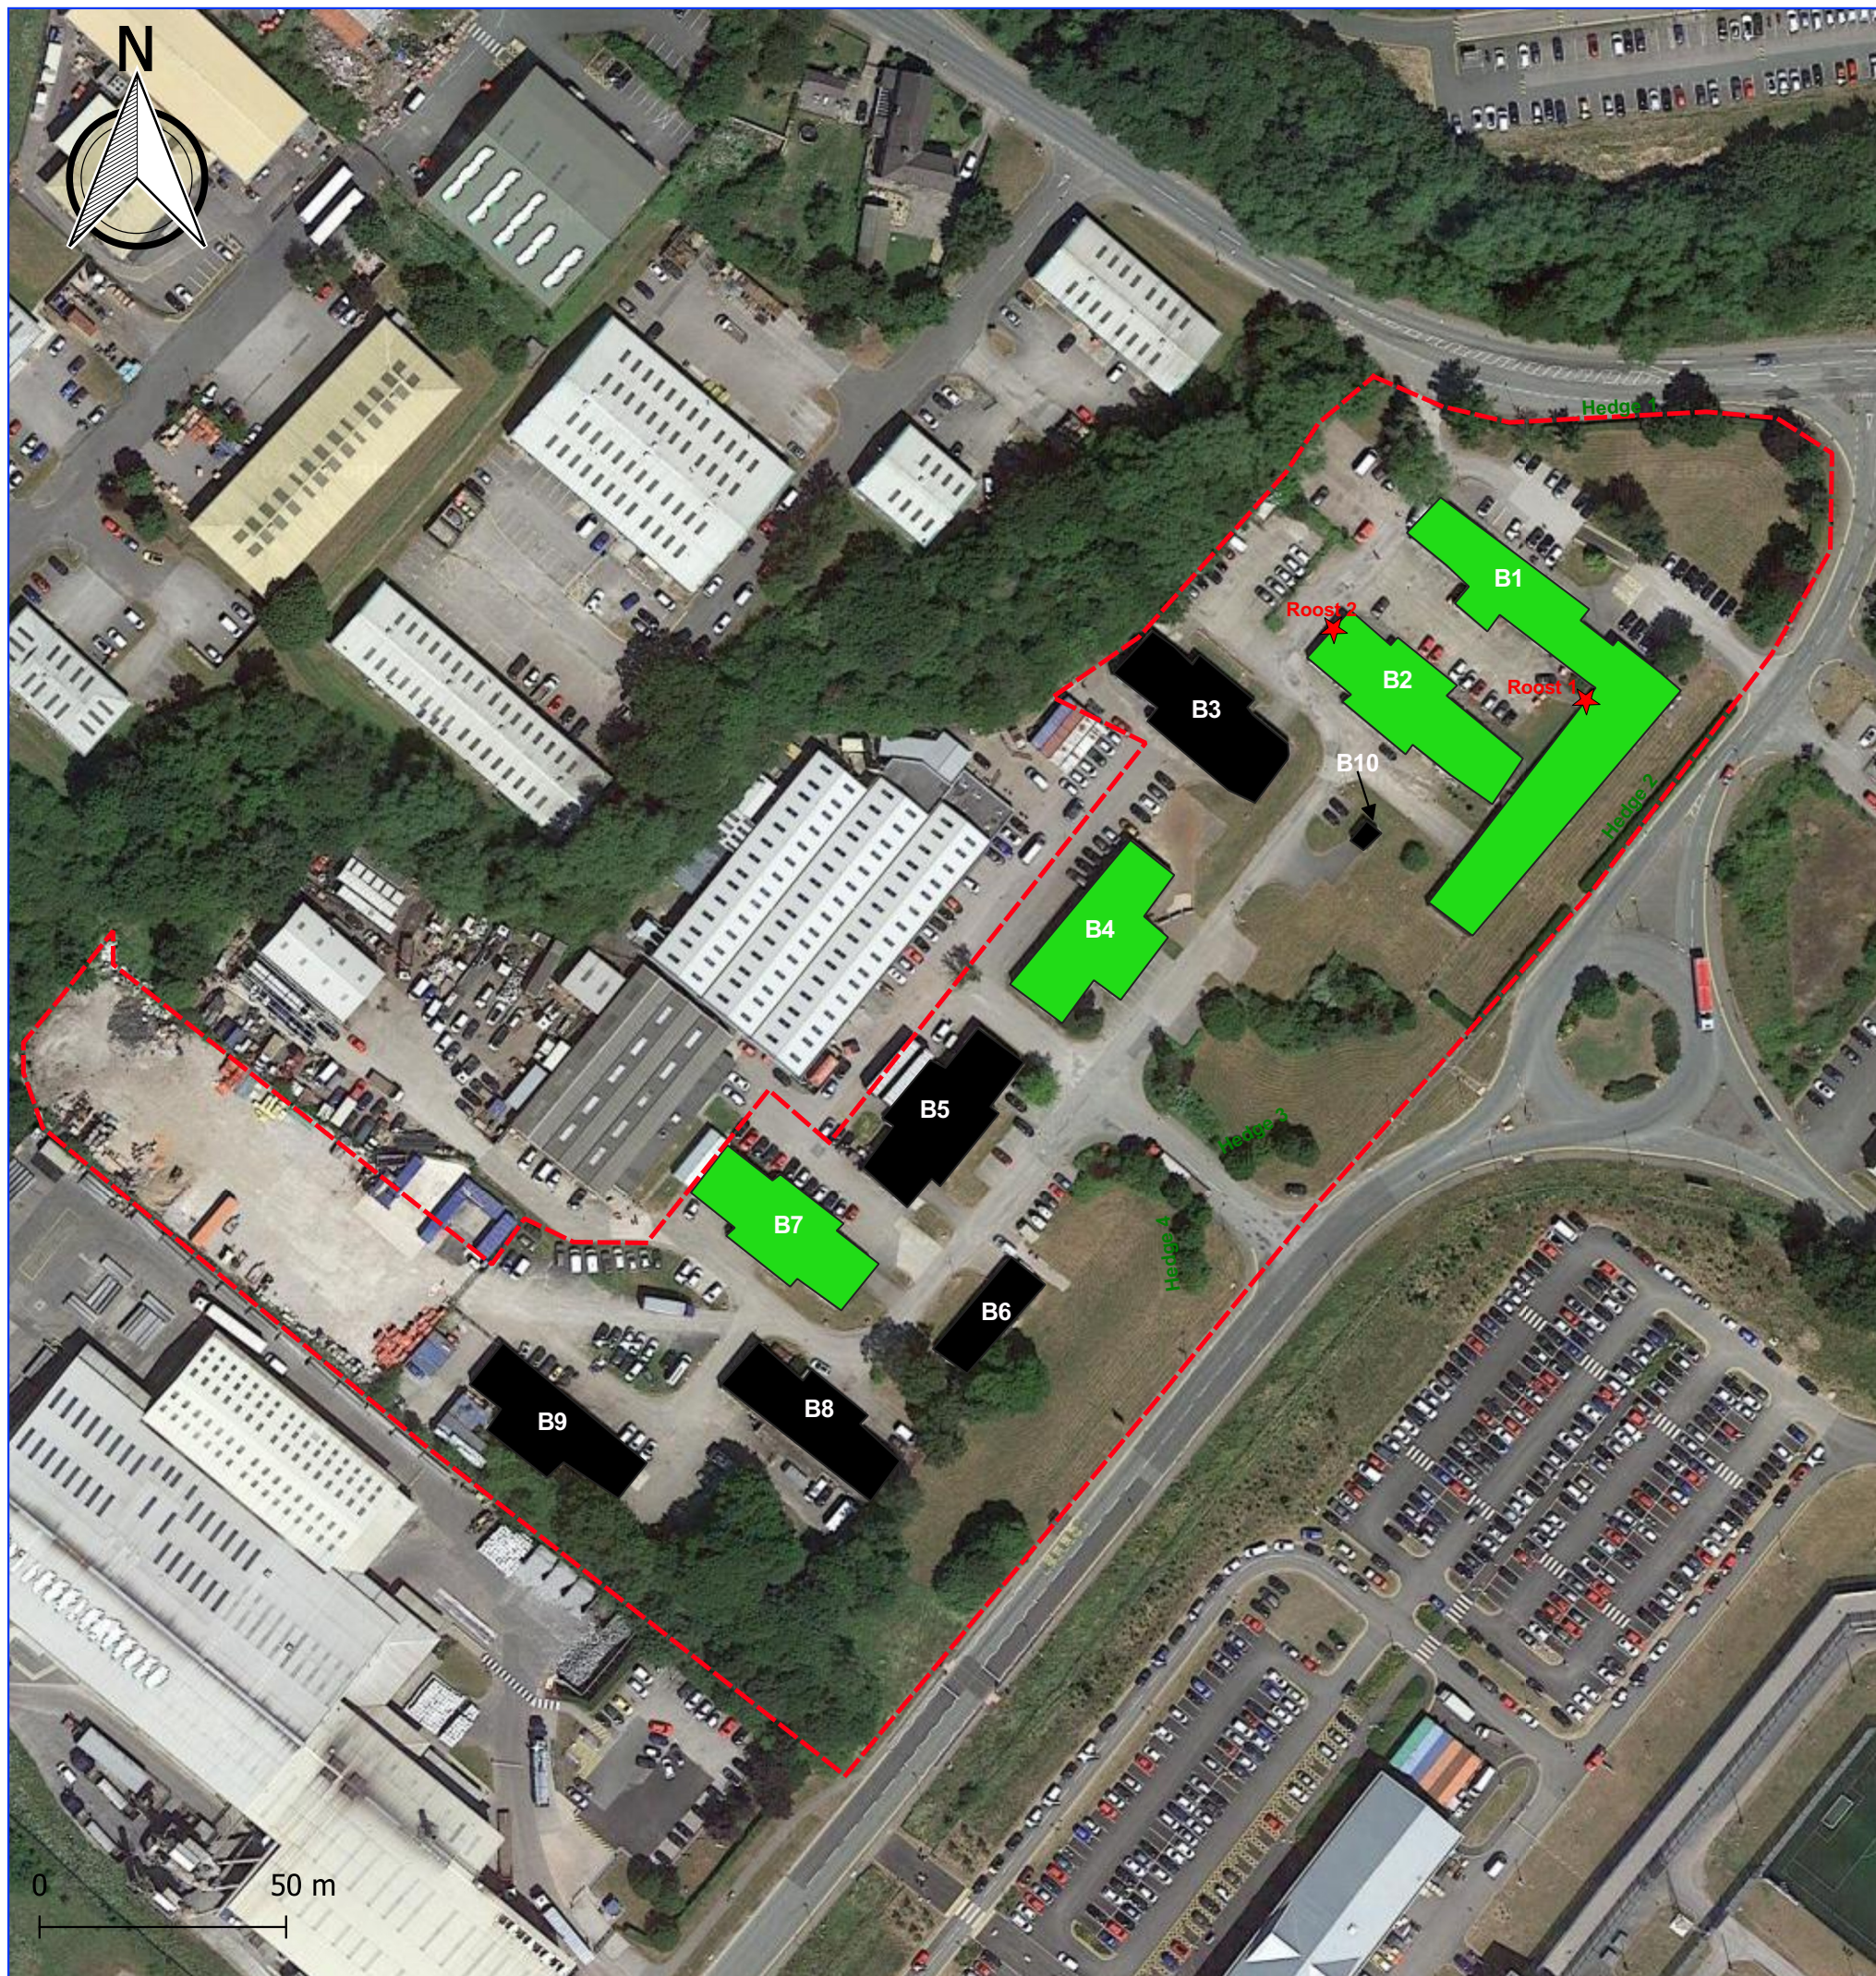
## Site plan

There are ten buildings at the Bridgeway Centre, eight of which are due to be demolished under the proposed development plans. These buildings have been numbered for the purposes of the report (see Appendix 1 – Site plan).

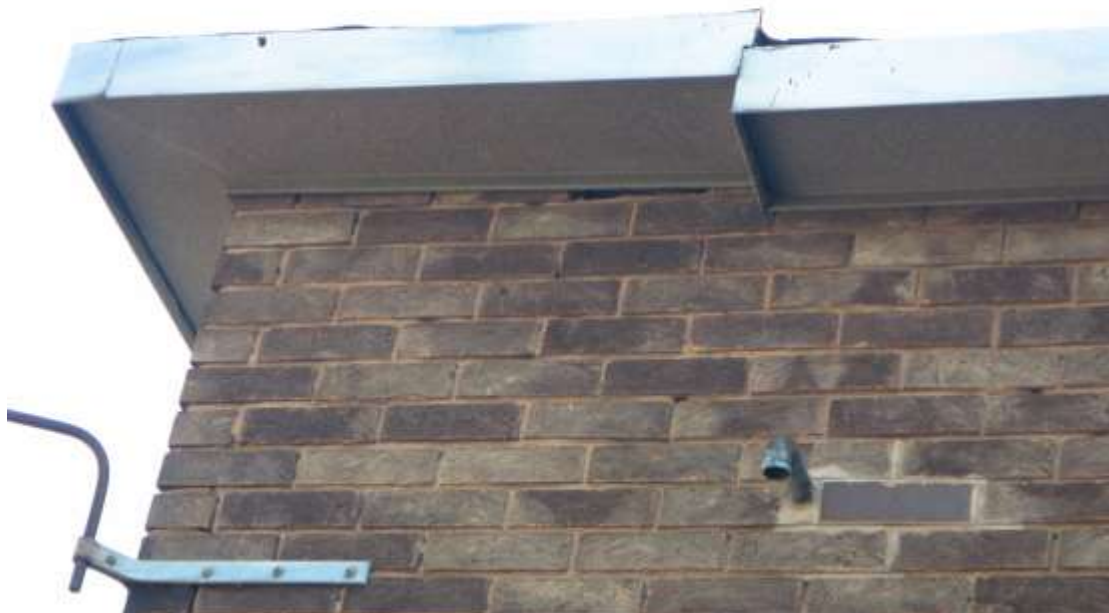
Photograph 3 - Gap in brickwork on southern aspect of Building 1.

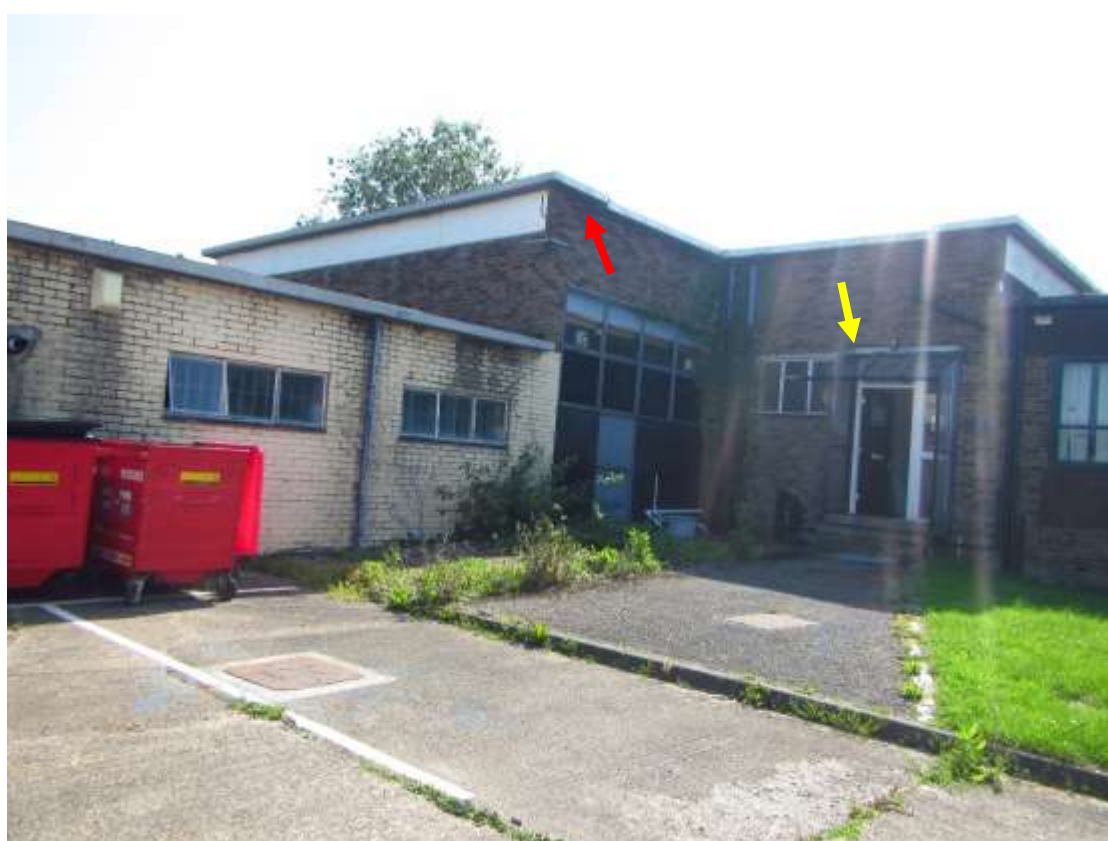
| DATE | SURVEY TYPE | SPECIES | NUMBER OF INDIVIDUALS | ROOST LOCATION | ACCESS POINT | TIMINGS |
|---|---|---|---|---|---|---|
| 22/09/20 | Emergence (Building 1) | Common pipistrelle | 1 | Western aspect of building, at corner of L-shape. (see Appendix 1, Site Plan – Roost 1) | Beneath lead flashing on northern side of porch (see Photograph 4) | 19:47 |

Photograph 4 – Red arrow shows location of gap in brickwork. Yellow arrow shows the location of Roost 1; beneath the lead flashing of the porch.

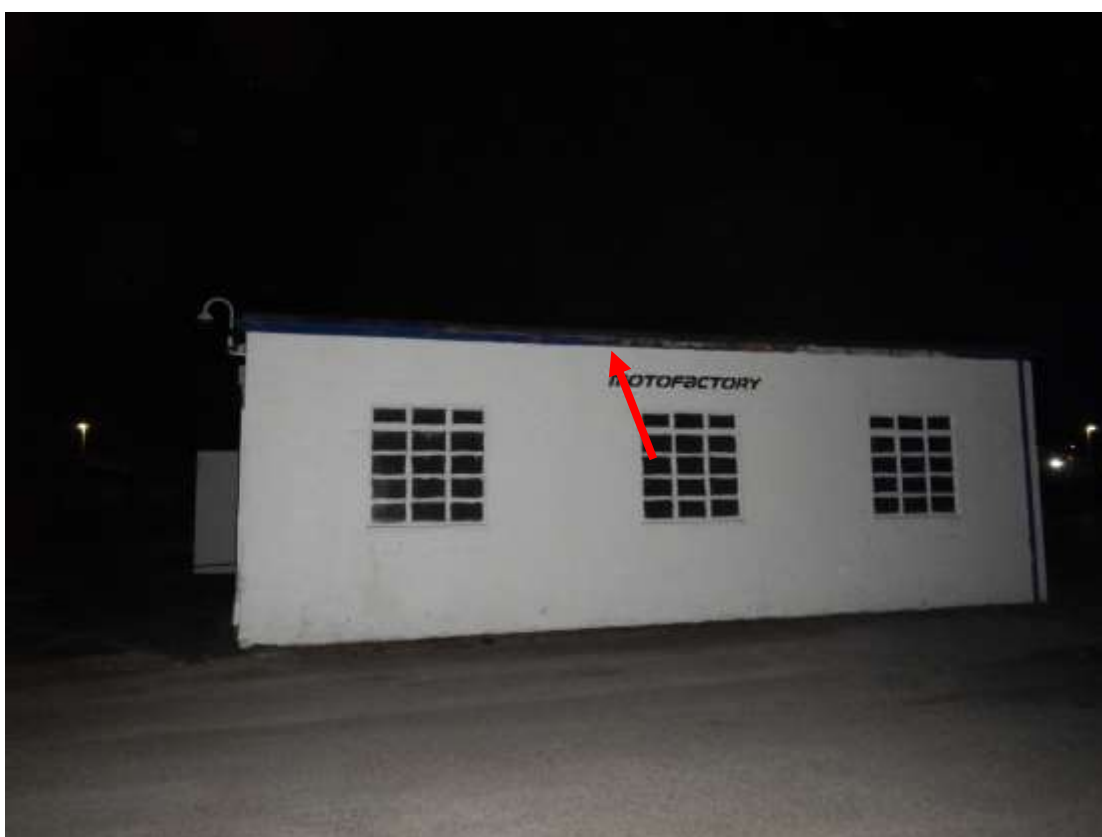
| DATE | SURVEY TYPE | SPECIES | NUMBER OF INDIVIDUALS | ROOST LOCATION | ACCESS POINT | TIMINGS |
|---|---|---|---|---|---|---|
| 22/09/20 | Emergence (Building 2) | Brown long eared bat | 1 | North-western aspect between roofing felt and fascia board - Roost 2 | Between roofing felt and wooden fascia board (Photograph 8) | 19:48 |

**Roost 2** is located on the western aspect of Building 2. An individual BLE bat was recorded emerging from between the raised roofing felt and the damaged wooden fascia board. The structure of this roost (a small crevice) makes it unsuitable for a large number of this species of bat (usually found free hanging in larger loft voids). Therefore, it is considered likely that the roost is used as a day / transitional roost on a casual basis, by an individual bat.

Photograph 8 – Western aspect of Building 2. Arrow showing the location of Roost 2.

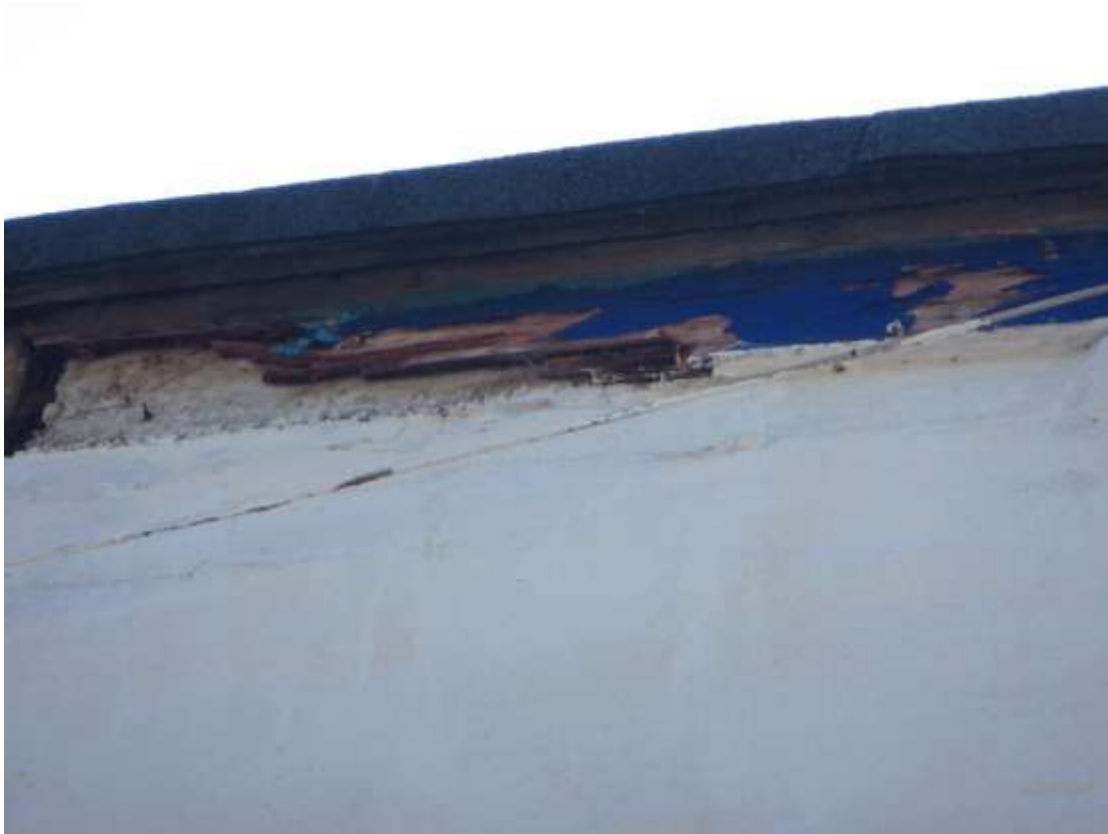
**Building 2** is a similar design but is rectangular in shape and has been painted white. There are wooden barge boards present on all aspects of the building, which are mostly in good condition. However, the fascia board on the western aspect is broken and lifted (Photographs 9 and 10) which leaves the bitumen roofing felt exposed, and a gap is present beneath.

Photograph 9 – Broken fascia board on Building 2, western aspect.

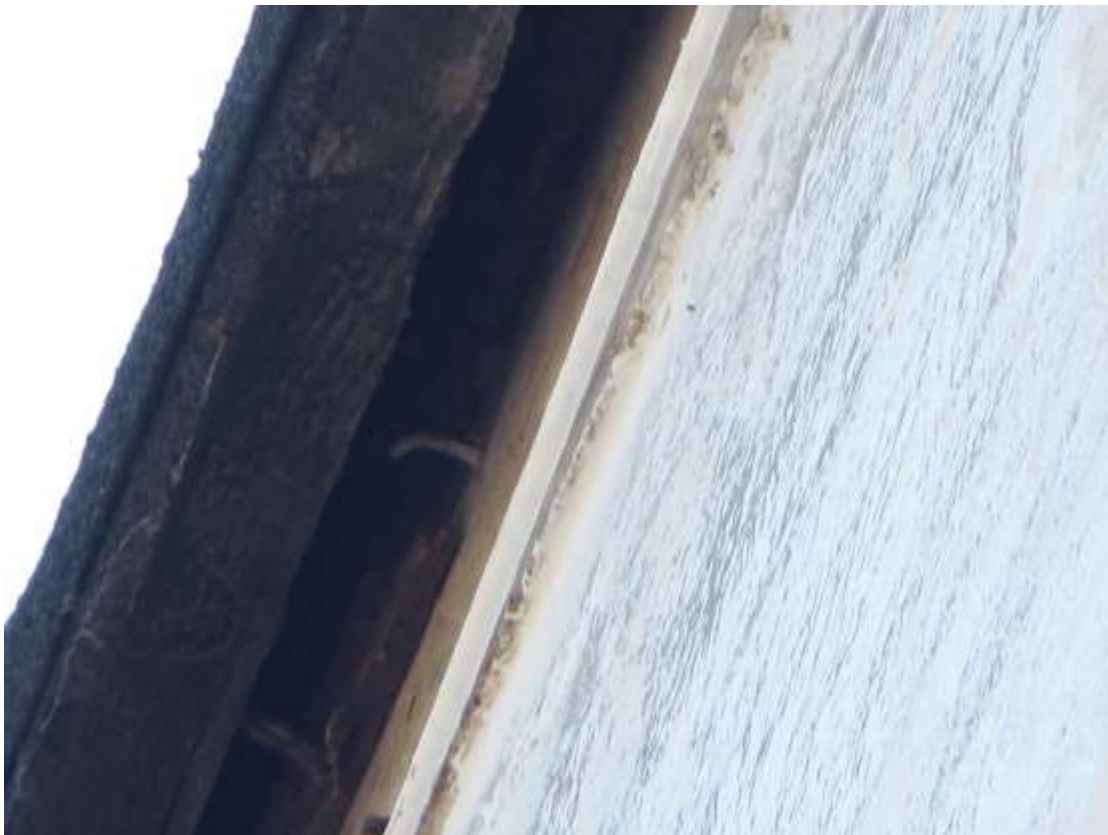
Photograph 10 – Gap between roofing felt and fascia board on Building 2, western aspect: the location of Roost 2.

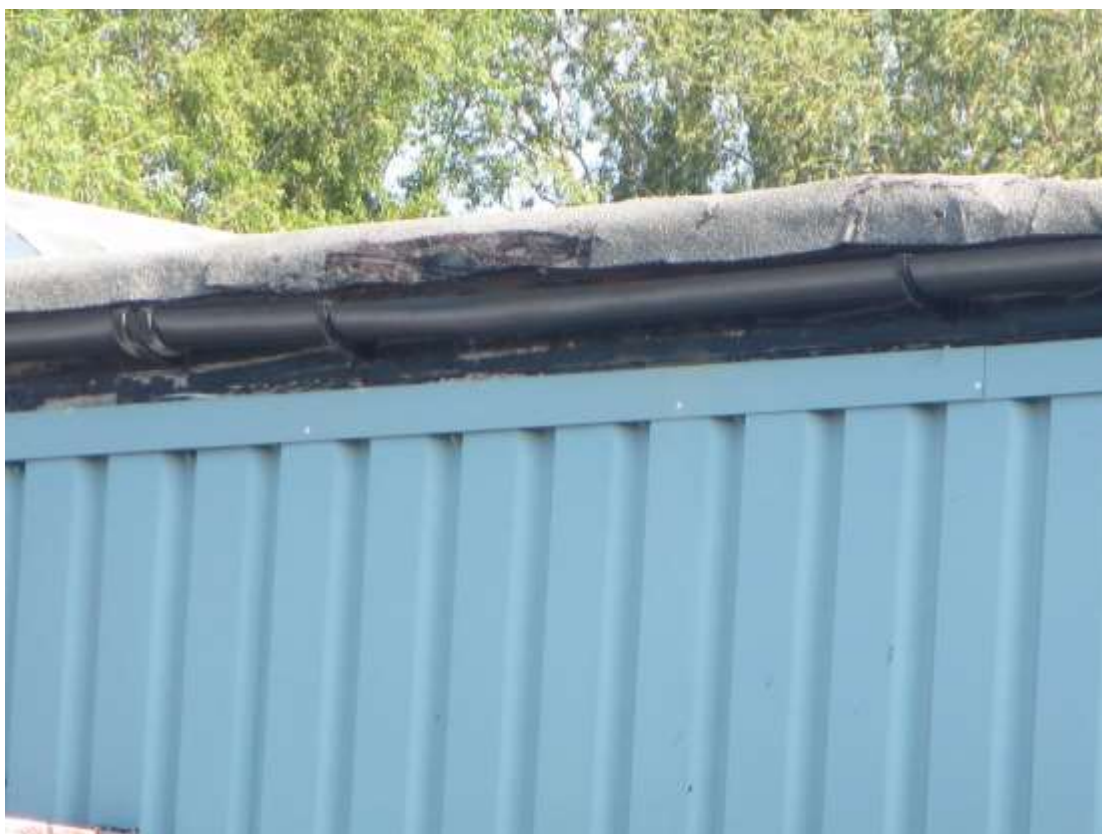
**Building 3** is a single storey rectangular building used for offices. It is constructed of corrugated metal with a flat roof lined with 1F bitumen roofing felt. Most of the roof is in good condition and tightly sealed. However, there is one small section which is lifted on the southern aspect (Photograph 13). However, this was fully inspected, and the gap is superficial and does not provide suitable roosting opportunities for bats. Furthermore, no evidence of roosting bats

Photograph 13 – Slightly lifted roofing felt on Building 3.

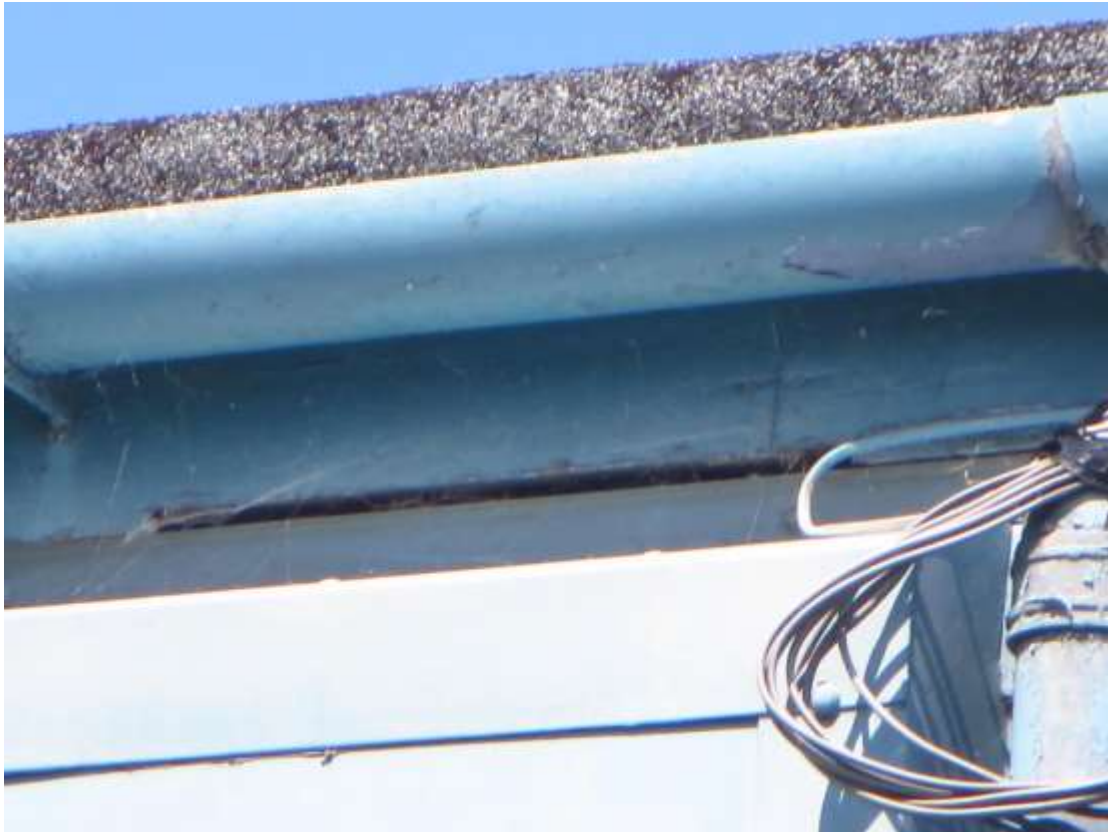
Photograph 15 – Gap in fascia on eastern aspect of Building 4.

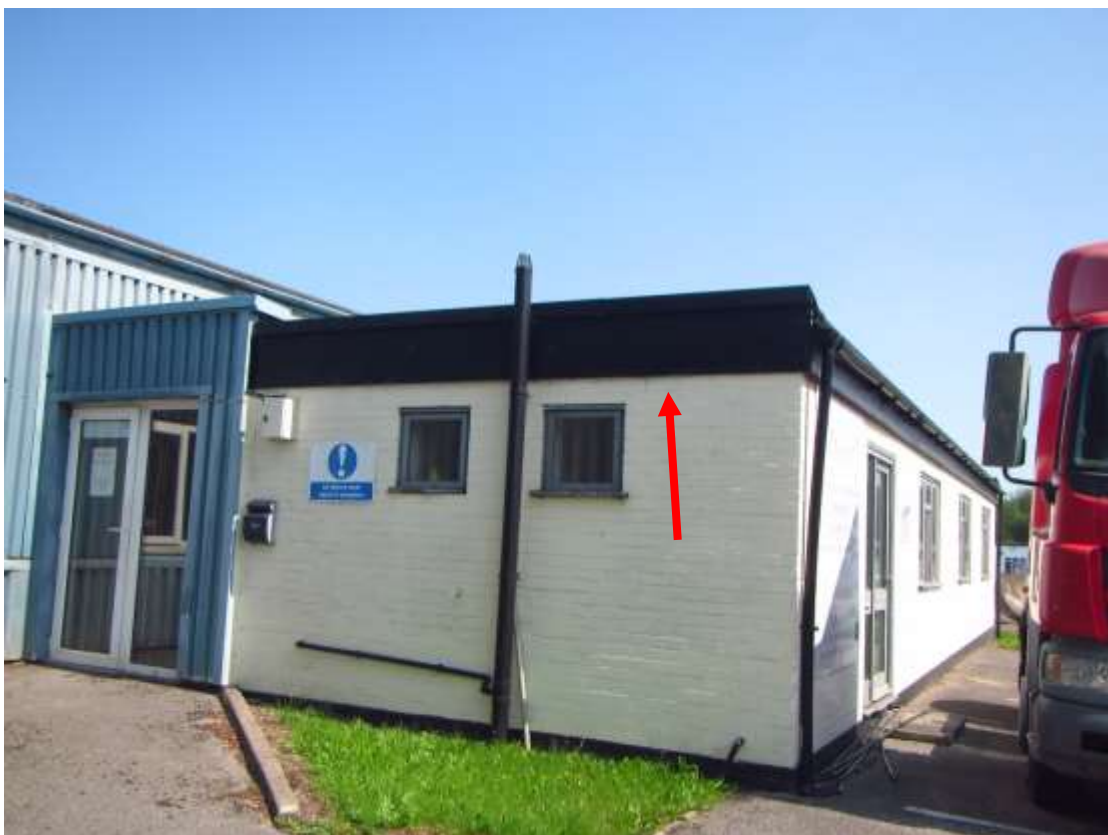
Photograph 16 – Southern aspect of Building 4, arrow pointing to gap in barge board.

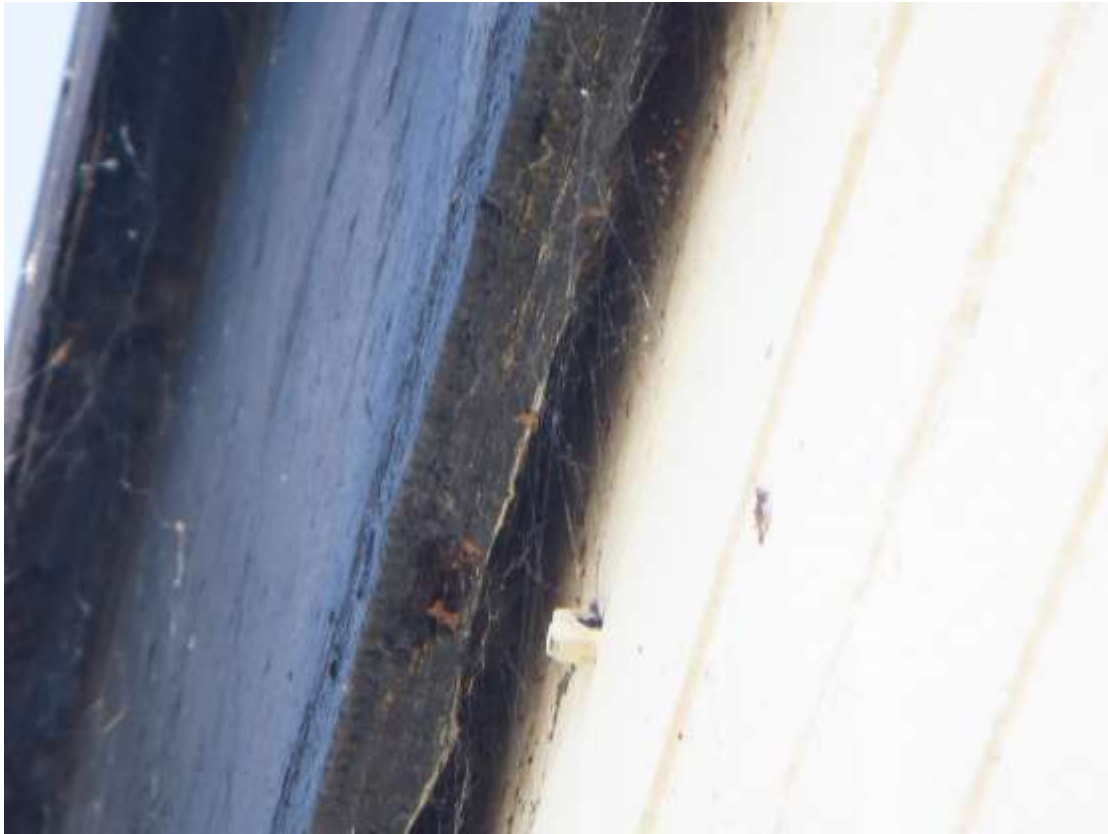
Photograph 17 – Close view of gap in barge board on southern aspect of Building 4.

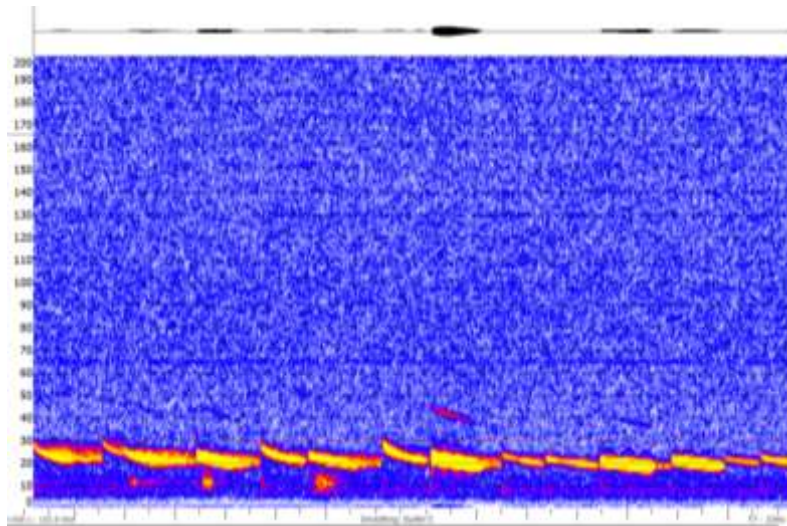
Sonogram 1. Showing the calls of a noctule bat recorded commuting high over the site (flying from west to east) at 19:40 during the emergence survey on 22<sup>nd</sup> September 2020.

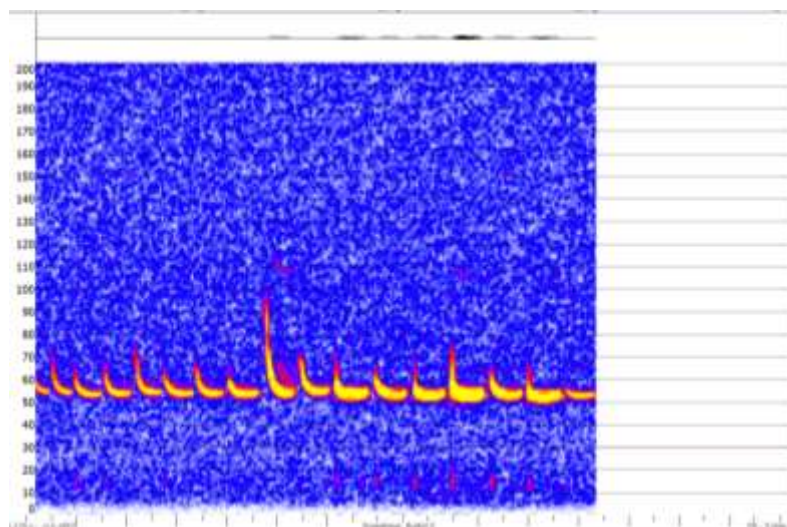
Sonogram 3. Showing the calls of a soprano pipistrelle bat recorded passing over site during the emergence survey on 22<sup>nd</sup> September 2020 at 20:15.

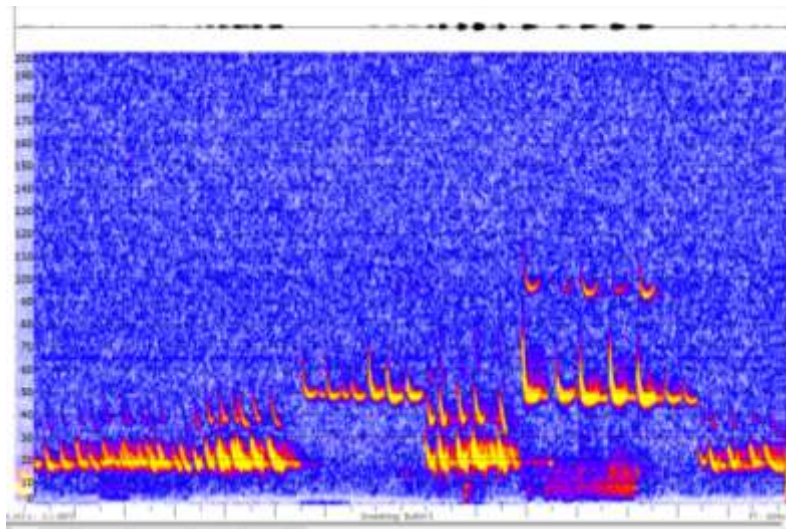
Sonogram 4. Showing the calls of a common pipistrelle bat recorded passing over site during the emergence survey on 22<sup>nd</sup> September 2020 at 20:16. Note the array of social calls.
