## **BAT SCOPING & BAT PRESENCE / ABSENCE SURVEY**

**Bridgeway Centre**

Wrexham

Date: 23<sup>rd</sup> November 2023  
UES reference: UES03012/12

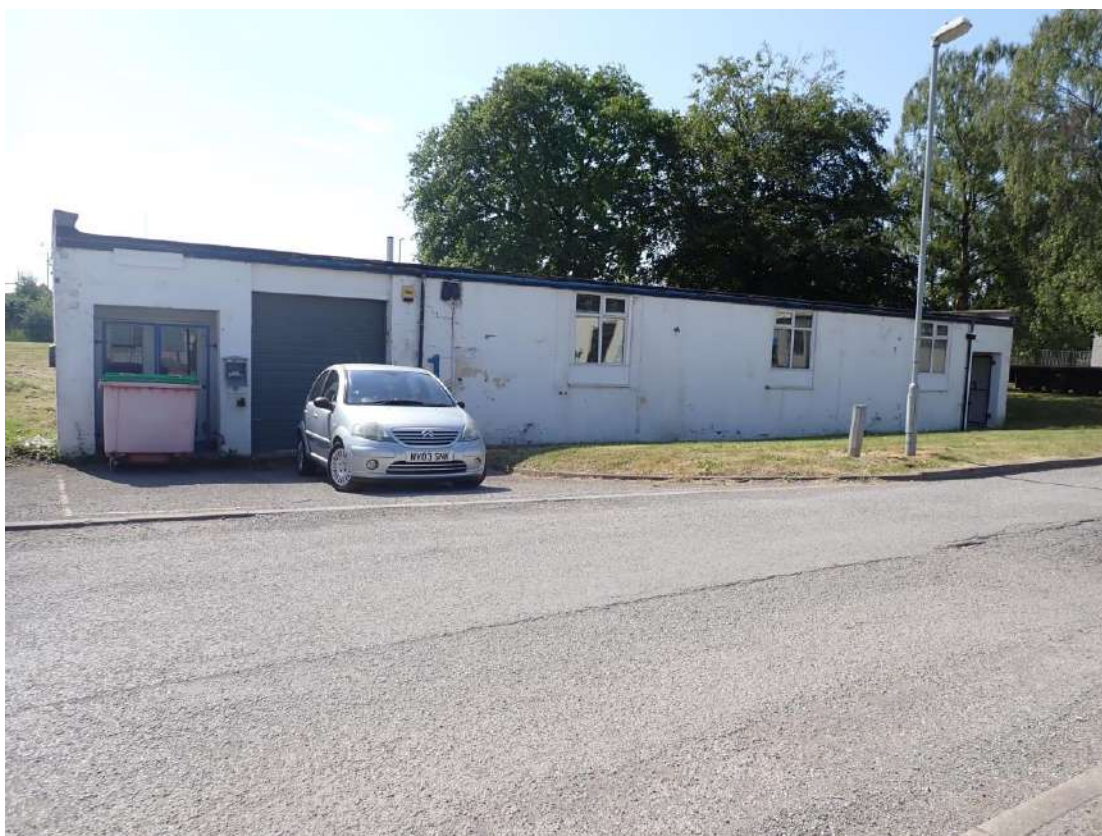
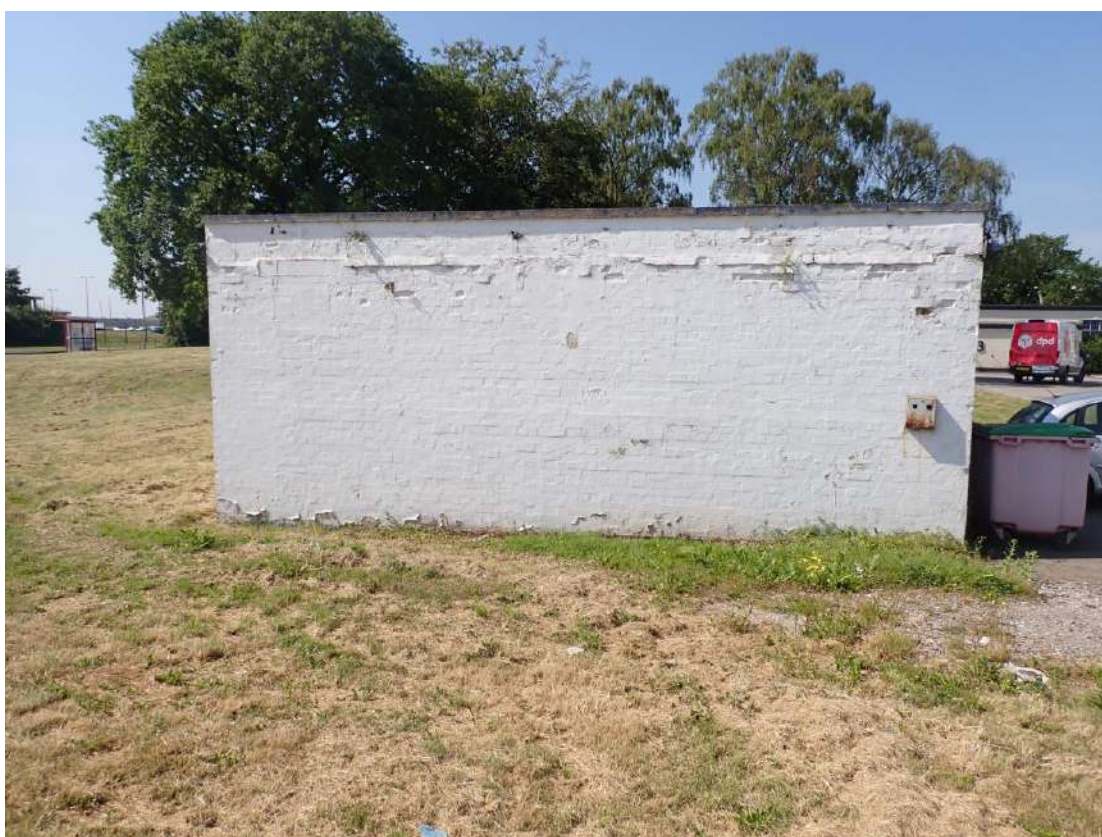
**Building 2** is a brick built rectangular building with a flat roof lined with bitumen roofing felt (Photographs 5-8). The windows have wooden frames in good condition. The building is currently unoccupied. The roof, fascia boards and brick work are in excellent condition with no PRFs identified.

Photograph 5 – Northwestern aspect of Building 2.

Photograph 6 – Northeastern aspect of Building 2.

Photograph 7 – Southeastern aspect of Building 2.

Photograph 8 – Southwestern aspect of Building 2.

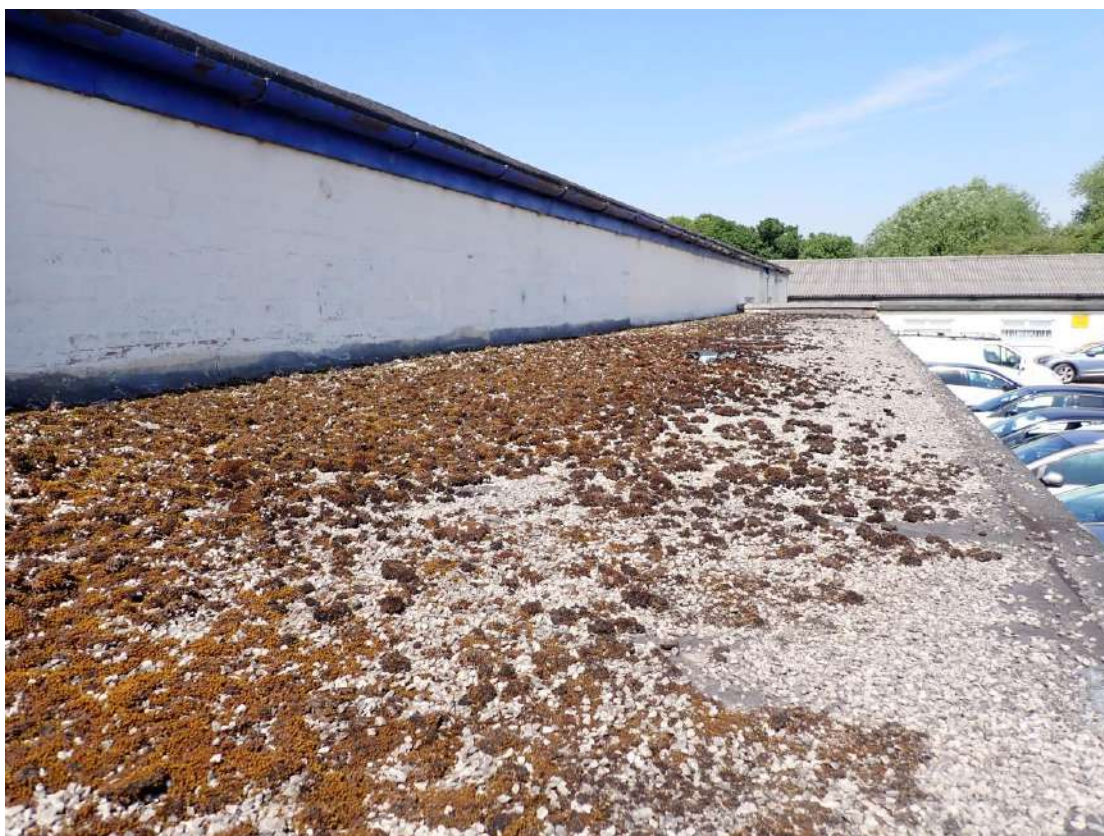
Photograph 9 – Southeastern aspect of Building 3.

Photograph 10 – Southern aspect of Building 3.

Photograph 13 – Northeastern aspect of Building 3.

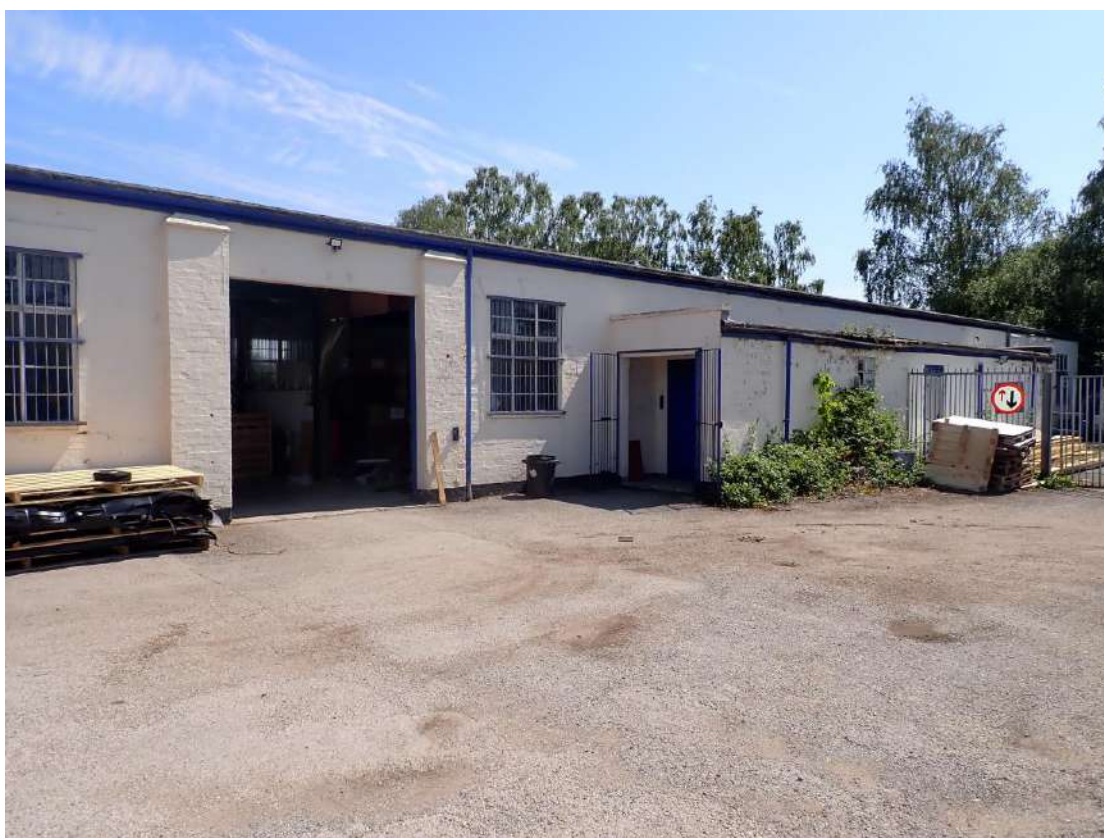
Photograph 14 – Southwestern aspect of Building 4.

Photograph 17 – Northwestern aspect of Building 4.

Photograph 18 – Northeastern aspect of Building 4.

Photograph 19 - Roof of Building 4.

Photograph 20 – Southwestern aspect of Building 4.

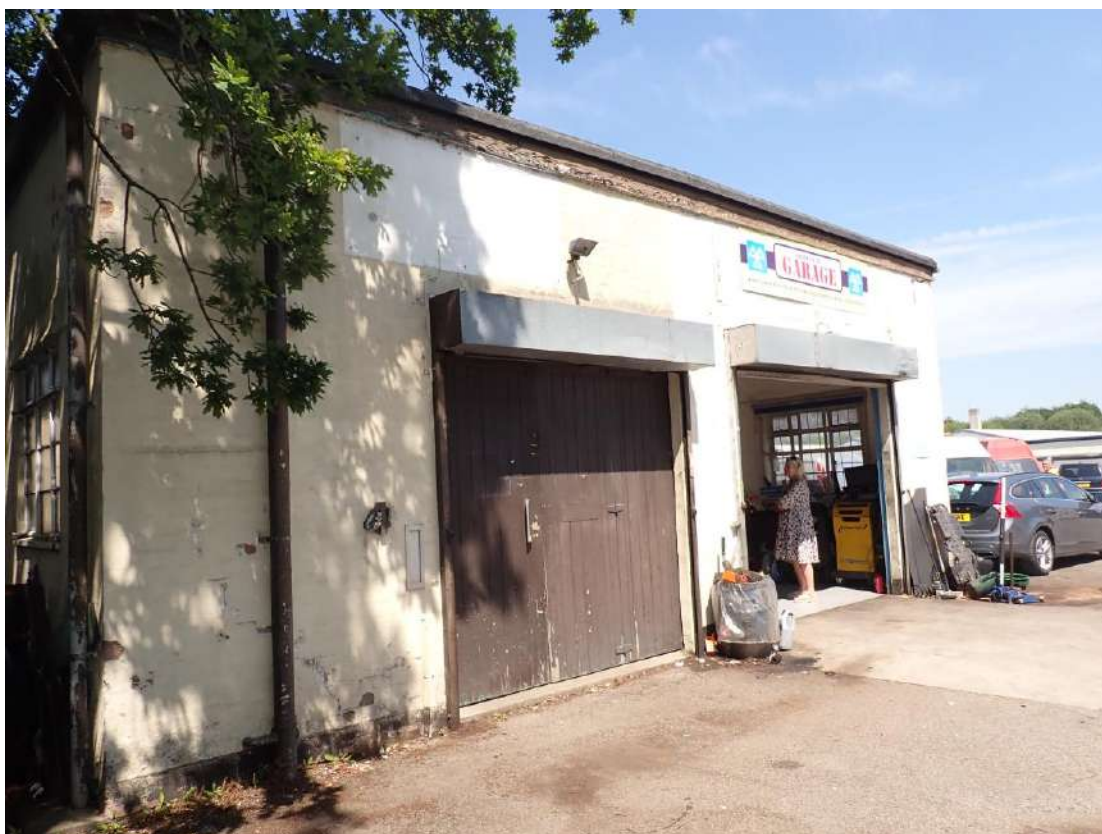
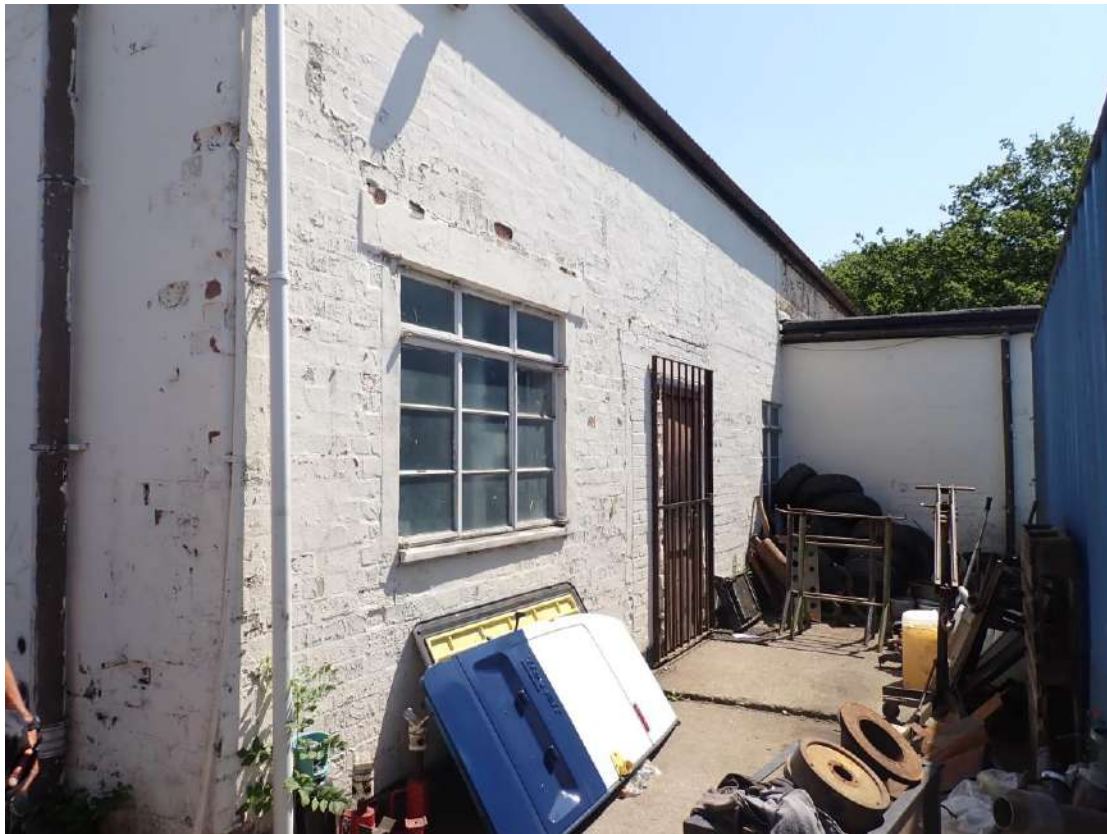
**Building 5** is a similar design to Building 3 and is currently used as a garage for repairing cars. The roof, wooden fascia boards and brick work are all in excellent condition with no PRFs identified.

Photograph 21 – Southeastern aspect of Building 5.

Photograph 22 – Northeastern aspect of Building 5.

Photograph 23 – Northeastern aspect of Building 5 (further north than Photograph 18).

Photograph 24 – Northwestern aspect of Building 5.

Photograph 25 – Southwestern aspect of Building 5 (further West than Photograph 16).

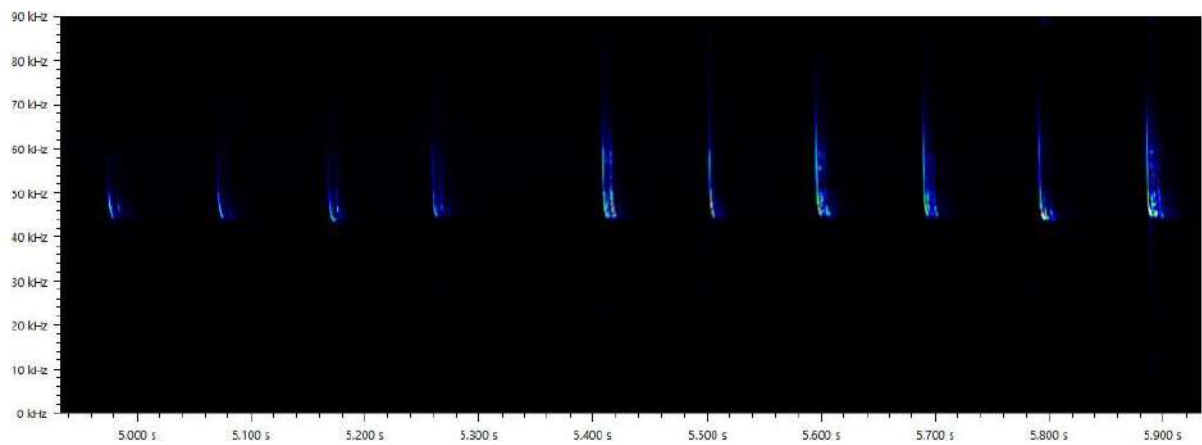
Sonogram 1. A common pipistrelle recorded at 22:08 on 24<sup>th</sup> July 2023.

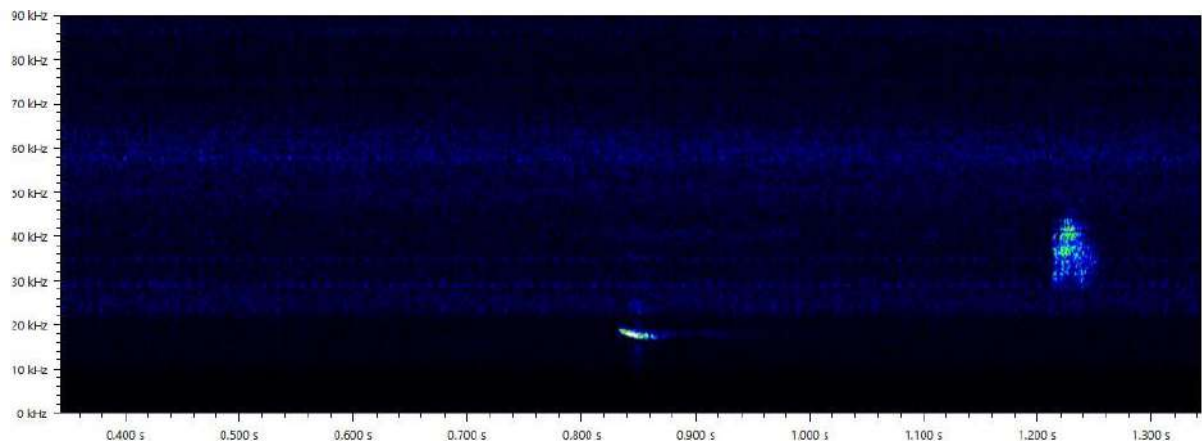
Sonogram 2. A noctule recorded at 21:49 on 28<sup>th</sup> July 2023.
