## PRELIMINARY ECOLOGICAL APPRAISAL

## RIDLEYWOOD FARM

**Project name:** Ridleywood Farm, Holt Road, Ridleywood,  
Wrexham, LL13 9YA

**Date:** 23/08/2023

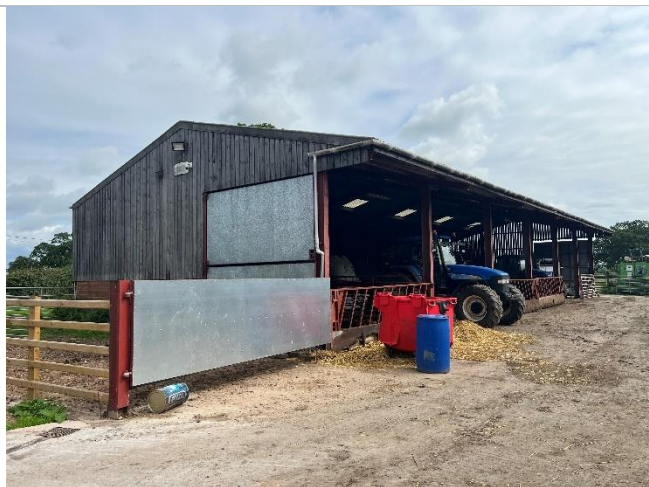
| Building reference | Description |
|---|---|
| <b>1</b> | A steel framed structure, open at the south facing elevation. The roof is covered with corrugated fibre cement sheets and the elevations are partly covered with Yorkshire boarding. The building sits on a concrete pad and there are several skylights present along the roof. |

| Building reference | Roosting potential |
|---|---|
| 1 | No cavities or crevices, materials not suitable for roosting bats. No evidence of bats or potential roosting features identified. Day time conditions light and drafty, internal conditions not suitable for roosting bats. |

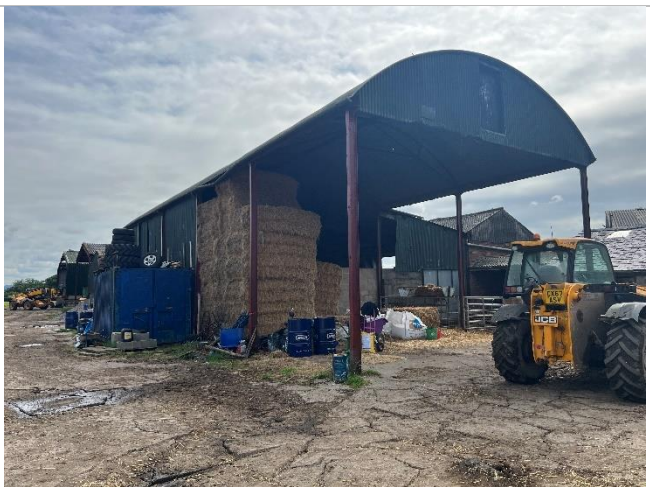
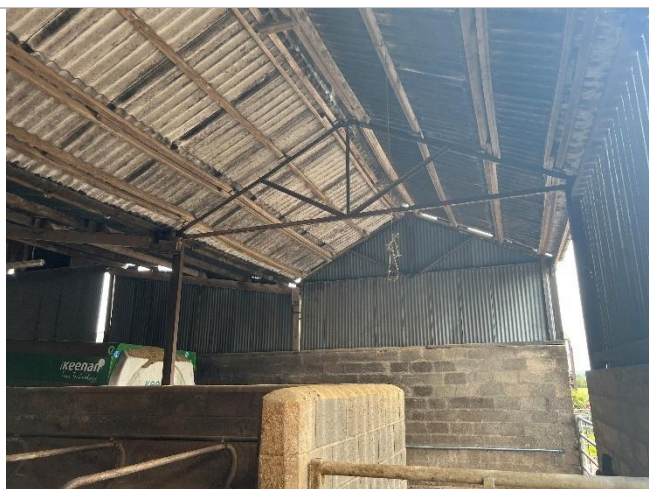
| Building reference | Description |
|---|---|
| <b>2a</b> | A steel framed Dutch barn with a corrugated tin roof and cladding at the elevations. Blockwork makes up low level walls at ground level and the building sits on a concrete pad. There is a half-pitch roof between the Dutch barn and a further steel framed building with a pitched roof. The building has a corrugated fibre cement roof and is open at the sides. |

| Building reference | Roosting potential |
|---|---|
| 2a | No cavities or crevices, materials not suitable for roosting bats. No evidence of bats or potential roosting features identified. Day time conditions light and drafty, internal conditions not suitable for roosting bats. |

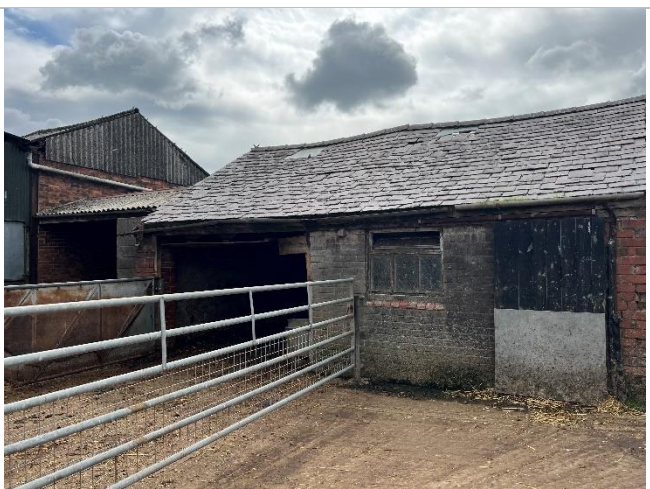
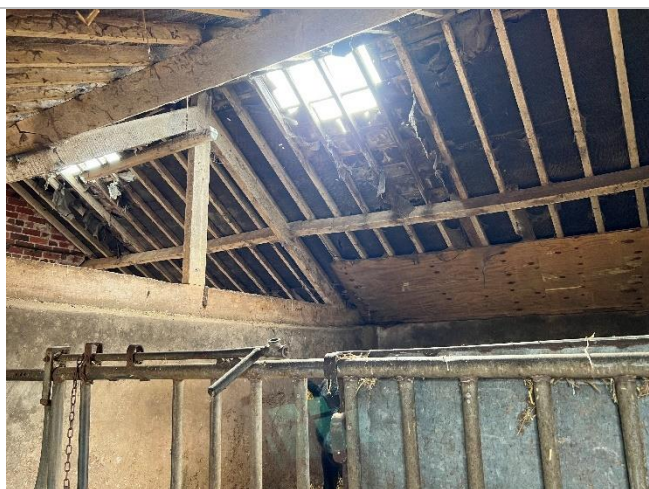
| Building reference | Description |
|---|---|
| <b>2b</b> | A very small single storey brick barn with corrugated fibre cement roof, adjoining a further very small brick barn with a slate roof. The slates are lined internally but the roof is in poor condition. The verges are cemented and the structure sits on a concrete pad, opening out onto the yard. |

| Building reference | Roosting potential |
|---|---|
| 2b | Some slipped slates visible from the external inspection and a handful of potential roosting features identified within e.g. at the top of the wall plate, beneath ridge tiles. Roosting features limited to small crevices, |

| | largely external. No evidence of bats but in use by livestock so would not be apparent. |

Building 2b provides 'low' suitability as a bat roost as per Table 4.1 of the Bat Conservation Trust survey guidelines. At least one bat activity survey will be required before any works can commence on this structure. The survey must be carried out between May and August in a given year, by suitably qualified surveyors.

Further survey work will be needed before works begin on building 2b.

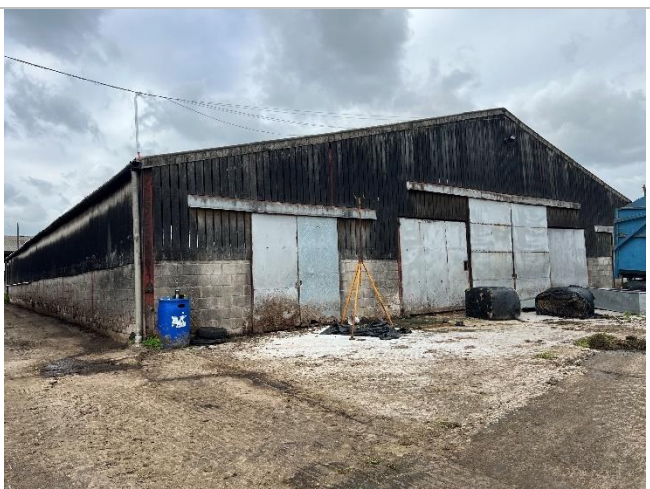
| Building reference | Description |
|---|---|
| <b>3</b> | A very large steel framed cow shed with blockwork at the wall base and corrugated fibre cement elevations and roof. Numerous sky lights sit along the pitched roof and the verges and ridge are capped with fibre cement material. The structure sits on a large concrete pad and has double width and height sliding doors. |

| 3 | No cavities or crevices, materials not suitable for roosting bats. No evidence of bats or potential roosting features identified. Day time conditions light and drafty, internal conditions not suitable for roosting bats. |

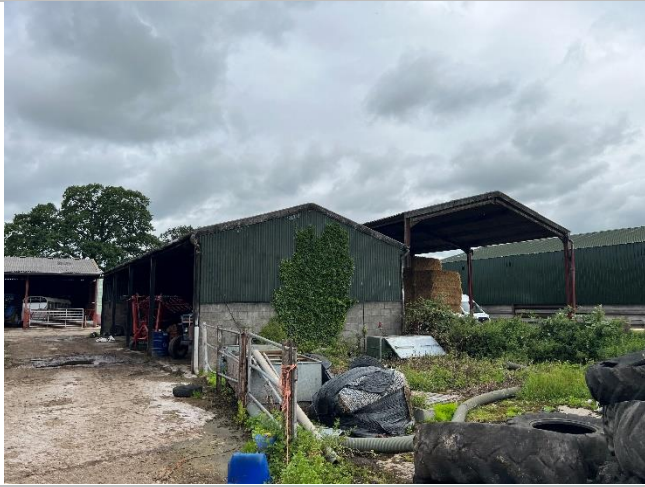
| Building reference | Description |
|---|---|
| <b>4a</b> | A steel framed open fronted shed with a corrugated fibre cement roof and numerous sky lights. There is blockwork at the wall base and corrugated tin sheets at the elevations. The building sits on a concrete pad. |

| 4a | No cavities or crevices, materials not suitable for roosting bats. No evidence of bats or potential roosting features identified. Day time conditions light and drafty, internal conditions not suitable for roosting bats. |

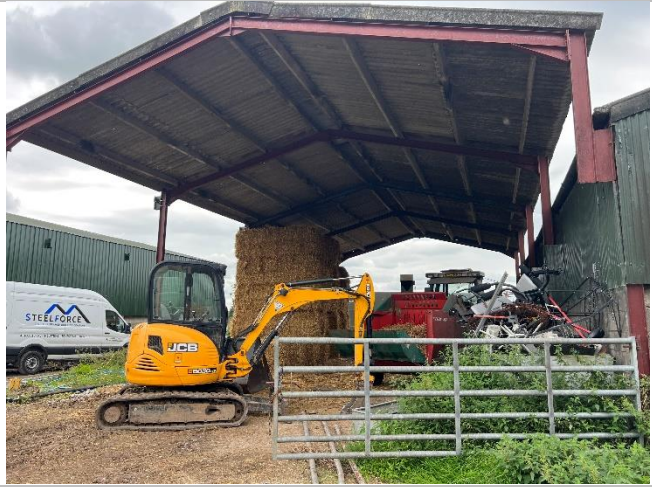
| Building reference | Description |
|---|---|
| <b>4b</b> | An open sided steel framed shelter with fibre cement roof and concrete floor. |

| 4b | No cavities or crevices, materials not suitable for roosting bats. No evidence of bats or potential roosting features identified. Day time conditions light and drafty, internal conditions not suitable for roosting bats. |

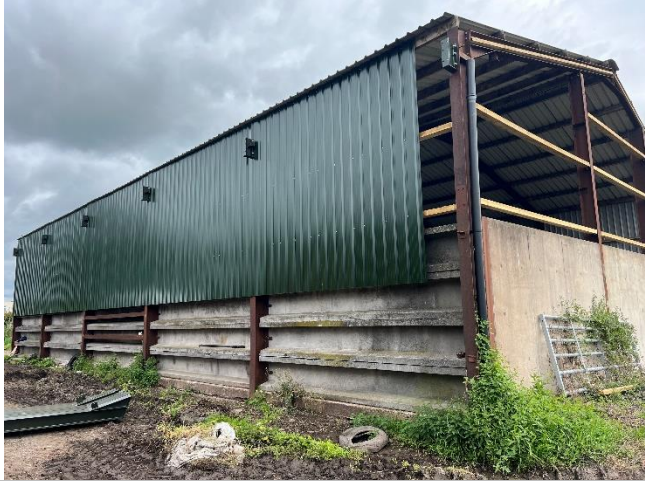
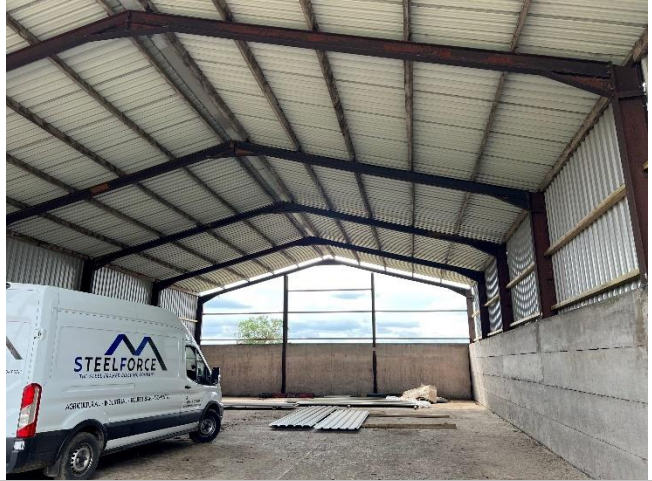
| 5 | A modern steel framed agricultural shed with box profile sheets on the roof and top third of the elevations. The building sits on a concrete floor and the wall bases are made up of pre-cast concrete panels. |

| 5 | No cavities or crevices, materials not suitable for roosting bats. No evidence of bats or potential roosting features identified. Day time conditions light and drafty, internal conditions not suitable for roosting bats. |
