**PHASE II  
GEOENVIRONMENTAL ASSESSMENT**

**AREA B2  
OVERTON-ON-DEE, WREXHAM**

Report No: 19148/3  
Date: September 2019

Prepared for  
**PICKSTOCK HOMES LIMITED**

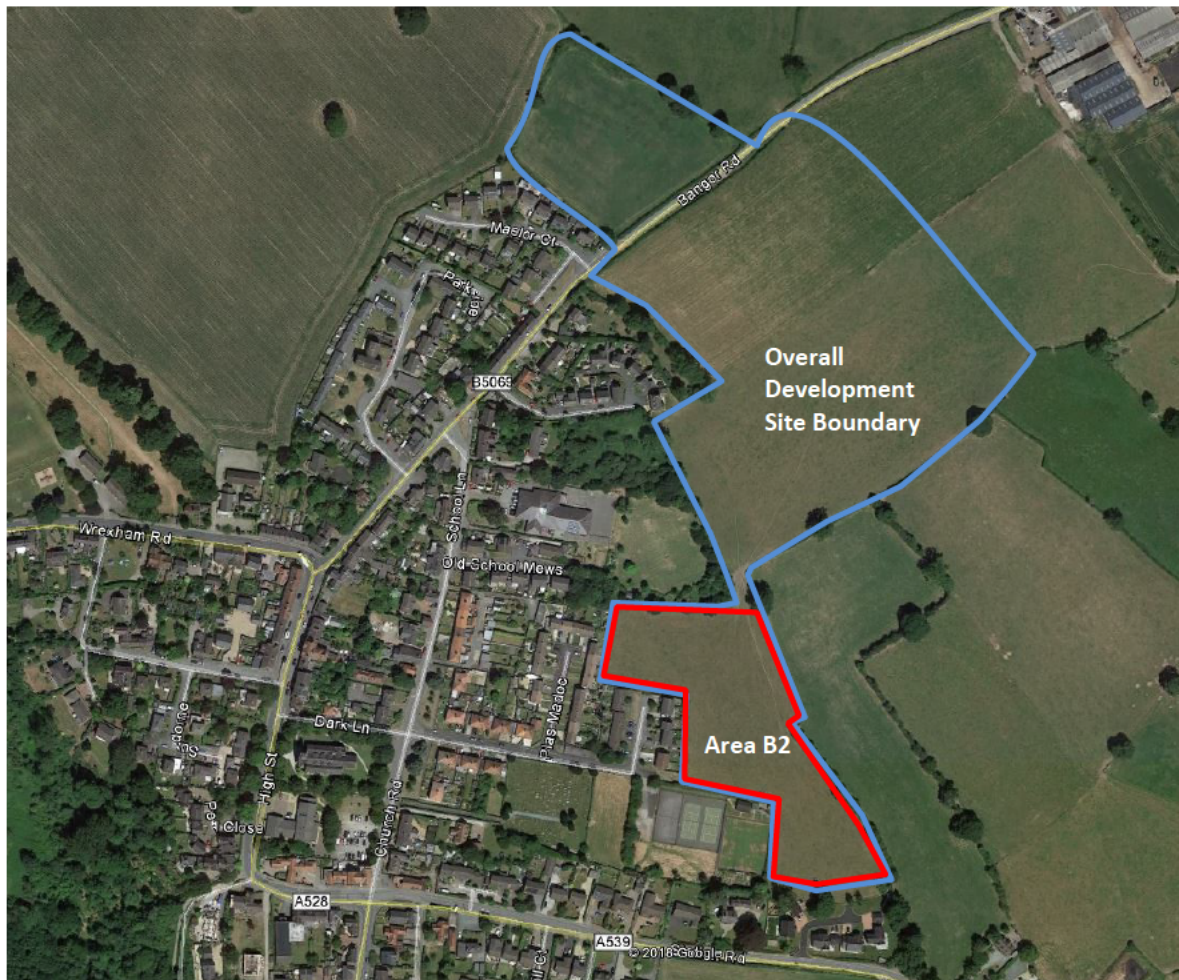
- 4.1 The site comprises land to the east of Overton-on-Dee and can be located approximately by National Grid Reference 337611, 341755. The general site layout is indicated on Drawing No. 19148/3, entitled 'Exploratory Hole Location Plan', included in Appendix A and on the satellite image presented overleaf.
- 4.2 Area B2 comprises a parcel of undeveloped agricultural land with the site boundaries formed by mature trees and hedgerows.
- 4.3 It is bound by a school and existing housing to the west, north-west and south with undeveloped agricultural land to the north-east and east.
- 4.4 No visual evidence of potential significant contamination was observed during the site visit.
