## SOAKAWAY ASSESSMENT

| <b>Project Number:</b><br>PT1346 | <b>Site Address:</b><br>Land Off St Mary's Avenue, Wrexham, LL13 0EQ | |
| <b>Weather:</b><br>Heavy Rain | <b>Date Of Testing:</b><br>21/11/2022 | <b>Client:</b> |

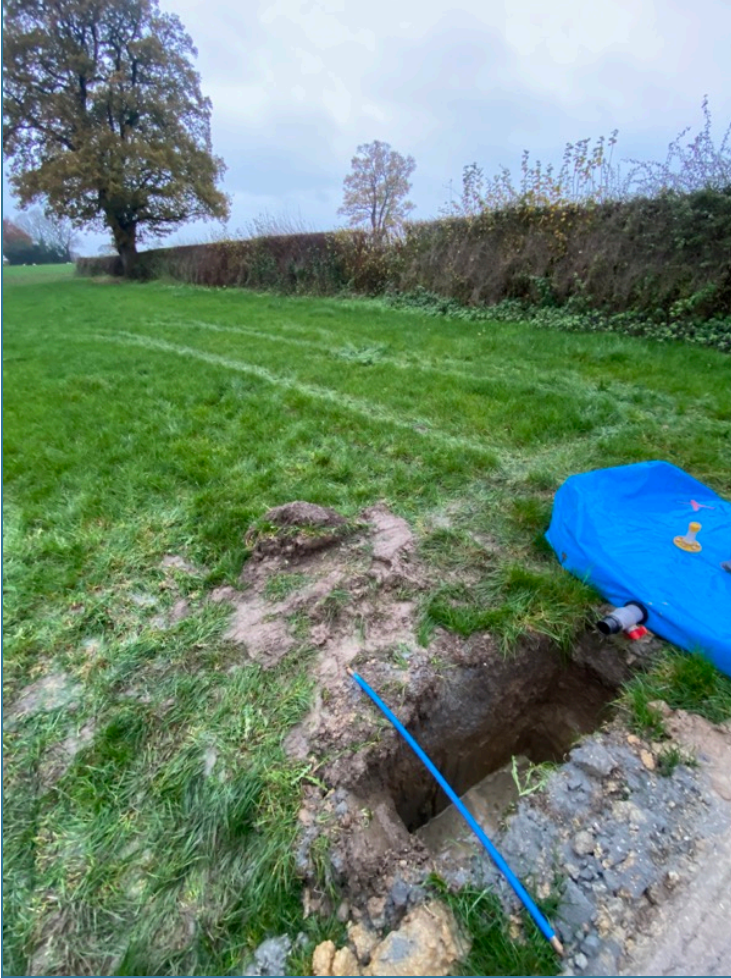
Trial Pit A

| A (1) | 1000 | 300 | 2000 | 1000 |

No ground water encroached during excavation, however care should be taken during drainage design as ground water encroached in other trial holes excavated on site

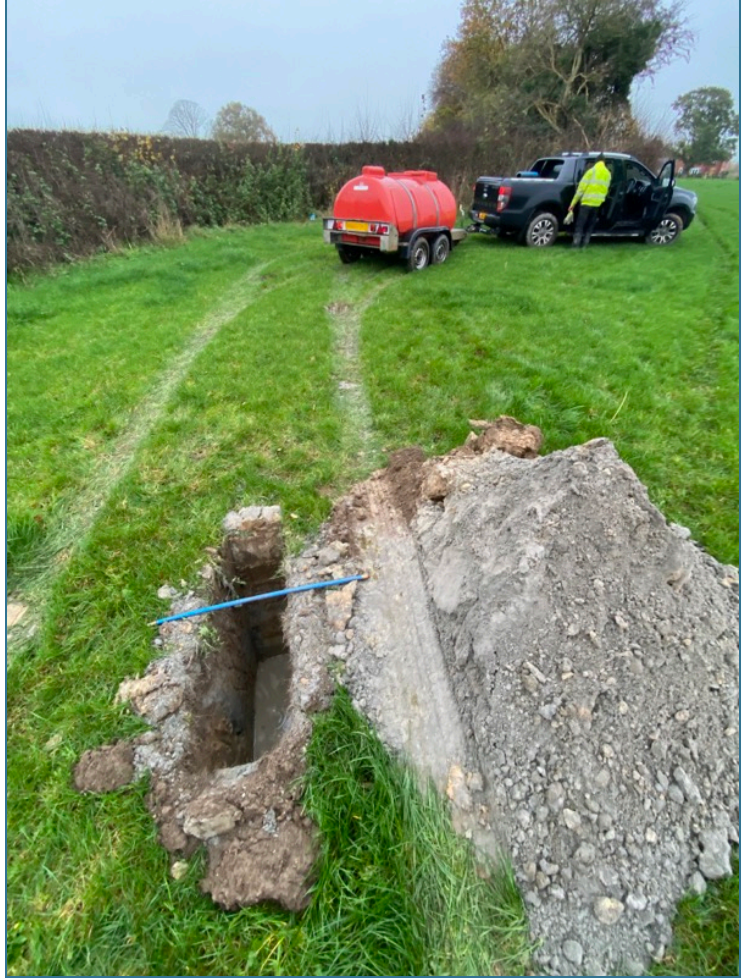
Trial Pit B

| B (2) | 1000 | 300 | 2000 | 1000 |

No ground water encroached during excavation, however care should be taken during drainage design as ground water encroached in other trial holes excavated on site

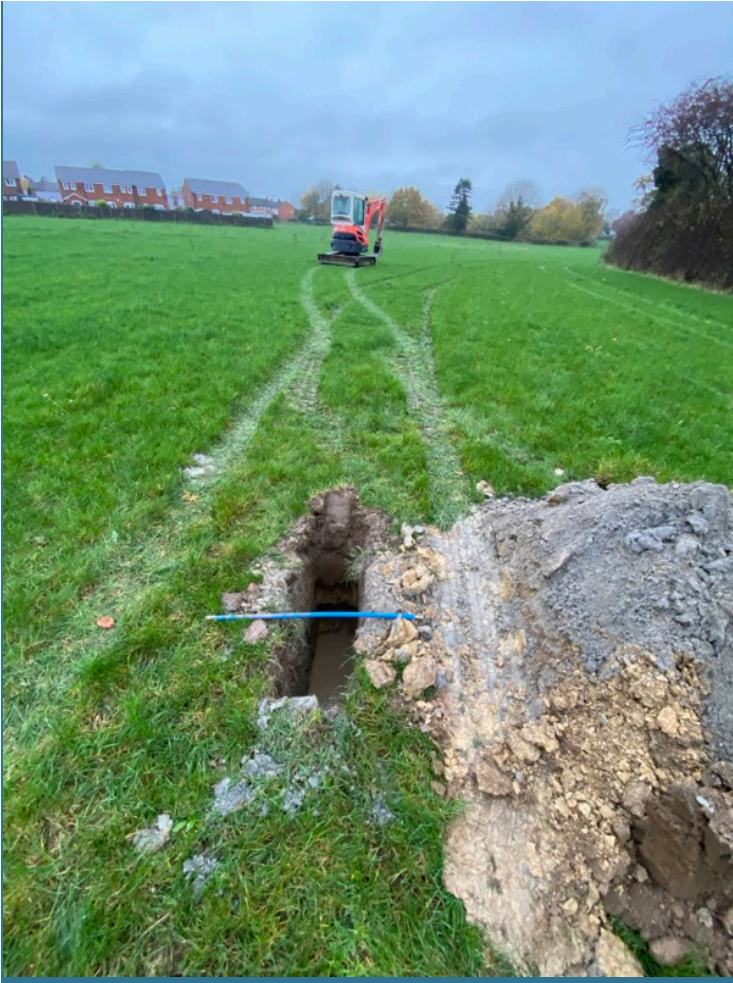
Trial Pit C

C(3)

No ground water encroached during excavation, however care should be taken during drainage design as ground water encroached in other trial holes excavated on site
