## **Arboricultural Impact Assessment & Method Statement**

### **Land off St Marys Avenue, Overton on Dee**

**PICKSTOCK HOMES**

Our Ref: 23/AIA/WXM/316

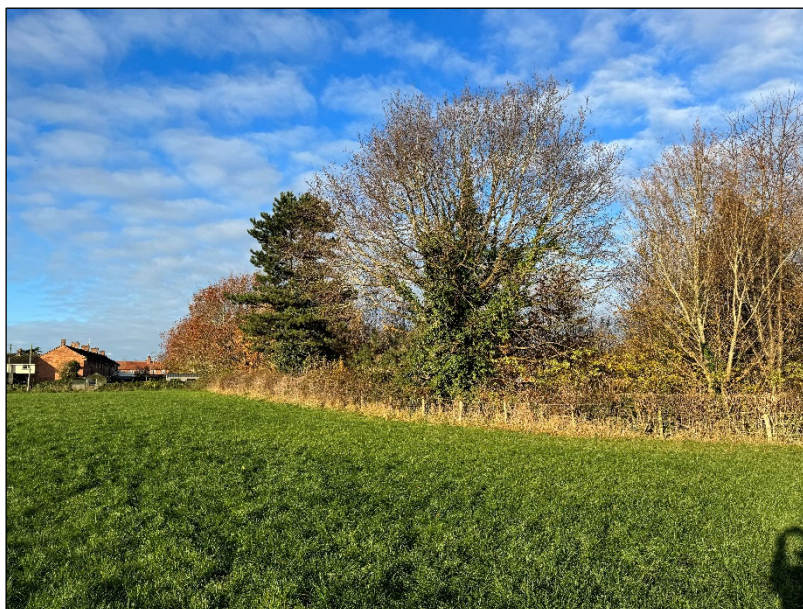
- 5.4.1 The nearest trees to any dwellings are located to the north of plots 26-28. T14 to the rear of plot 26 is a Scots Pine with a small diameter crown spread that will not cause substantial shade to the rear garden area or plot. The canopy of T13 does however partially cover the garden areas of plots 27 and 28 and the applicant intends to undertake pruning works to alleviate this for future occupants. These plots do enjoy an unimpeded southernly aspect to the front and will receive morning and evening sunlight from an east and westerly aspect as they are also unimpeded by trees.

P1 – Tree numbers 13-14 located to north of plots 26-28

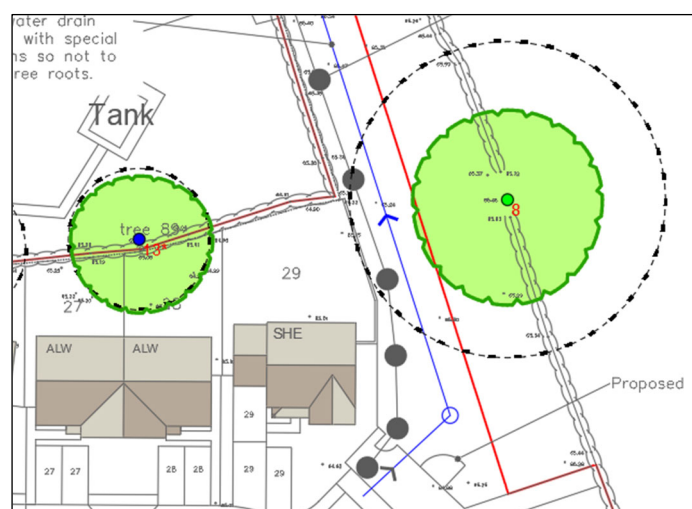
7.2.1 The proposed surface water drain alignment has been amended following on-site consultation with Tree Solutions. It now runs on the outer periphery of the RPA of tree number 8 with a maximum incursion of 1.5m. The necessary trench is 250mm wide and 900mm deep and will be excavated by a mini-tracked excavator working off ground protection boards laid within the necessary easement area as indicated on the Tree Protection Plan at Appendix 4. All works will be undertaken under the direct supervision of the contract Arboricultural Clerk of Works (ACoW) with any roots encountered carefully pruned back to a suitable available inner node. We are confident that with careful working practices and appropriate supervision that these works will have no adverse impact to the health and vitality of tree number 8.

Plate 1 – original surface water drain alignment 10.8m from tree stem

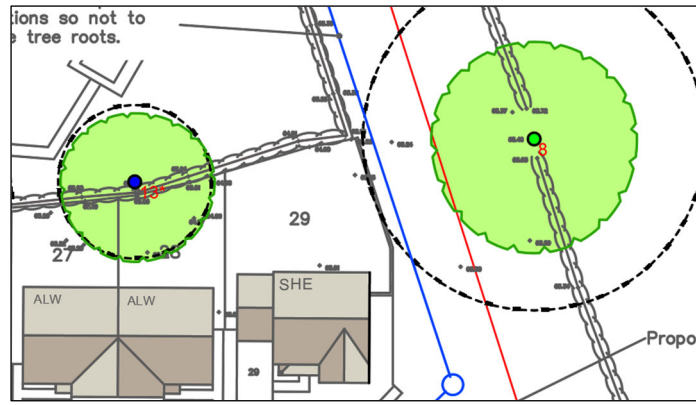
Plate 2 – realigned surface water drain alignment 13m from tree stem

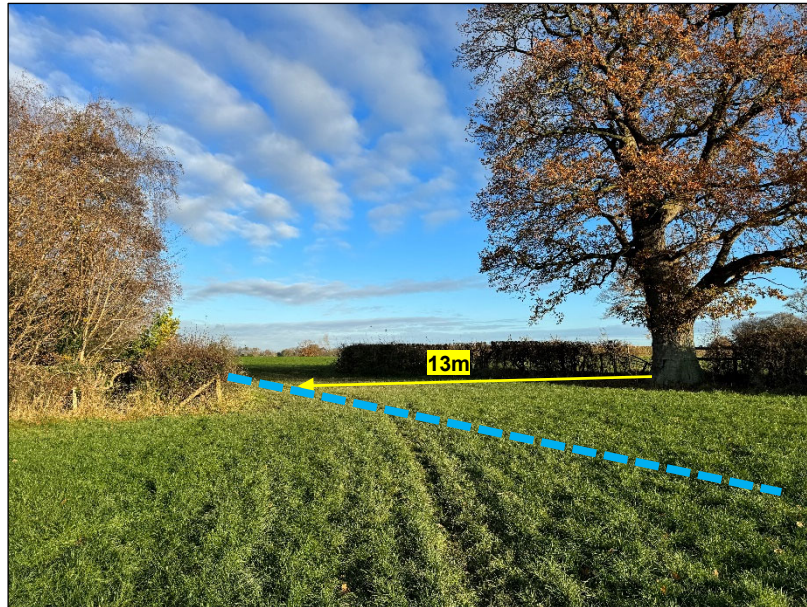
P2 – Proposed surface drain alignment 13m from T8

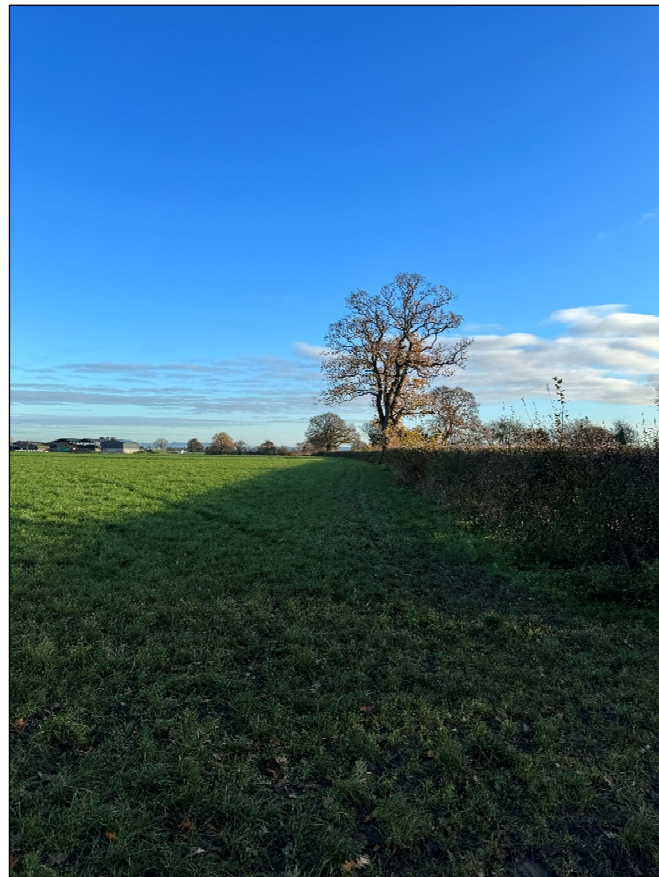
P3 – Proposed surface drain alignment outside RPA of T9 & T10

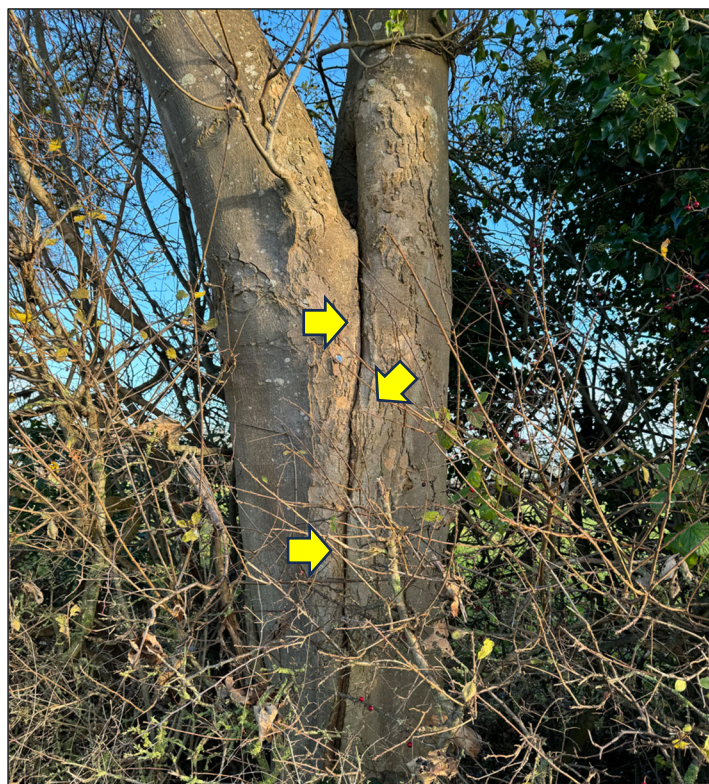
- 8.3 Whilst unnecessary to facilitate any works we have identified tree number 7 as hazardous due to a significant longitudinal crack in the main stem either side of the main union. As a result, this tree has been categorized as 'U' grade as it is in such a condition that it cannot realistically be retained in the context of the current land use for longer than 10 years. This tree has therefore been marked for removal for H&S reasons and will be replaced by new planting as detailed in the landscape proposals.

P3 – Crack below union on T7

| TREE NO.<br><small>T - Tree<br/>G - Group<br/>H - Hedge</small> | SPECIES<br>(COMMON NAME) | AGE | HEIGHT (m) +<br>CROWN<br>CLEARANCE/<br>DIRECTION<br>OF GROWTH<br>(N.S.E.W) | RADIAL CROWN SPREAD (m) | | | | STEM/<br>MULTI-STEM*<br>DIA.(mm) | VITALITY | COMMENTS | MANAGEMENT | CATEGORY & SUB-CATEGORY GRADING BS 5837 | BS 5837 RADIUS (m)<br>RPA (m²) |
|---|---|---|---|---|---|---|---|---|---|---|---|---|---|
| T7 | Maple | | | | | | | | P | <ul style="list-style-type: none"> <li>Large crack in main stem either side of compression union</li> <li>Hazardous and liable to complete failure</li> </ul> | <ul style="list-style-type: none"> <li>Remove for H&amp;S</li> </ul> | U | N/A |

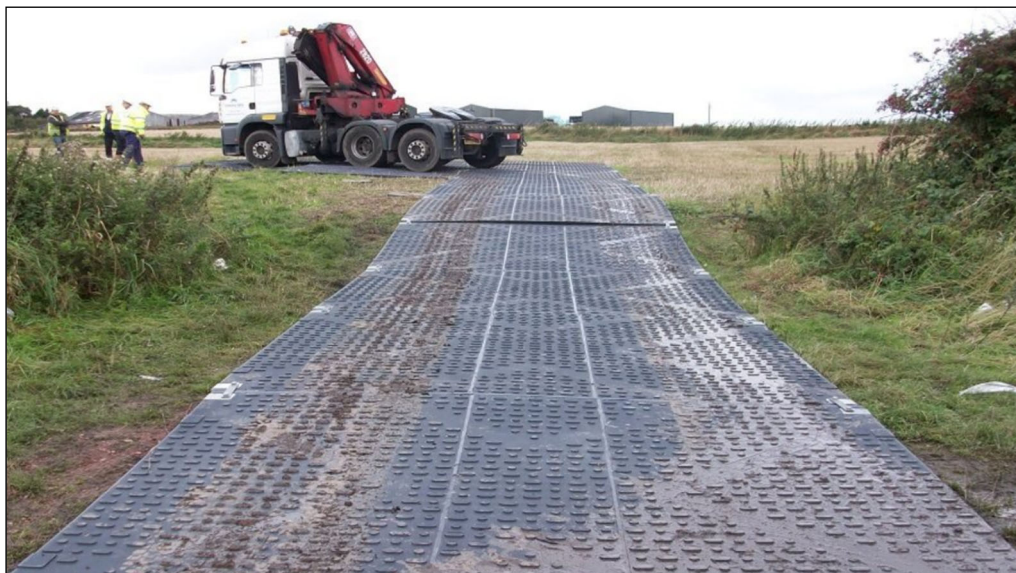
P6 – Example of ground guards used for plant access within RPA of trees

1. Prior to commencement of any trenching works ground protection must be installed where indicated with an orange hatch on the Tree Protection Plan at **Appendix 4**
2. The ground protection measures must be capable of supporting the expected plant loads and evenly distribute the carried weight over the track width to avoiding rutting, compaction, and damage to the soil.
3. Temporary ground protection materials shall be delivered and moved by low impact tracked machinery and installed by hand
4. The ground protection will involve the use of a bog mats or ground guards to be agreed with the LPA
5. The ground beneath the mats will be left undisturbed and will be protected with a porous geotextile fabric and side butting scaffold boards on a 100mm compressible layer such of sharp sand or wood chip
