Phase I Geoenvironmental Site Assessment  
Bryn Lane, Wrexham Industrial Estate

## **PHASE I GEOENVIRONMENTAL SITE ASSESSMENT**

Bryn Lane  
Grafters Ltd, Unit 6  
Wrexham Industrial Estate  
LL13 9UT

Prepared for:  
Portal Construction N.W. Ltd

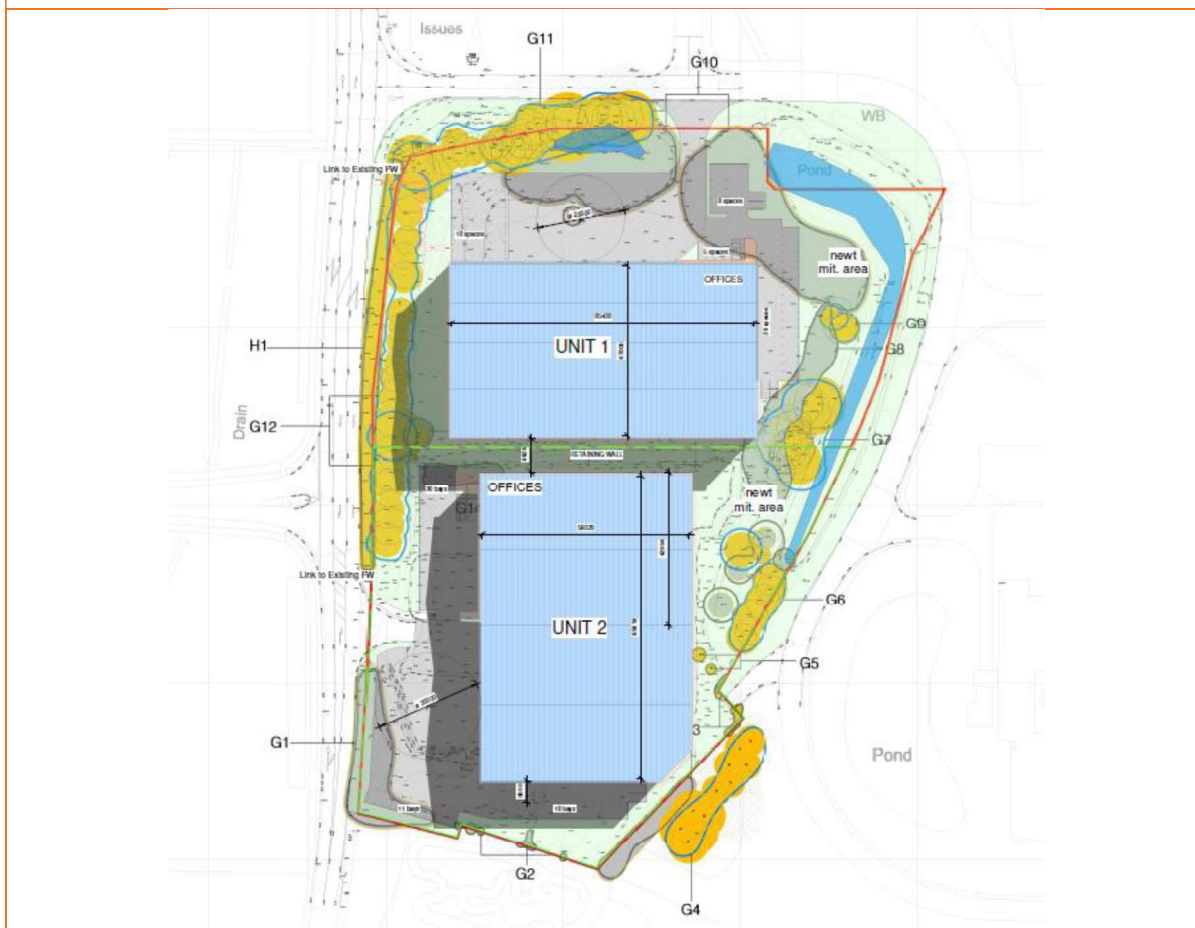
FIGURE 1.1 SNAPSHOT OF PROPOSED DEVELOPMENT OPTIONS

A snapshot of the proposed development layouts is indicated in Figure 1.1.

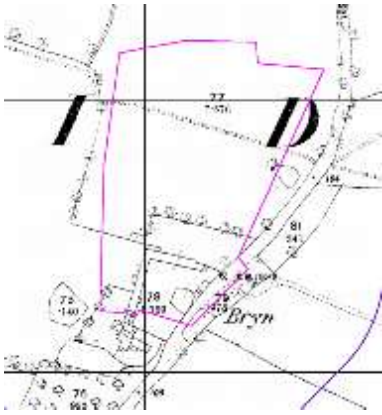
| MAP EDITION | HISTORICAL LAND USE | HISTORICAL MAP EXCERPT |
|---|---|---|
| <p><b>1873</b><br/><b>1:2,500</b></p> | <p>The site is predominantly agricultural land with a pond located along the eastern boundary and one located to the south of the site. Unspecified structures are located in the south of the site.</p> | |

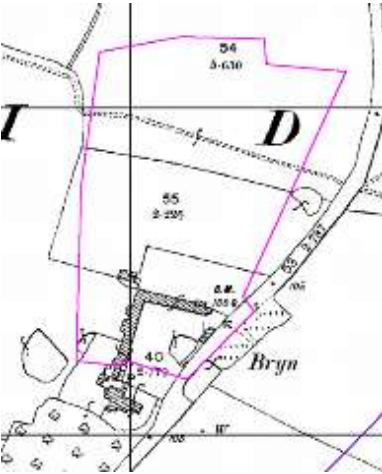
| MAP EDITION | HISTORICAL LAND USE | HISTORICAL MAP EXCERPT |
|---|---|---|
| <p><b>1899</b><br/><b>1:2,500</b></p> | <p>Two pumps are recorded on the southern boundary of the site with close proximity to the buildings present.</p> | |

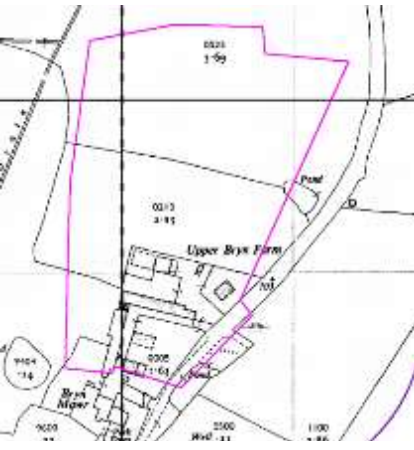
| MAP EDITION | HISTORICAL LAND USE | HISTORICAL MAP EXCERPT |
|---|---|---|
| <p><b>1961</b><br/><b>1:2,500</b></p> | <p>Several more buildings have been developed in the site noted as Upper Bryn Farm, that extends from the centre and to the south of the site farm buildings are noted as Bryn Mawr and Park Farm. The pond in the south of the site is no longer recorded.</p> | |

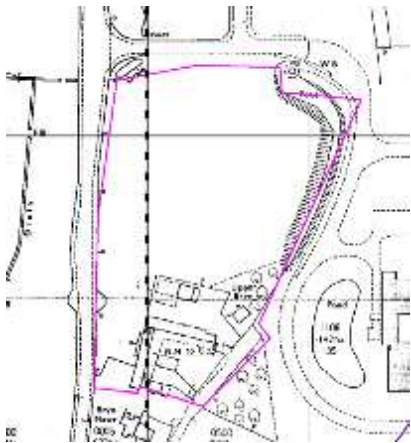
| MAP EDITION | HISTORICAL LAND USE | HISTORICAL MAP EXCERPT |
|---|---|---|
| <b>1972-1974</b><br><b>1:2,500</b> | <p>A pond is present in the north-eastern corner of the site and extends along the eastern boundary. The area in the northeast of the site has been excavated to create the pond with an embankment formed around the perimeter. A drain is recorded in the northwest of the site. New roadways have been built around the site.</p> | |

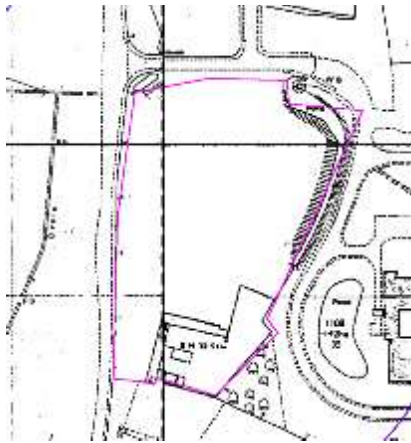
| MAP EDITION | HISTORICAL LAND USE | HISTORICAL MAP EXCERPT |
|---|---|---|
| <b>1982</b><br><b>1:2,500</b> | <p>The farm buildings associated with Upper Bryn Farm have been demolished, with only a few buildings remain in the south of the site.</p> | |

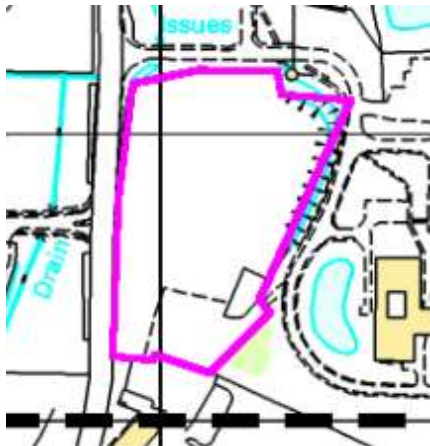
| MAP EDITION | HISTORICAL LAND USE | HISTORICAL MAP EXCERPT |
|---|---|---|
| <b>2006</b><br><b>1:10,000</b> | <p>The remaining buildings in the south of site have been demolished.</p> | |

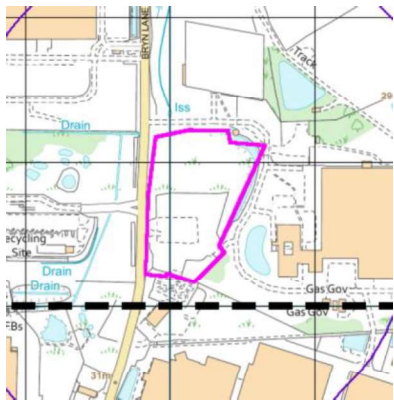
| MAP EDITION | HISTORICAL LAND USE | HISTORICAL MAP EXCERPT |
|---|---|---|
| <b>2006</b><br><br><b>1:10,000</b> | No significant changes to site. | |

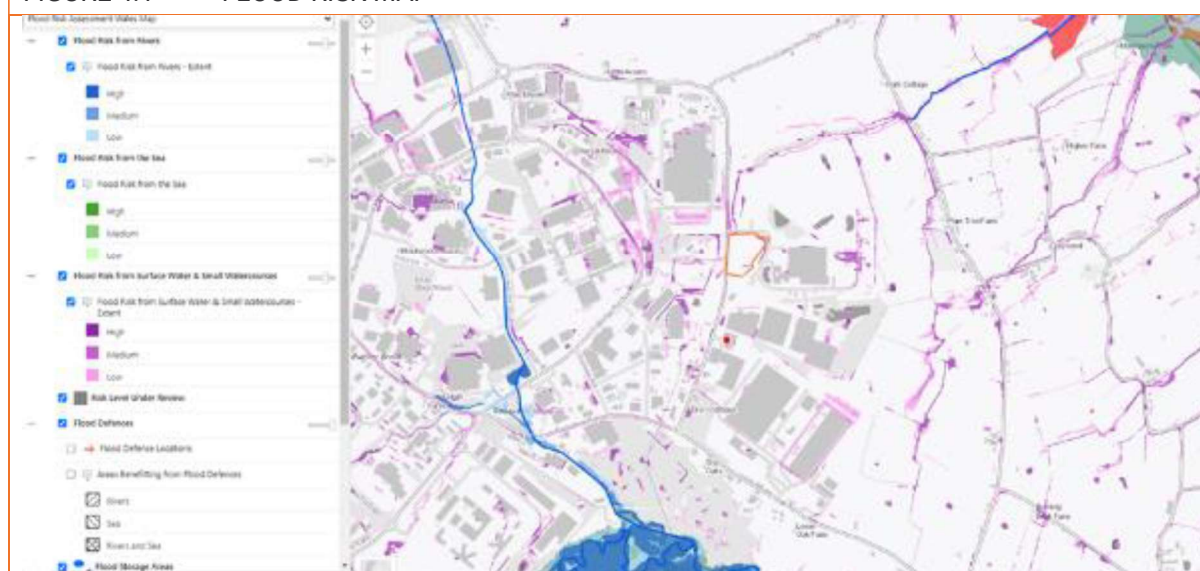
FIGURE 4.1 FLOOD RISK MAP

The site is predominantly located within a currently defined "Flood Risk Zone 1"; defined as land assessed as having less than 1 in 1,000 annual probability of river or sea flooding (< 0.1%), and as such is considered to be unaffected by river flooding. In addition, the Envirocheck report states there is a limited potential for groundwater flooding to occur at the site. The Natural Resource Wales Flood Risk Map for the site is presented as Figure 4.1.

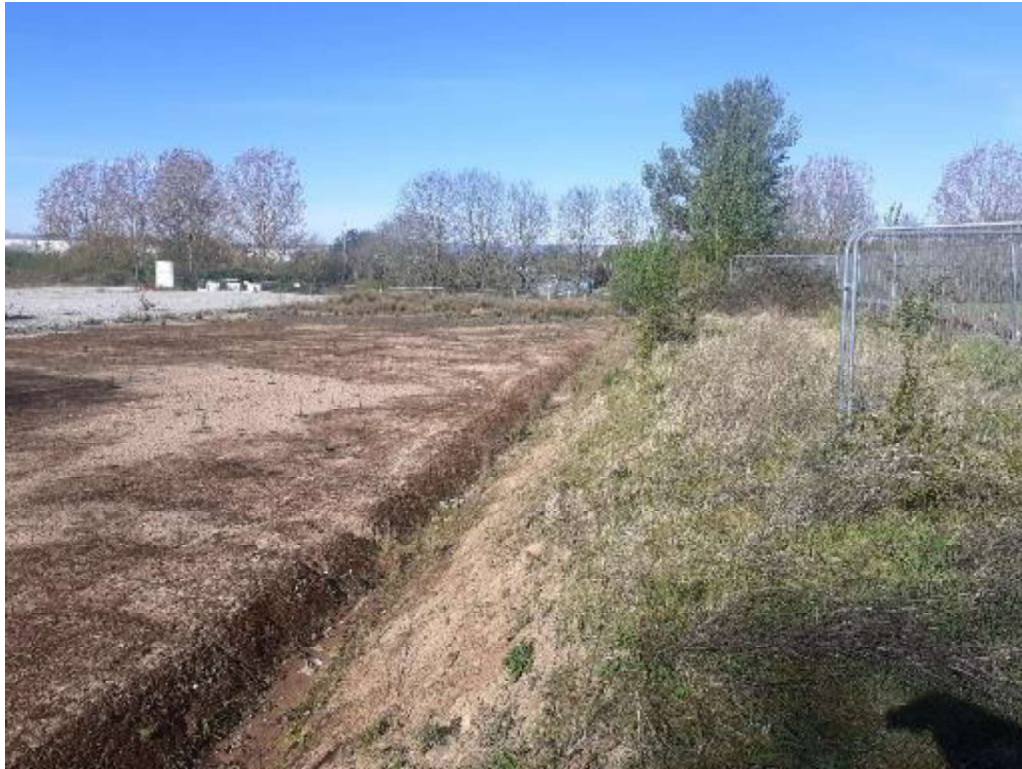
| <b>Slope</b> | Imagery from google maps has identified a slope of 2-3m from the grassed area in the north to the area of hardstanding in the south. The site has a gentle slope on the grassed western boundary roughly 2-3m. Along the eastern boundary, there is a steep embankment from the drainage ditch. | |

PLATE 1      SOUTH OF THE SITE – 2-3 m LOWER IN ELEVATION

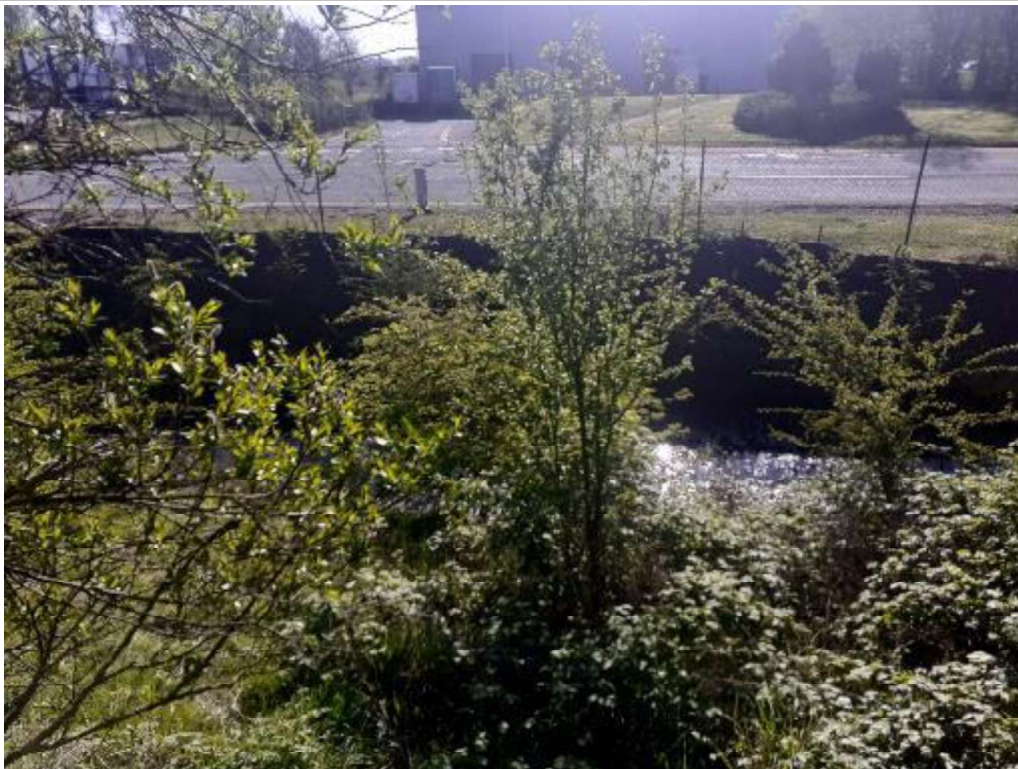
| <b>Drainage</b> | A formal drainage survey has not been completed; however, a review of online imagery shows several drainage ditches on the site that flow into the River Dee. |

PLATE 2      DRAINAGE DITCH ALONG THE EASTERN BOUNDARY

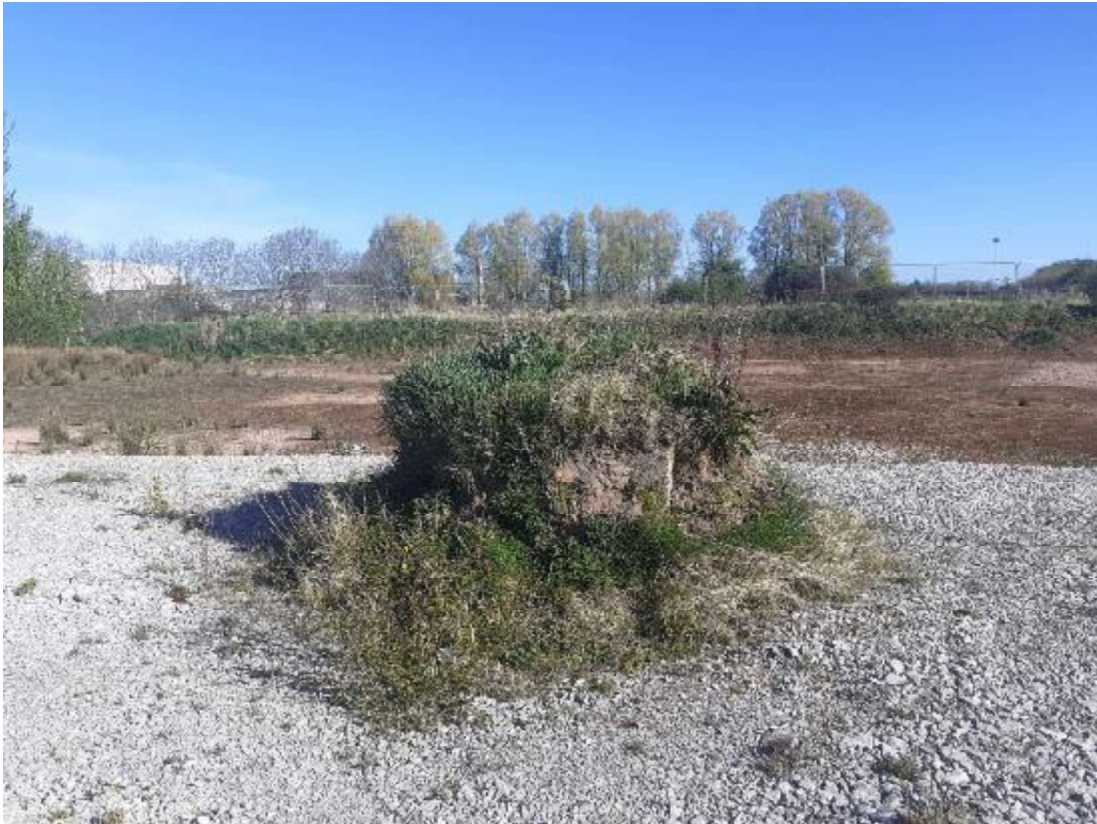
| <b>Utility Locations</b> | A formal drainage survey has not been completed; however, a manhole was noted in the northeast corner of the hardstanding. A site walkover has also identified potential services entering the site from Bryn Lane. | |

PLATE 4      MANHOLE IN THE NORTH EAST CORNER OF THE HARDSTANDING

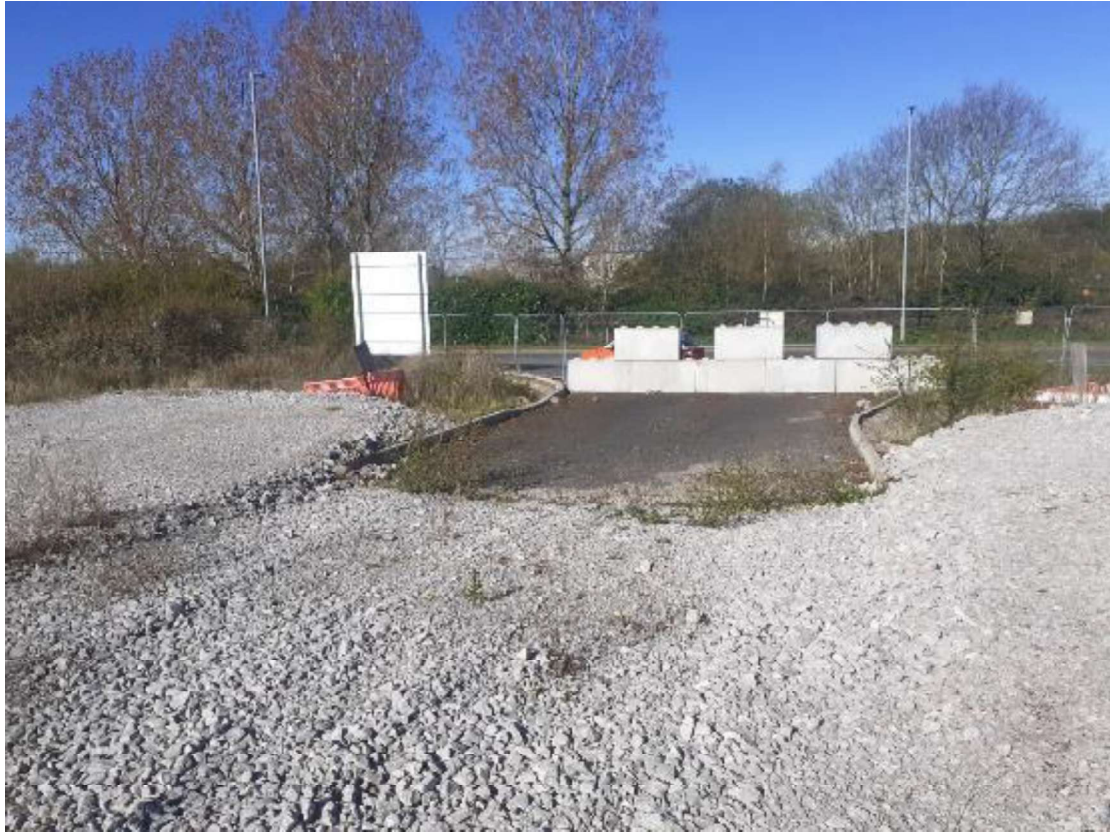
| <b>Access</b> | Vehicle access off Bryn Lane via a private road leading to Kingmoor Park along the northern boundary of the site. There is another point of access along the south east corner of the site from the road leading to Kingmoor Park. | |

PLATE 6 POSSIBLE ACCESS TO SITE FROM BRYN LANE
