**FIR TREE HOUSE CLOY LANE OVERTON - OUTBUILDING**

As requested, we carried out a structural appraisal on the above mentioned outbuilding on Tuesday 4 August 2020.

**Proposed conversion of outbuilding  
at Fir Tree House**

**Bat and bird survey**

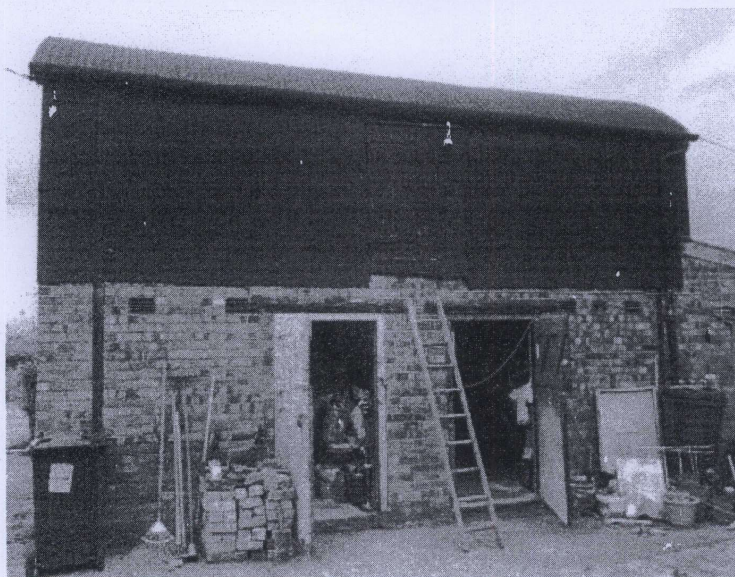
Photograph P1

**1.1** The outbuilding is constructed from a combination of steel framework combined with loadbearing masonry walls and piers. The building has facing brickwork elevations from ground floor to first floor levels, then single skin corrugated steel cladding above first floor level.

The roof has a barrel vaulted, corrugated steel sheeted finish, see photograph P1.

The roof construction will need to be replaced for both the two storey building and the lean-to.

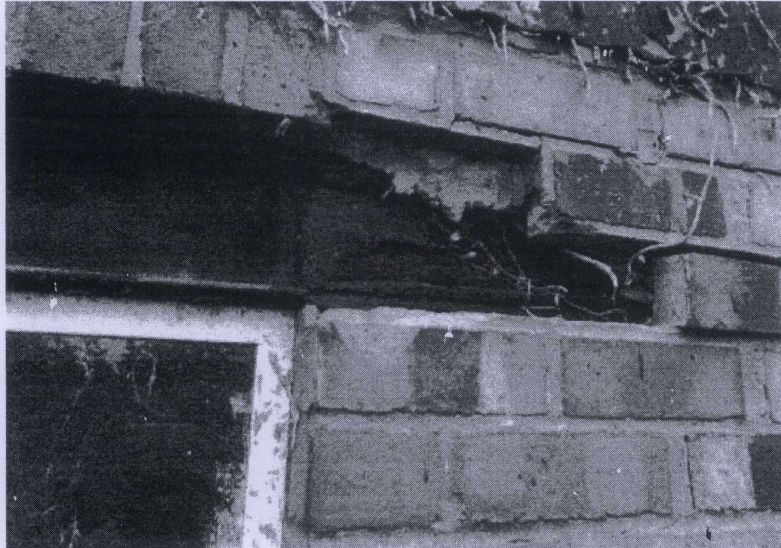
Photograph P3

**1.3** Externally the steel columns have steel tie members just below first floor level which are exposed externally and the brick walls are constructed above and below them. The exposed steel members have corroded badly and delamination has occurred in numerous locations, see photograph P3. The delamination of the steelwork has forced the brickwork to dislodge locally.

The steel framework would not be suitable for re-use in the proposed development for change of use, as the exposed steelwork has corroded badly in numerous locations. The steel frame should be removed from the structure and new loadbearing walls taken up to form the new upper wall construction. The brickwork will require bonding together when the existing steel columns are removed from the wall panels.

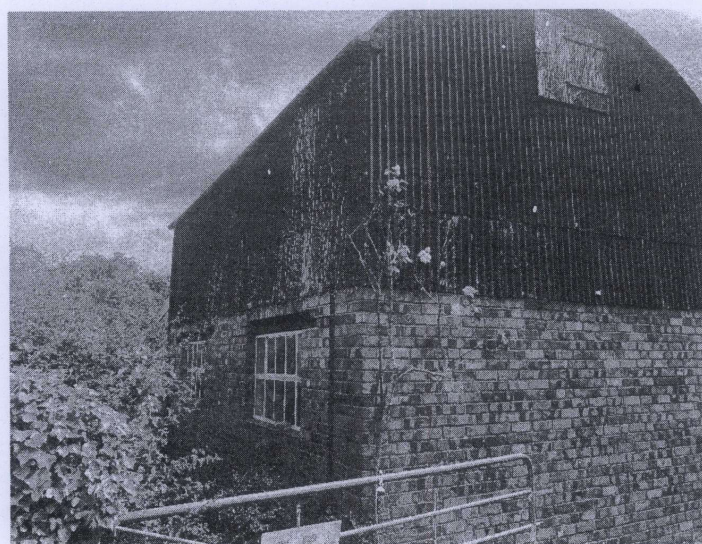
A1.2 Plate 2: View of Western (back) and Southern gable end of the outbuilding

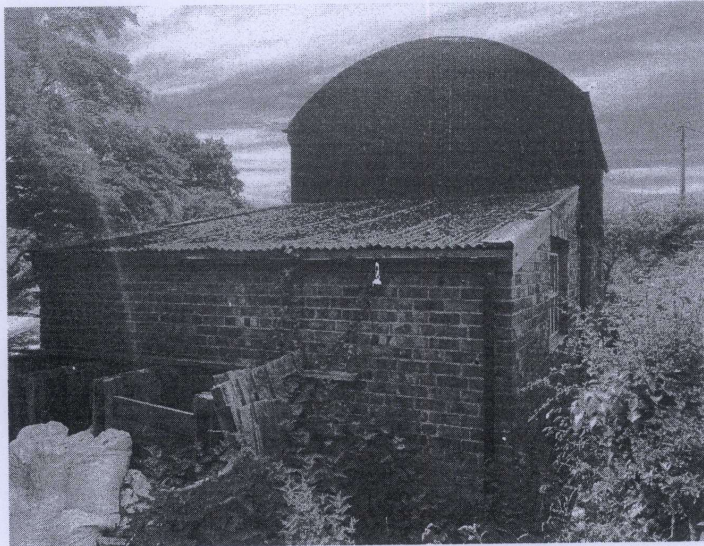
A1.3 Plate 3: View of Northern gable end of outbuilding and adjoining lean to shed

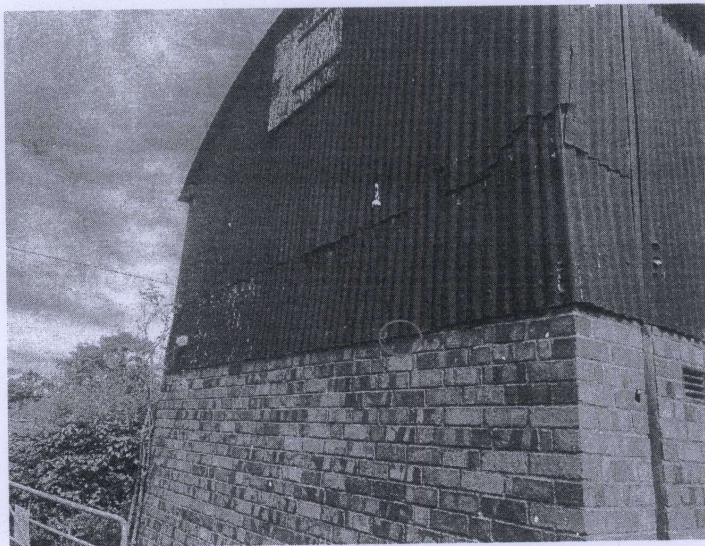
- 3.7.6 Two individual Soprano pipistrelles (*Pipistrellus pygmaeus*) emerged from between corrugated sheet metal and brickwork on southern aspect of the outbuilding at 21.52 & 21.59, from the same position as was seen during the Visual Assessment (Roost R1). No roosts were identified within Fir Tree House. Activity within the survey consisted of moderate levels of foraging activity of two Common pipistrelle, and a few brief passes of a myotis species. Too brief to analyse with confidence as to species. A single pass of a Brown long-eared bat (*Plecotus auritus*) was heard at 22:34.

A1.4 Plate 4: View of Southern gable end where bat was found during visual assessment and identified during nocturnal survey

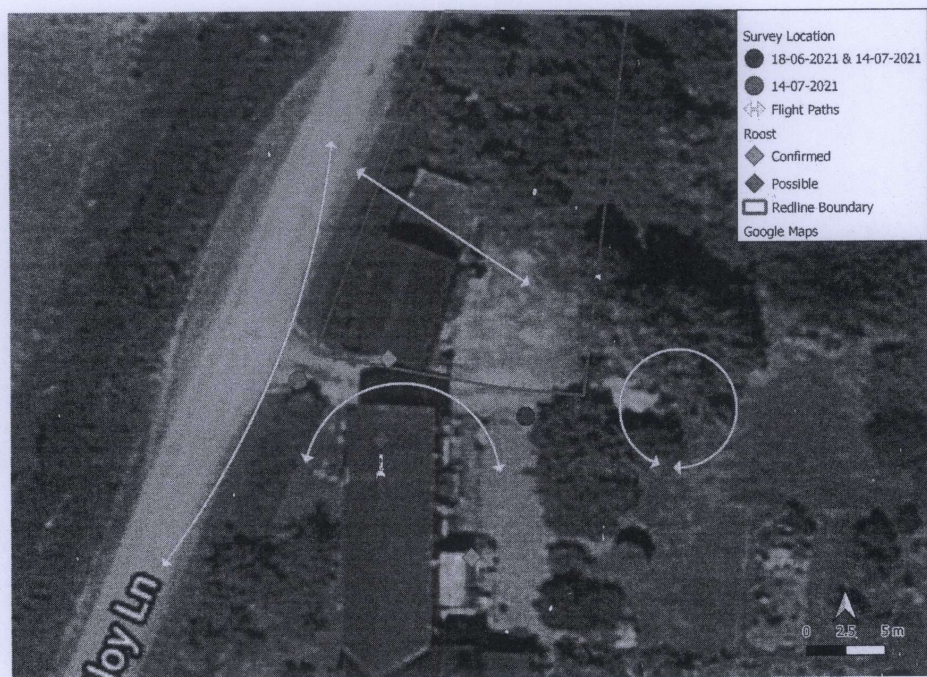
Figure 2: Bat Survey Results Plan

- 3.3.4 Overall, the building appeared to provide limited external roosting opportunities for bats; however, during the preliminary visual assessment on the 8<sup>th</sup> June, a single pipistrelle bat was seen to be roosting between the corrugated metal sheeting and brickwork on the southern elevation (plate 1 and 4). This roost is called Roost R1. The full depth of the roost can be checked externally from the ground.
