**Proposed conversion of outbuilding  
at Fir Tree House**

Cloy Lane, Overton, Wrexham

**Bat and bird survey**

July 2021

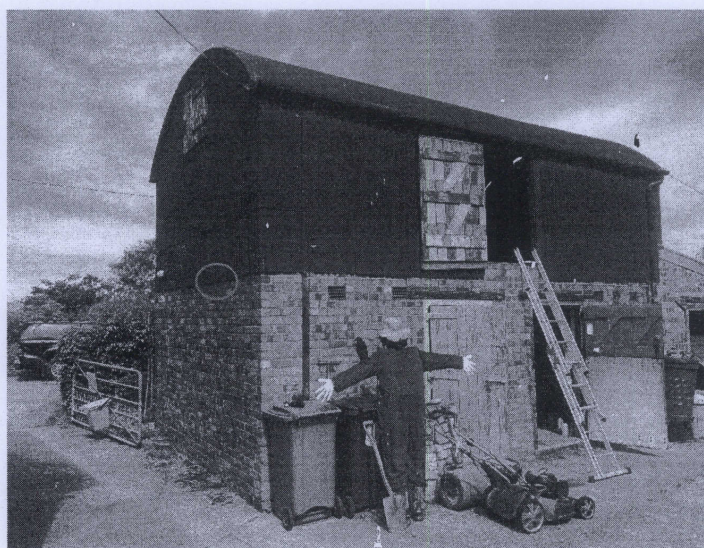
- 3.3.4 Overall, the building appeared to provide limited external roosting opportunities for bats; however, during the preliminary visual assessment on the 8<sup>th</sup> June, a single pipistrelle bat was seen to be roosting between the corrugated metal sheeting and brickwork on the southern elevation (plate 1 and 4). This roost is called Roost R1. The full depth of the roost can be checked externally from the ground.

A1.1 Plate 1: View of Eastern (front) aspect of the outbuilding. Note location of roosting bat marked with red circle.

- 4.7 Prepare a Precautionary Non Licensed Method Statement to facilitate the development of the outbuilding to be agreed by Wrexham Council and NRW prior to works commencing on Site. A summary of what the RAMS would include is below.

- The initial works will be carried out under "soft works" technique to include removal of roost features by hand. A licensed ecologist will provide a watching brief during the initial works and during works to areas where a potential bat roost is present and will be available throughout construction on an 'on call' basis.

- If works to the outbuilding are scheduled in the bat activity season (May to September, inclusive) A dawn return to roost survey will be conducted the morning before works to potential roost features takes place. A licensed ecologist will be present during the roof stripping.

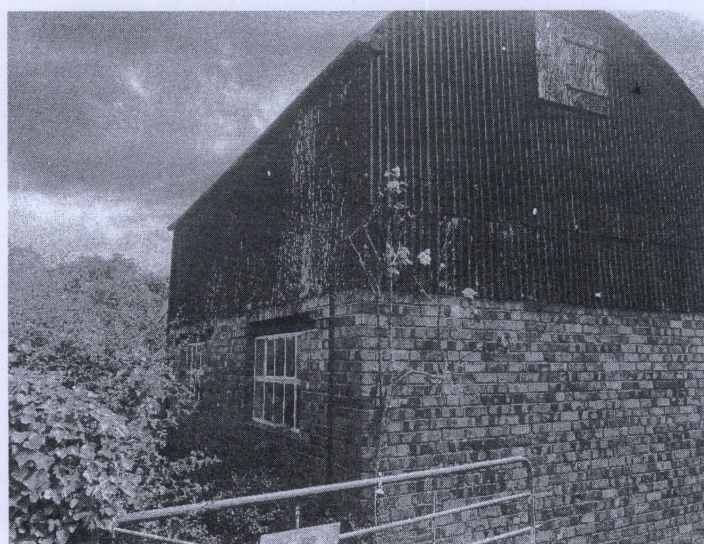
A1.2 Plate 2: View of Western (back) and Southern gable end of the outbuilding

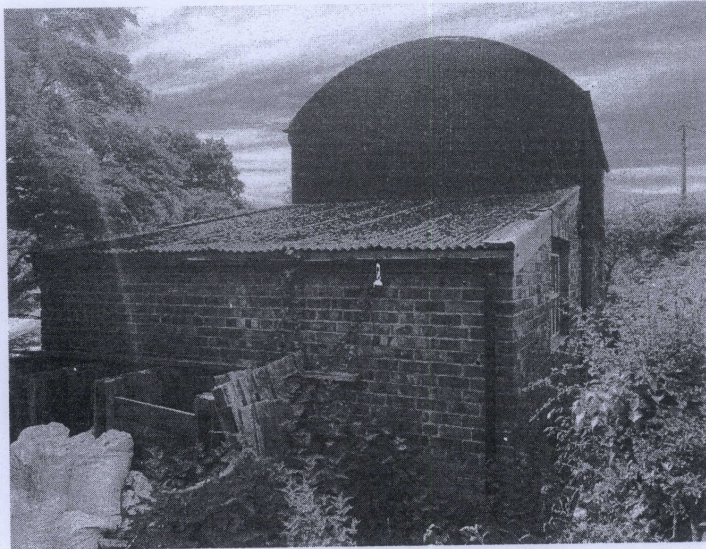
A1.3 Plate 3: View of Northern gable end of outbuilding and adjoining lean to shed

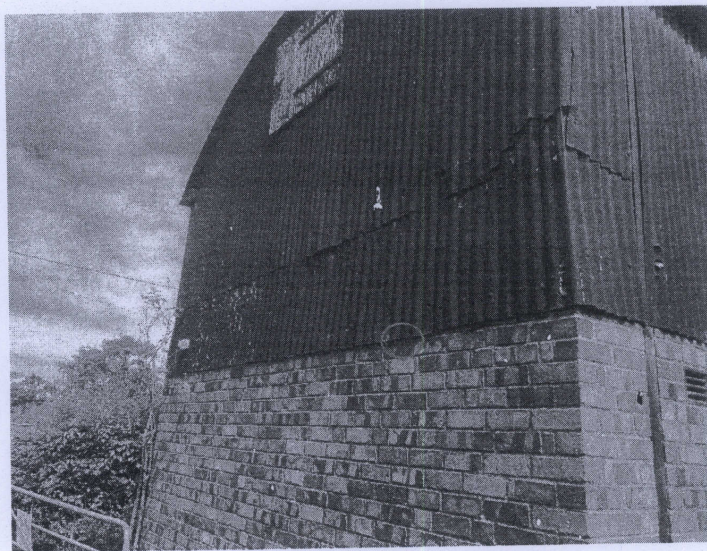
- 3.7.6 Two individual Soprano pipistrelles (*Pipistrellus pygmaeus*) emerged from between corrugated sheet metal and brickwork on southern aspect of the outbuilding at 21.52 & 21.59, from the same position as was seen during the Visual Assessment (Roost R1). No roosts were identified within Fir Tree House. Activity within the survey consisted of moderate levels of foraging activity of two Common pipistrelle, and a few brief passes of a myotis species. Too brief to analyse with confidence as to species. A single pass of a Brown long-eared bat (*Plecotus auritus*) was heard at 22:34.

- 4.4 No bats were seen returning to a roost within the outbuilding on the June dawn survey. Two common pipistrelle bats were seen emerging from the outbuilding during the dusk survey in July (Roost R1). No bats were seen roosting in Roost R1 on the 22<sup>nd</sup> July during a second Visual Assessment. It is considered that the outbuilding to be converted is being used occasionally by individual common pipistrelle bats to roost during the day. Bats are known to move between a number of roost through the year depending upon weather conditions, feeding opportunities etc. The roost in the outbuilding is between brick and steel corrugated sheets and faces Fir Tree House. The size, location, susceptibility to temperature variations and type of roost space does not provide opportunities for a high conservation status roost. There are no opportunities for hibernation roosts within the building. The outbuilding has a day roost of individual common pipistrelle bats and has a low conservation status. Other roosting opportunities are limited to occasional gaps in brickwork on the western aspect within the barn.

A1.4 Plate 4: View of Southern gable end where bat was found during visual assessment and identified during nocturnal survey

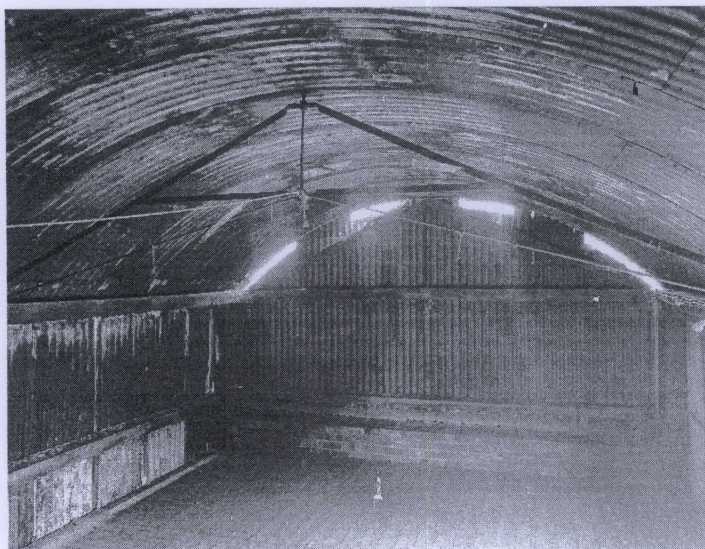
- 3.3.6 The corrugated sheeted roof of the barn is supported by a steel frame internally which has four columns to each corner. The steelwork is exposed internally. See plate 5

- 3.3.7 Internally the building provided negligible opportunities for roosting bats. No bat droppings or other signs of bat use was seen within the inside of the building. There are no opportunities for hibernation roosts within the building.

A1.5 Plate 5: Internal view of northern gable end of outbuilding

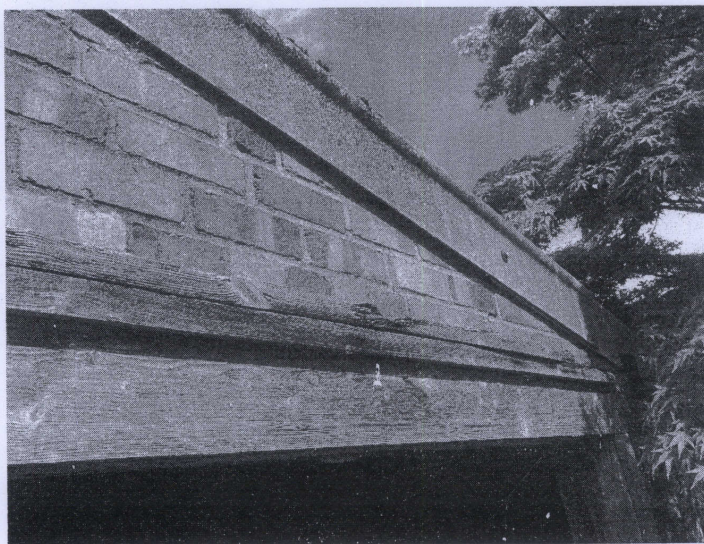
- 3.3.3 Potential roosting features are limited within the building. Potential roosting features consist of gaps between corrugated metal sheets and brickwork on southern, western and eastern building aspects (Plate 1-6); However, these were predominantly covered with dead ivy or heavily covered in cobwebs. The number of gaps suitable for roosting bats are limited to those on the southern elevation and further limited to only 18 in number due to the presence of cobwebs. The western aspect is heavily cluttered by vegetation growth and roosting features are limited to 3 gaps within brickwork around the windows (plate 7). A gap behind the

asbestos/concrete sheet facia board on the lean to also provides a potential roosting opportunity (plate 6).

A1.6 Plate 6: View of adjoining lean to shed on eastern aspect (front) showing gap between barge board and brick

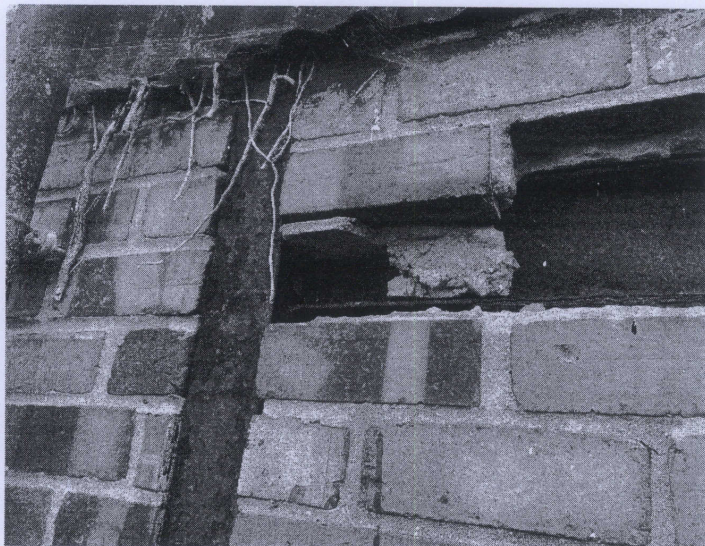
During the visual assessment, no evidence of use of the building by birds was identified. Opportunities for nesting birds do exist within the outbuilding in the form of cracks in the brick works around the windows.

A1.7 Plate 7: Dislodged brickwork showing voids and crevices

To avoid impacts on nesting birds, a nesting bird survey will be undertaken by a qualified ecologist prior to any works taking place within the above-mentioned breeding season. If nests are identified, the nests must remain intact and undisturbed until young have fledged. The demolition of the buildings will result in long-term loss of nesting opportunities for birds. Mitigation will be required to compensate for the loss of nesting habitat and to facilitate the development.

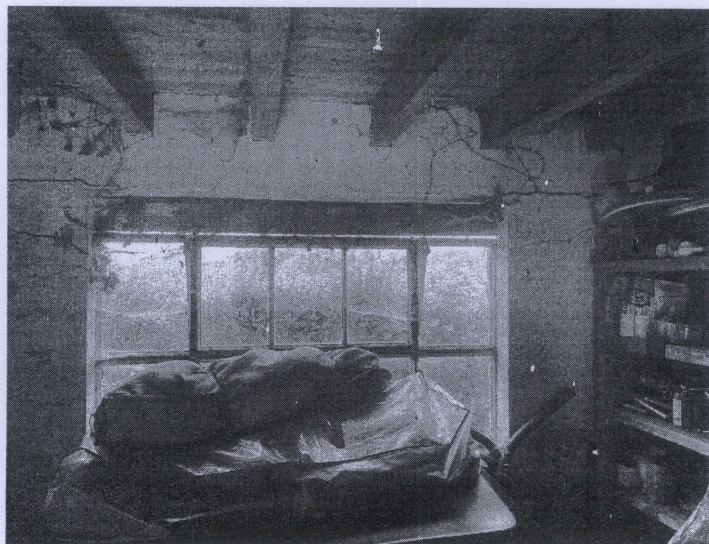
A1.8 Plate 8: ground floor stable used for storage
