**BAT PRESENCE / ABSENCE SURVEY**

**Carlton Garden Centre**

Pinfold Lane  
Llay Industrial Estate  
Wrexham  
LL12 0PX

| UES reference: | UES04084/04 |

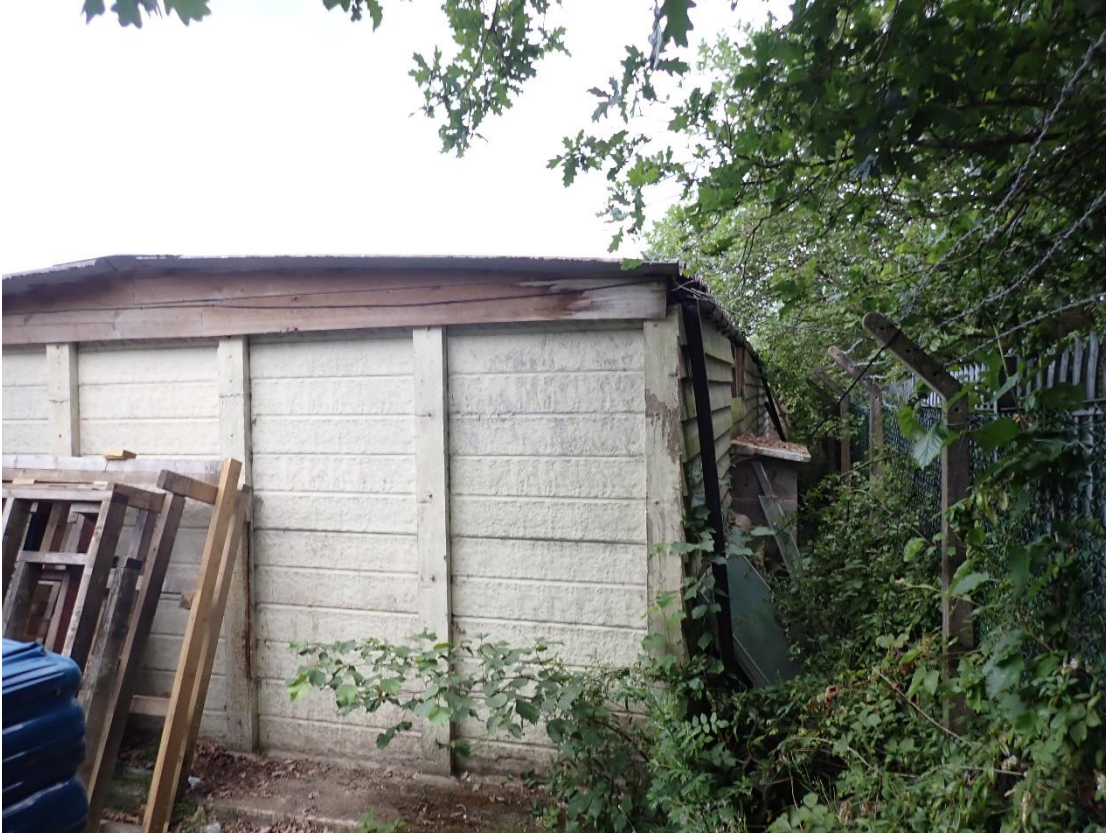
**Building 1** is single story with a pitched roof of asbestos sheeting (see Appendix 3 – Photographs, Photograph 1). The corrugated roof is generally well sealed with the exception of a small number of areas where it is slightly raised (Photograph 2), timber bargeboards surround the periphery of the building some of which are in good condition but have gaps between them and the external walls. These gaps are heavily blocked by cobwebs, suggesting they are not currently in use by bats (Photograph 3). The walls are constructed of concrete cladding with timber cladding to the south aspect. Some gaps in between the concrete

Photograph 1 – northeast aspect of building 1 on site.

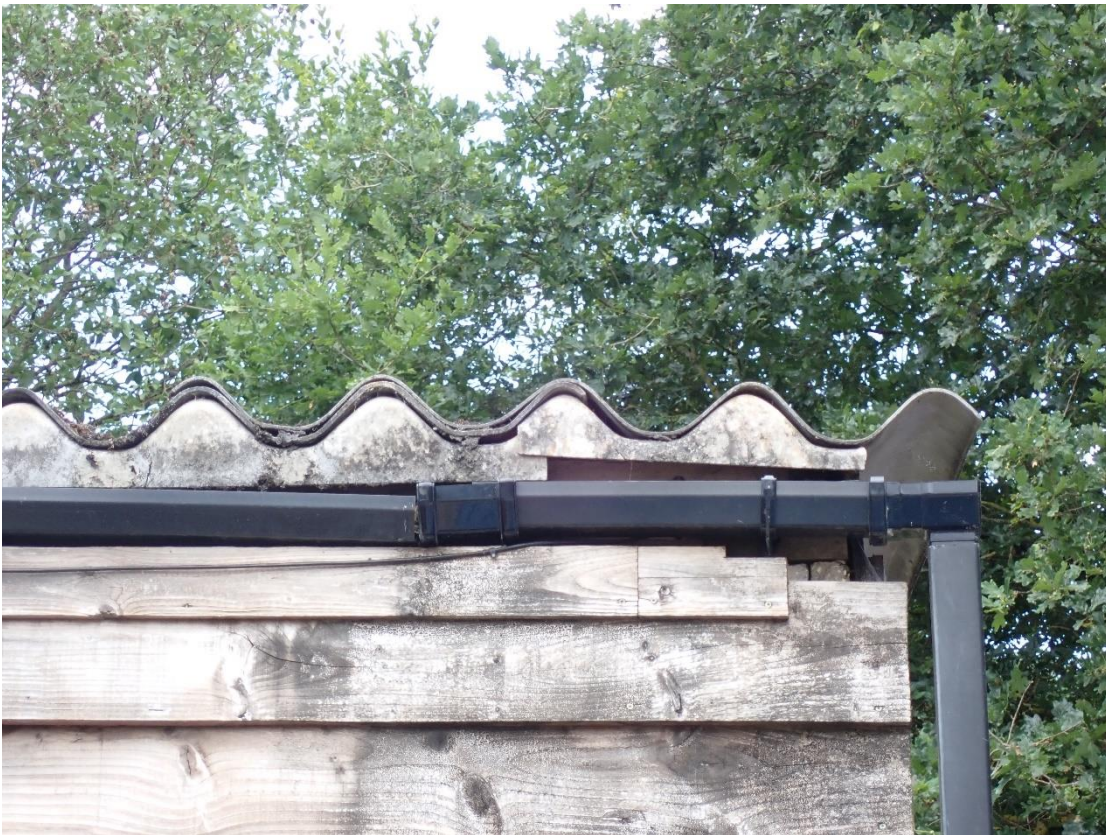
Photograph 2 – southeast aspect of building 1 showing lifted corrugated asbestos sheeting.

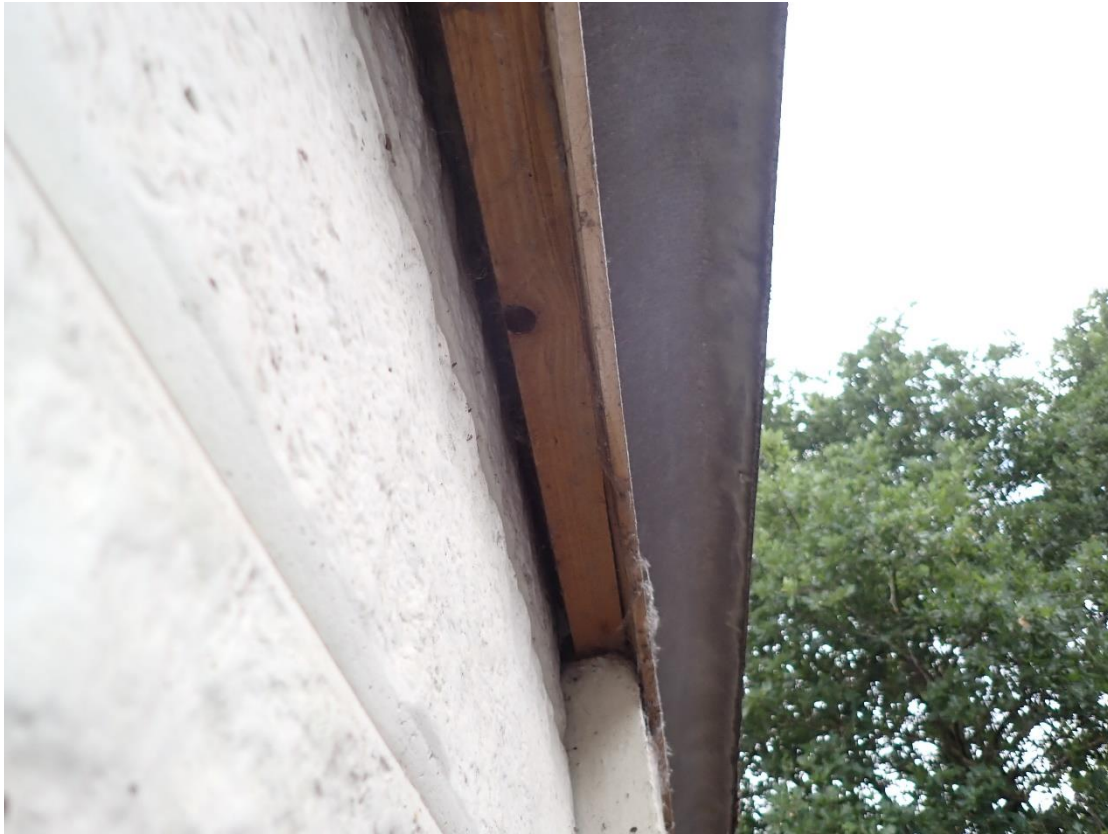
Buildings 1 and 2 present a number of PRFs which could be used by roosting bats such as gaps between bargeboards, fascia and the walls. However, no field signs of bat activity such as droppings, were identified, and the majority of PRFs are heavily cobwebbed suggesting no recent use by bats.

Photograph 3 – gap beneath timber barge board on northeast aspect.

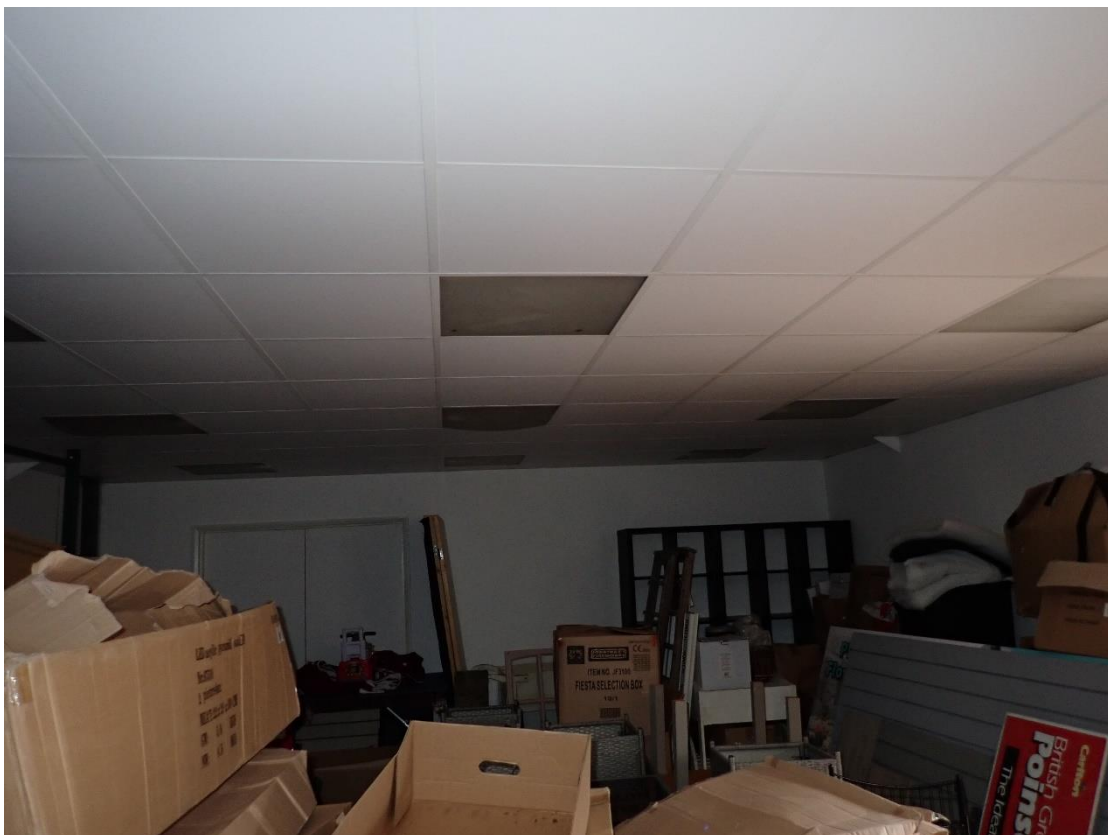
**Building 1** is currently utilised as a storage and is not in regular use, it has a suspended ceiling and no loft space. The space had a floor to ceiling height of approximately 3.5m and has no natural light ingress. There are no PRF's associated with the internal space and no evidence of roosting activity was identified.

Photograph 4 – south to north across internal space within building 1, false ceiling and no roof void.

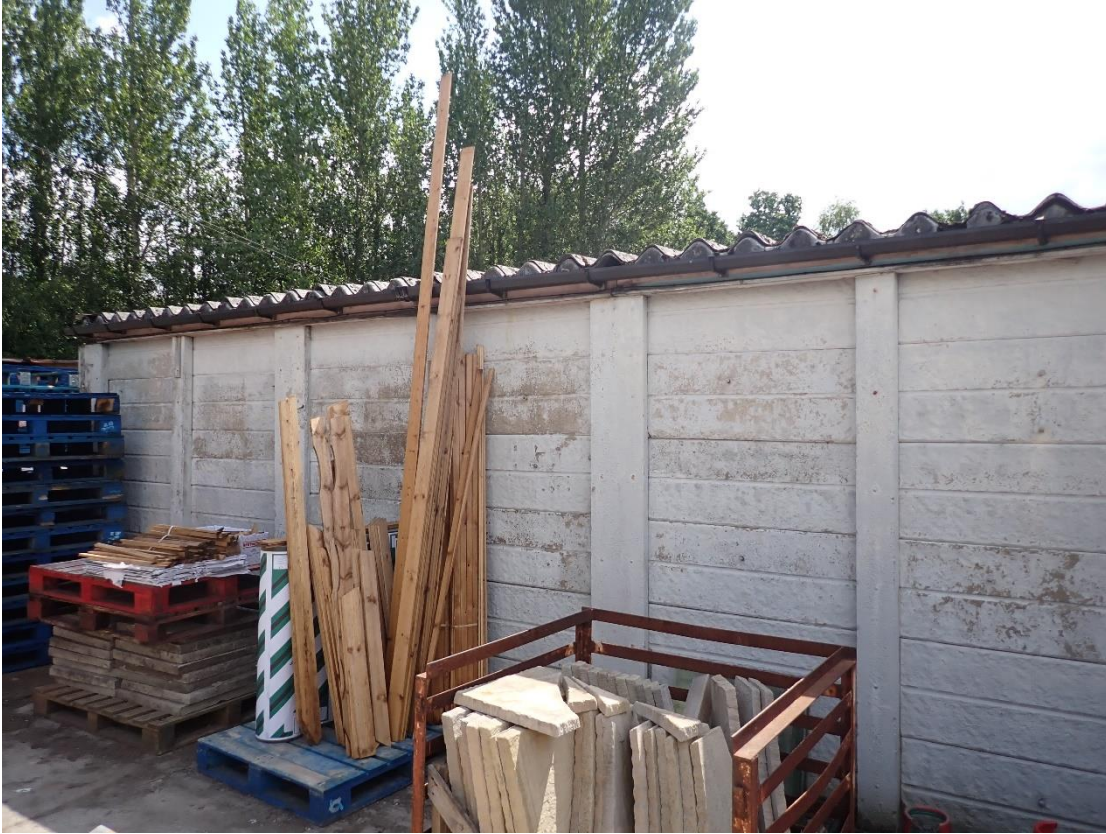
**Building 2** is constructed of similar materials to building 1 with a pitched roof primarily covered with corrugated asbestos (Photograph 5 & 6) that adjoins the garden centre. The portion of roof extending out to the west is pitched with felt roof tiles that do not contain any suitable PRFs (Photograph 7). The eaves of the roof have both timber box soffits and bargeboards, some of which present PRFs by way of gaps between them and the external wall (Photograph 8 & 9). The facade of the building is clad in concrete and is in generally good condition.

Photograph 5 – northwest aspect of building 2.

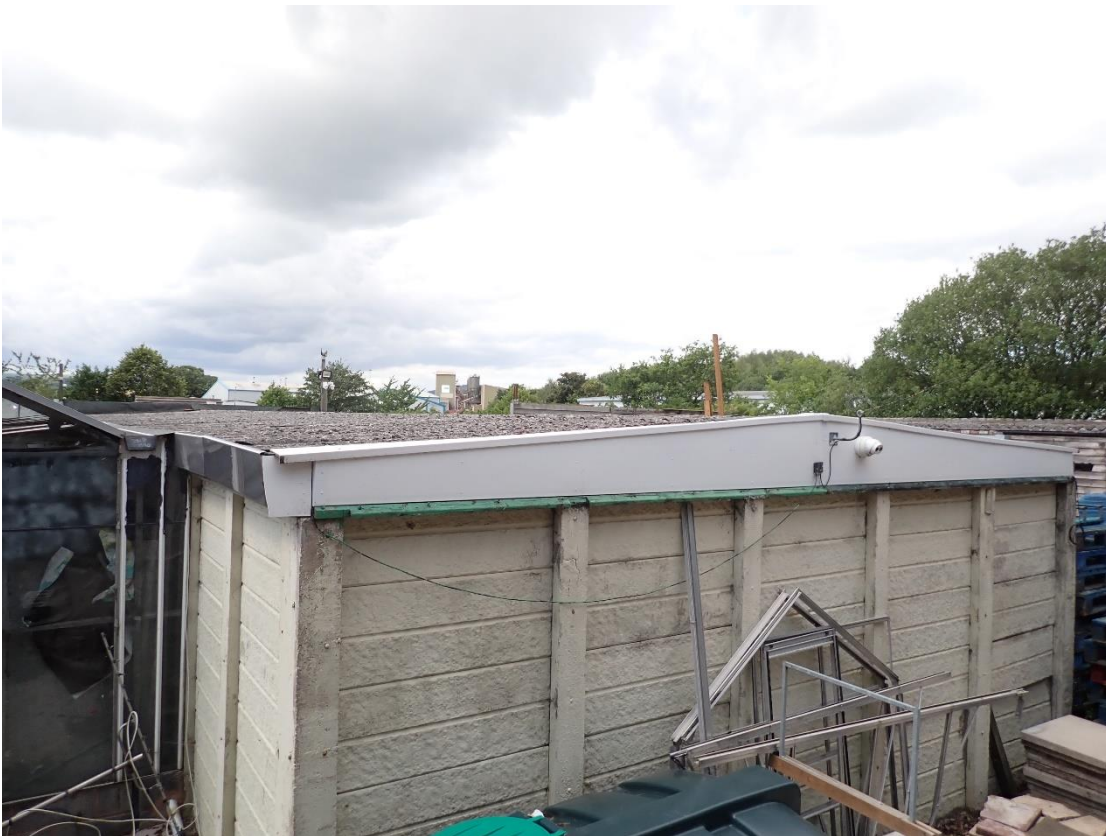
Photograph 6 – northeast aspect of building 2 with asbestos flat roof.

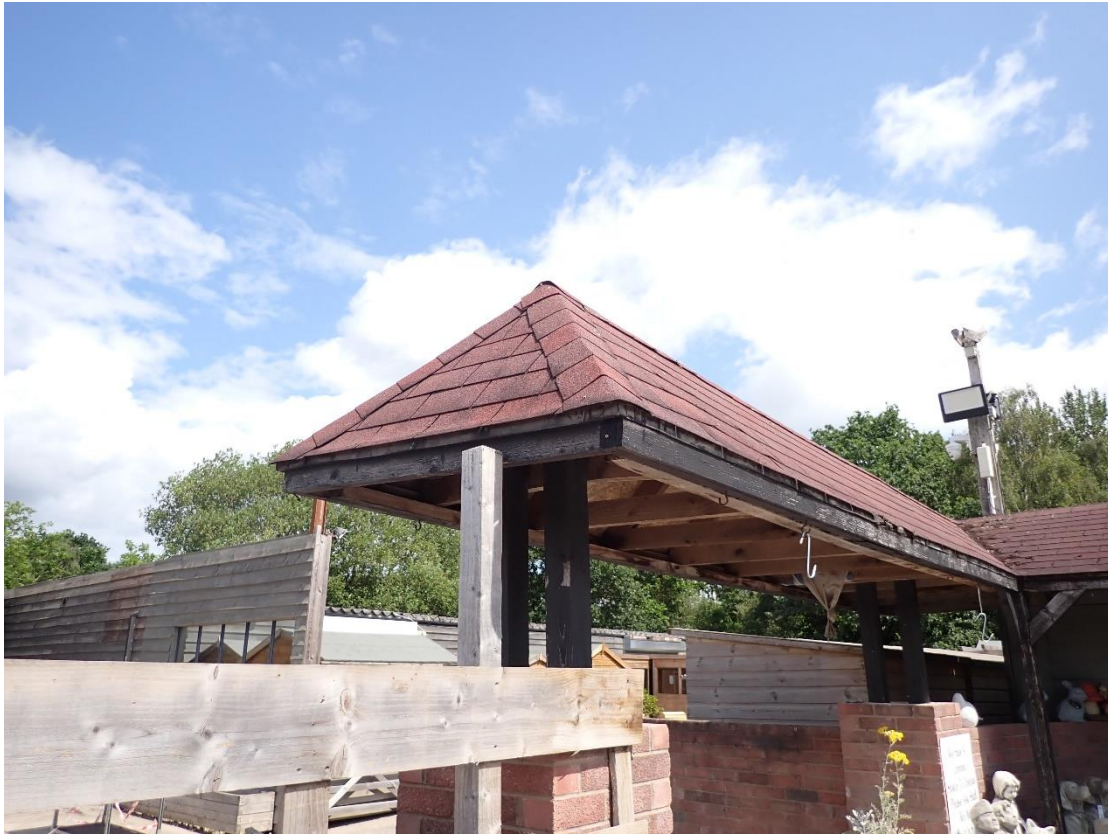
Photograph 7 – roof structure extending from west aspect of building 2.

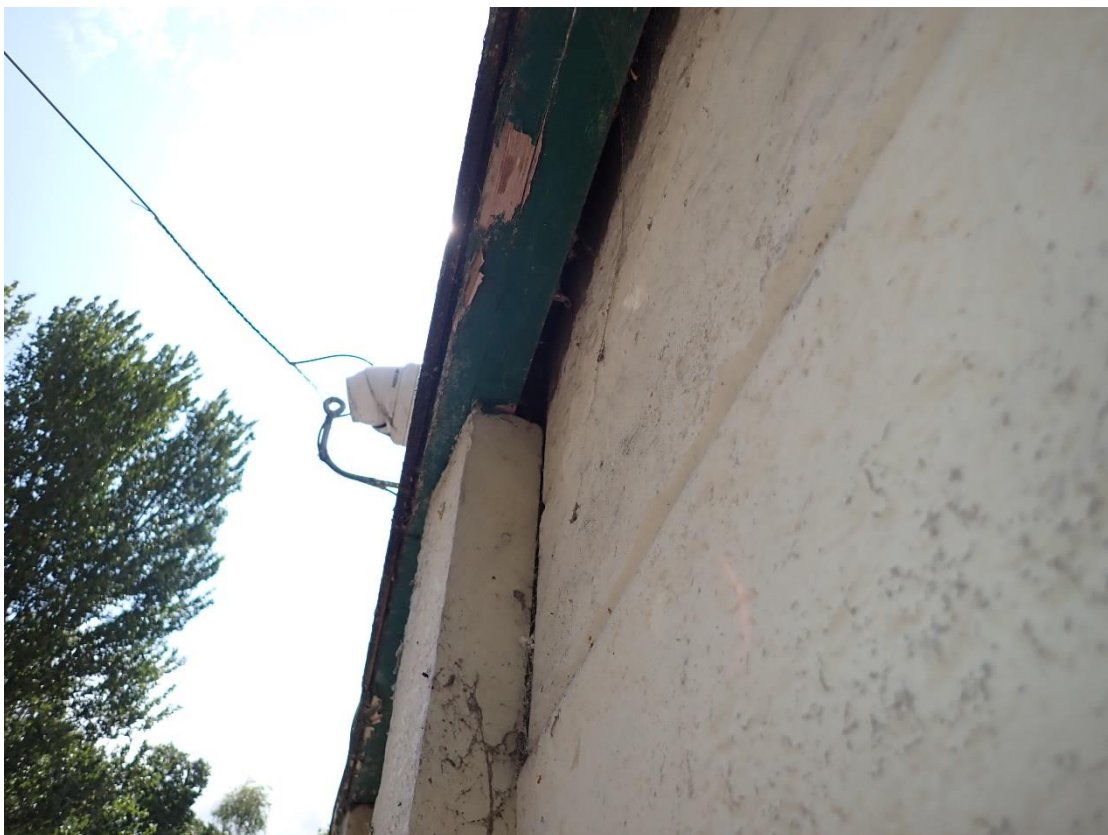
Photograph 8 – gap beneath timber barge boards on northeast aspect of the building on site.

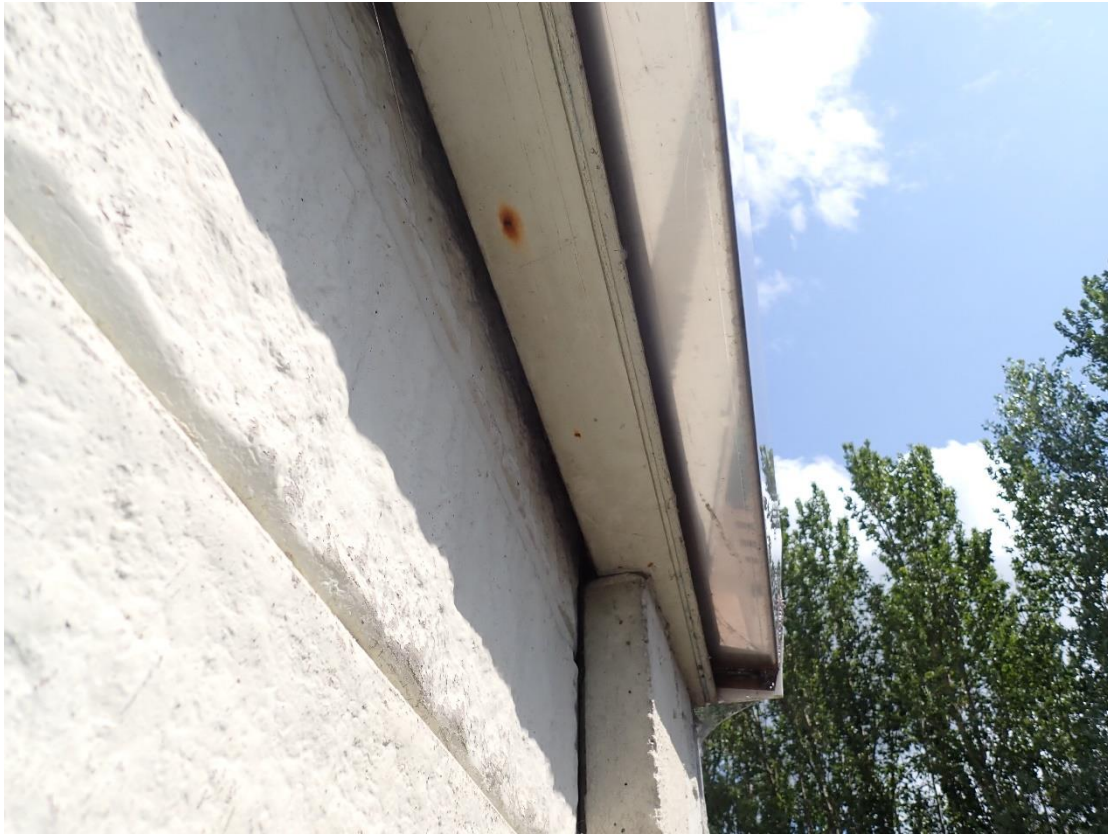
Photograph 9 –gap between timber soffit and concrete façade on south aspect of building on site.

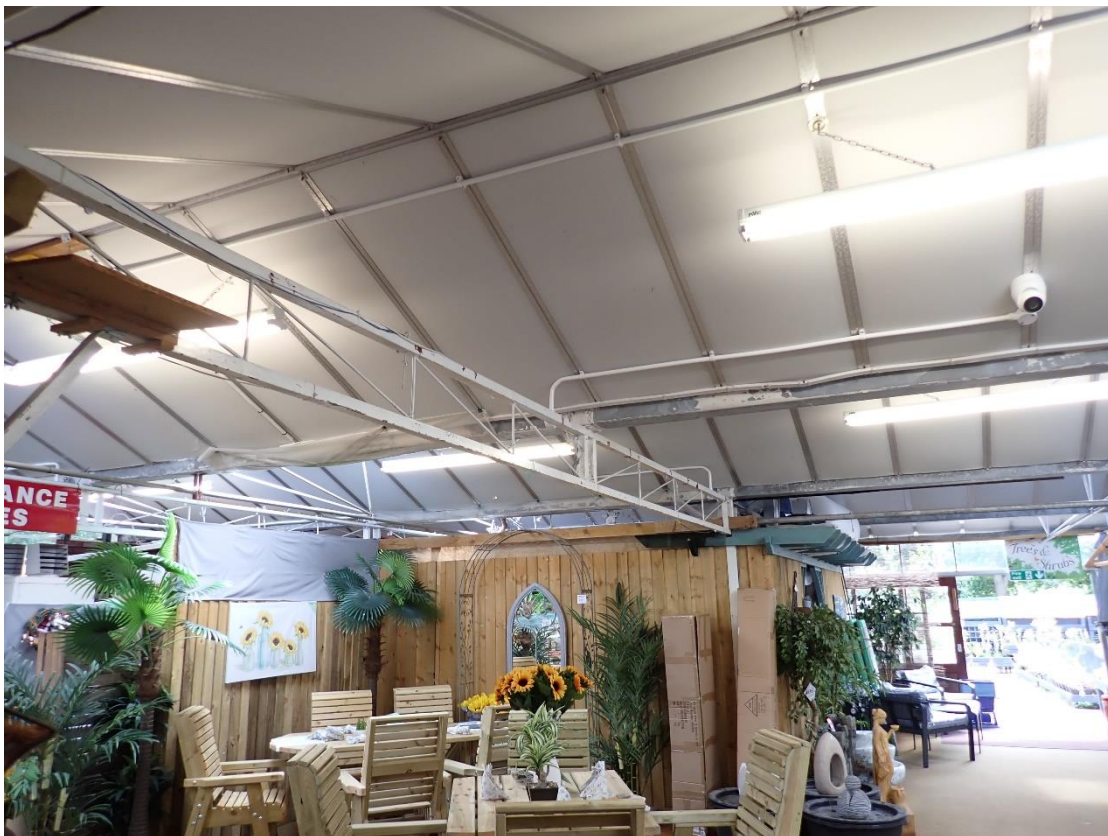
**Building 2** is a functioning garden centre. The space is open from floor to ceiling with varying roof heights. The internal space is largely well-lit with large proportions of the walls and roof, constructed of glass. Some areas of the internal space are open to the above roof structure, whilst in other areas a suspended ceiling is present as with Building 1. There are no PRF's within the internal spaces and no evidence of roosting activity was found internally..

Photograph 10 – north to south across garden centre showing single lined pitched roof.

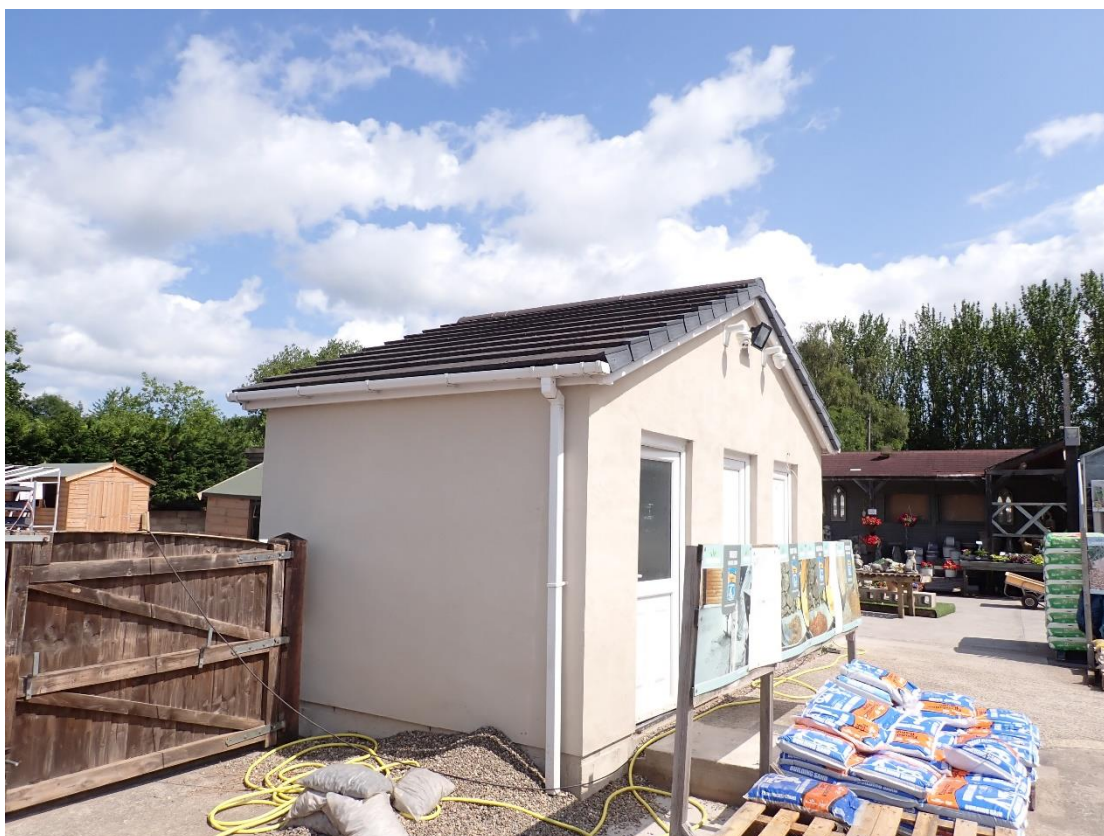
**Building 3** there is an additional recently constructed toilet block on site with a concrete roof and rendered walls. This structure was assessed as having negligible potential to support roosting bats, furthermore it is due to be retained as part of the proposed plans and will not be discussed further.

Photograph 11 – negligible WC structure on site due to be retained as part of proposed plans.
